# TECHNICAL BULLETIN

JTB00313

### Headlamp Internal Staining

**XK Range (X150)**

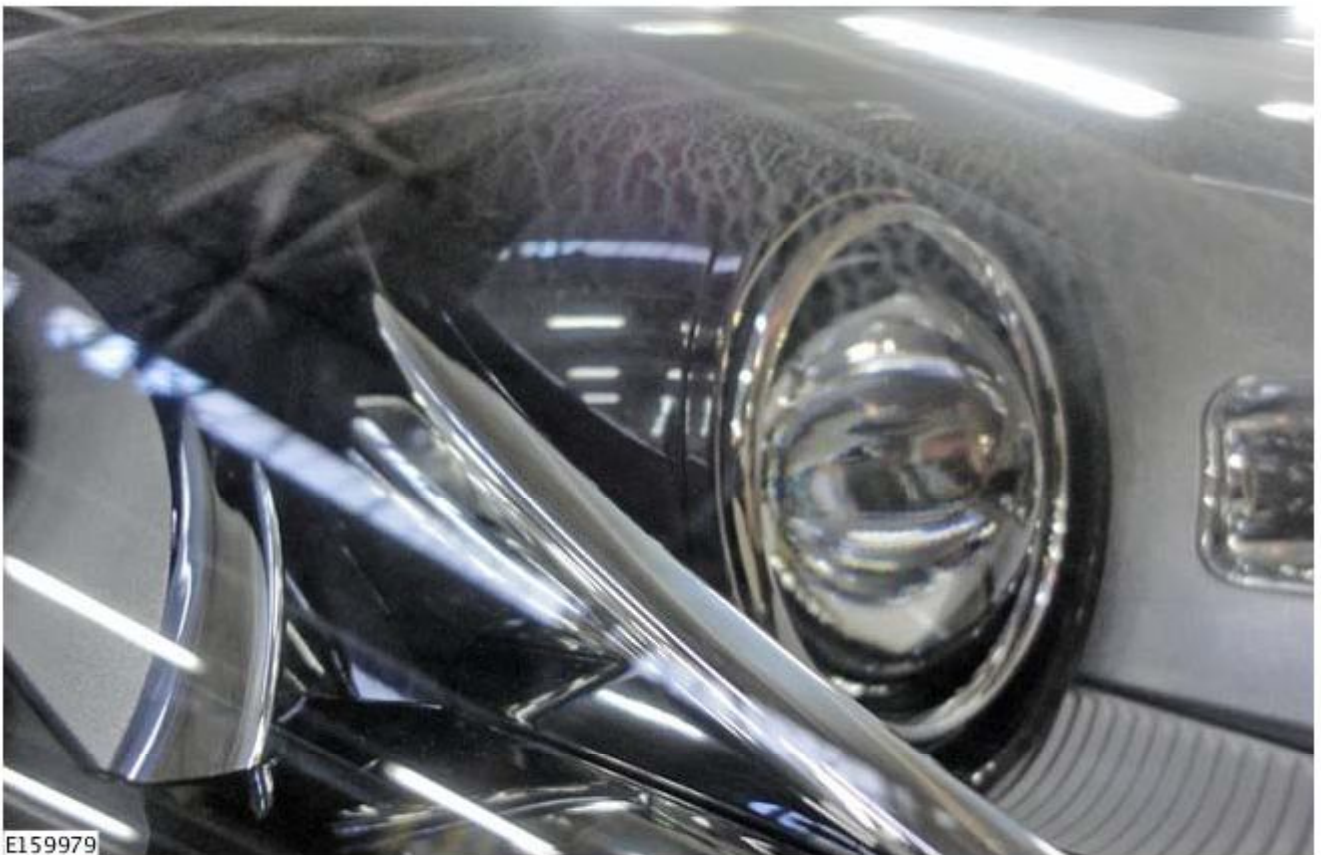
1.

**NOTE: Example of headlamp staining**

Inspect headlamp unit.

3. If staining is present replace both headlamps (see Topix Workshop Manual, Section 417-01).

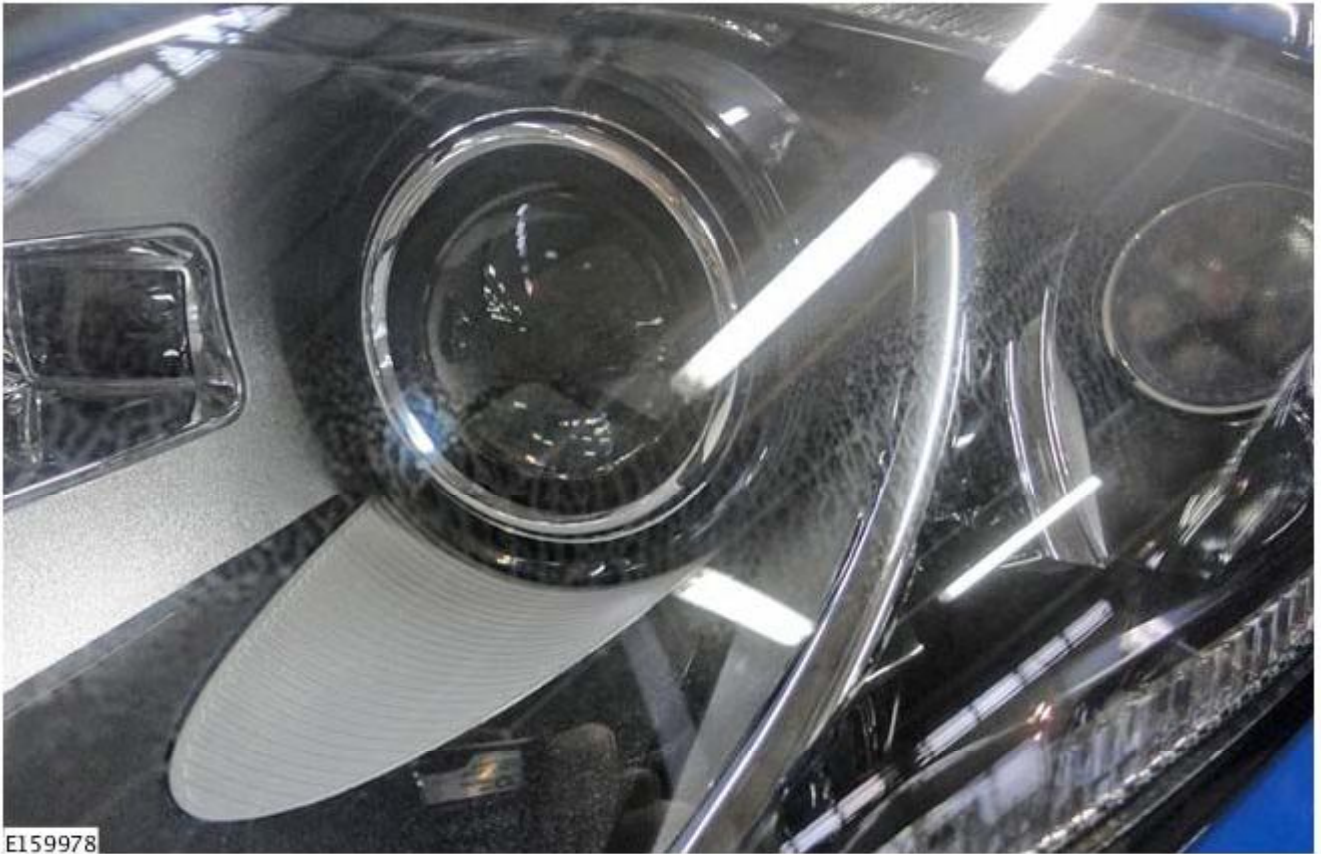
2.

**NOTE: Example of headlamp staining**

Inspect headlamp unit.
