V8 XJ Series/XK

303-S514

TECHNICAL BULLETIN

Operation Of Throttle While In Closed Position – Service Action S514

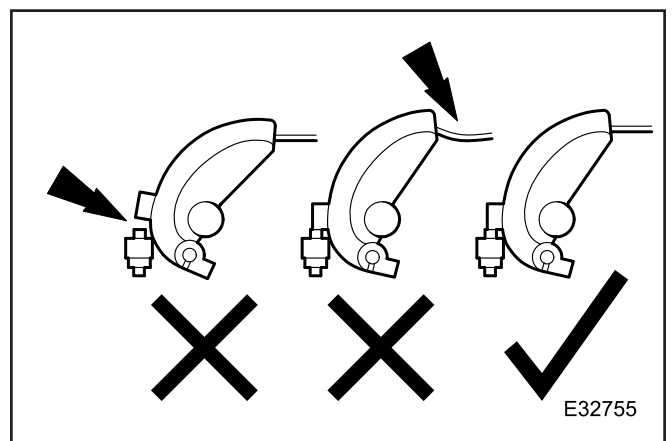
ILLUSTRATION 15

⚠ Caution: Under no circumstances should the quadrant be held clear of the throttle stop by cable tension. Ensure there is no tension or slack in the cable.

Install the throttle cable. Tighten the locknut without altering the setting or introducing any twist into the outer cable.
