Water Entry Into Front Footwell –
Repair Procedure –
Service Action S824

MODEL 1998 MY
XK8 Range
VIN 024687-026557
see list for exceptions

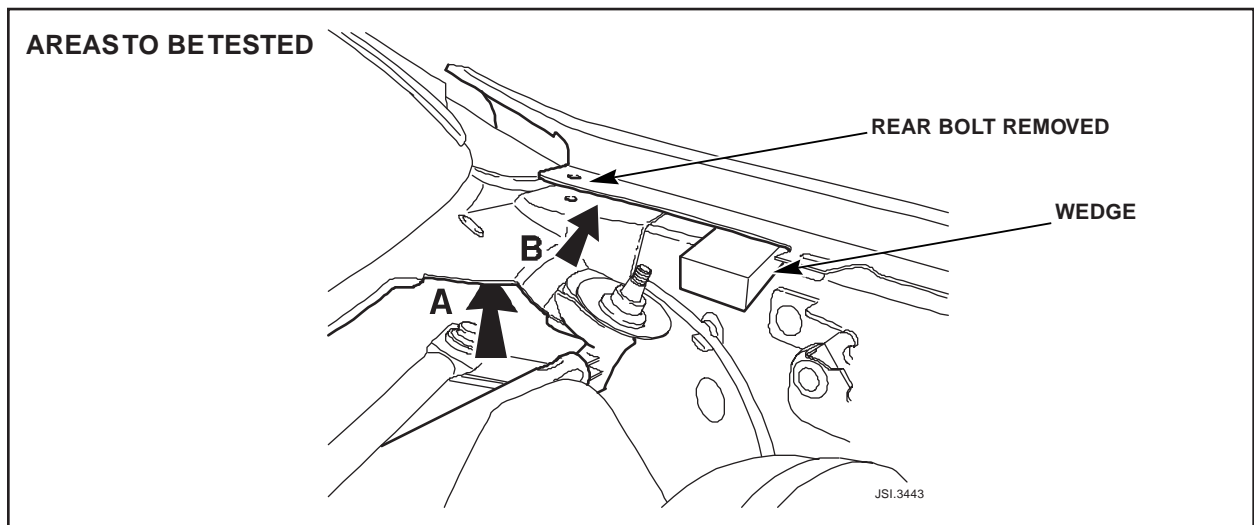
ILLUSTRATION 1

The following instructions apply to both left and right sides of the vehicle.
Seam areas which have been shown to leak are shown in Illustration 1, as follows:

- A. In the top corner, inside the false bulkhead area under the plenum finisher.
- B. Between the rear upper corner of the fender and the cowl.

1. Aim a jet of water in the direction of arrow **A**, Illustration 1, (under the finisher, to the rear), into that area for **at least 2 minutes**.

1. Remove both windshield wipers and the plenum finisher.
2. Remove the two mounting screws furthest to the rear of the front fender. Support the rear of the fender with a wedge, to provide access to the seam (Illustration 1.)
3. Aim a jet of water in the direction of arrow **B**, (under the fender, to the side), into that area for **at least 2 minutes**.
4. Wait for **at least 2 minutes**.
5. Check the area for the presence of water by removing the paper or rag and then looking for absorbed water.
6. Check for evidence of water in the area, visually with the aid of a lamp and also by feel.
7. If the area is dry, at both sides, then the vehicle is OK. Refasten the fender and then reinstall the plenum finisher and windshield wipers.
8. If water is detected, proceed with the following repair procedure:

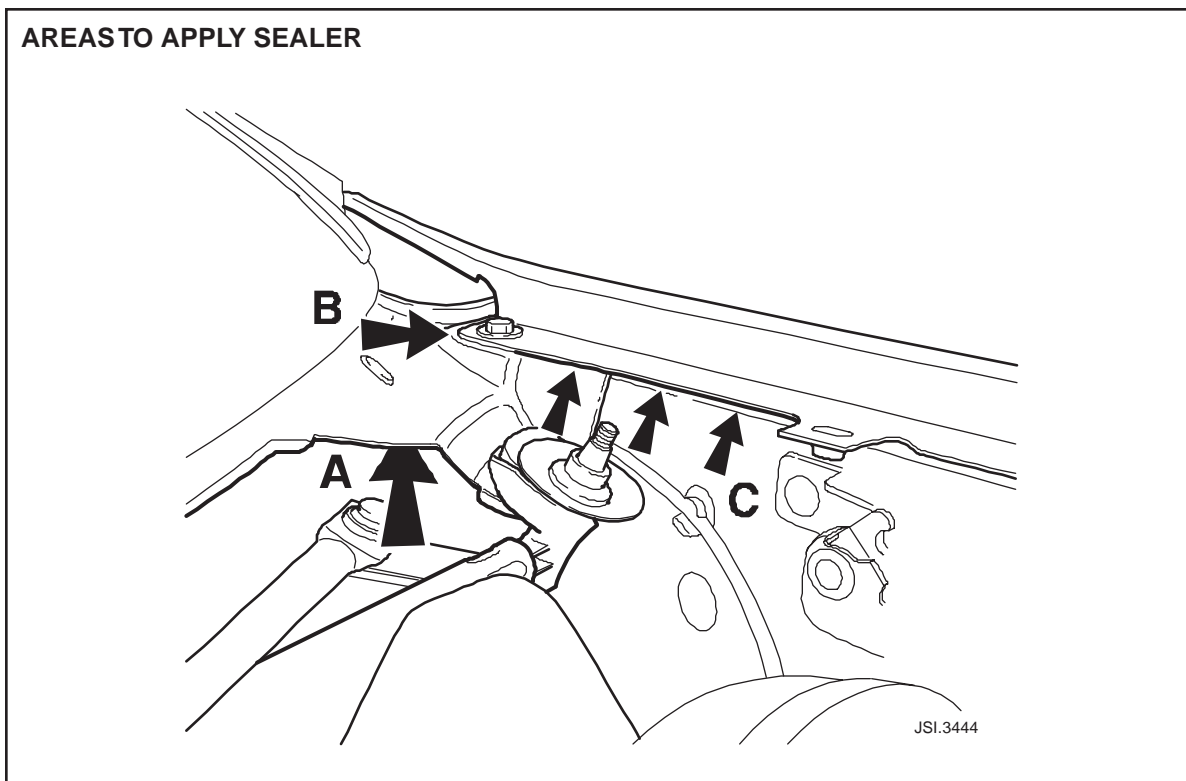
ILLUSTRATION 2

1. Remove both windshield wipers and the plenum finisher.
2. Use a lamp and mirror to examine the areas to be sealed. Since it is not possible to see the gap that is the cause of the leak, the whole available area of the seam must be resealed.

3. Seal the seams in the A-pillar, plenum and fender areas, (A, Illustration 2), with suitable clear sealant.
4. Seal the seams in the area below the plenum panel and up into the outer corners, (B, Illustration 2), with a suitable caulking compound and a suitable clear sealant.
5. Fill the area, (C, Illustration 2), below the fender edge, with a suitable caulking compound.

6. Seal the seam, in the area exposed by the lifting of the rear of the fender, with a suitable clear sealant.
7. Check the effectiveness of the sealing operation by repeating the water tests described above. If a leak is still evident, repeat the sealing procedure and retest.
8. Refasten the fender and then replace the plenum finisher and windshield wipers.
