© D. Jensen 2006	REPLACEMENT OF XK8 CONVERTIBLE REAR WINDOW REGULATOR	V. 1.0 September 2006
Distribution: www.jag-lovers.com

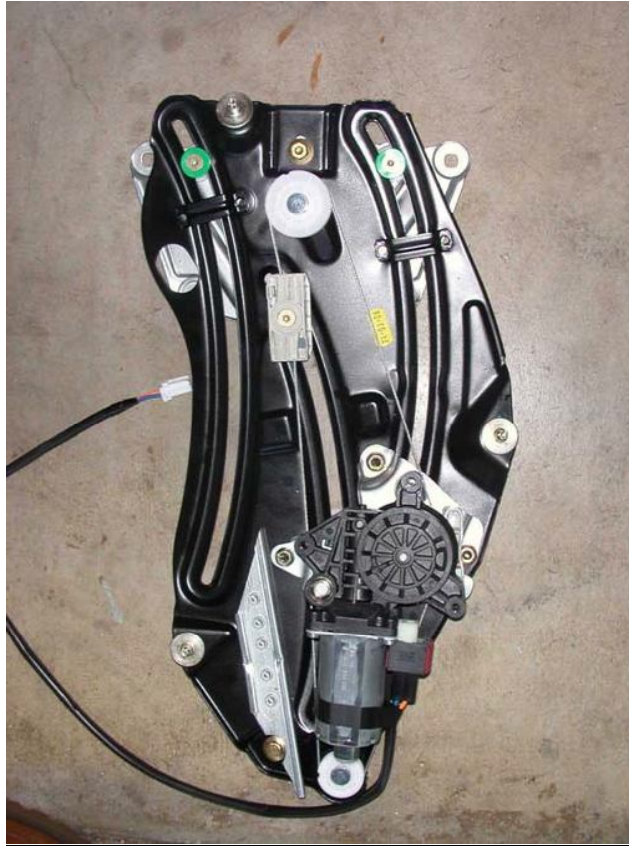
Fig. 1 New window regulator

While I probably could have repaired the regulator given enough time and a good machine shop, I wanted to get the car back on the road as soon as possible. I also didn't want to repeat this repair if my fix failed at a later date. Thus I opted to buy the replacement regulator for \$294 (before tax) (see Fig. 1). This unit did not include new glass or seals, which I didn't need. Jaguar apparently no longer sells just the regulator alone so the cost of a replacement unit with glass and seals can be expected to be significantly more.

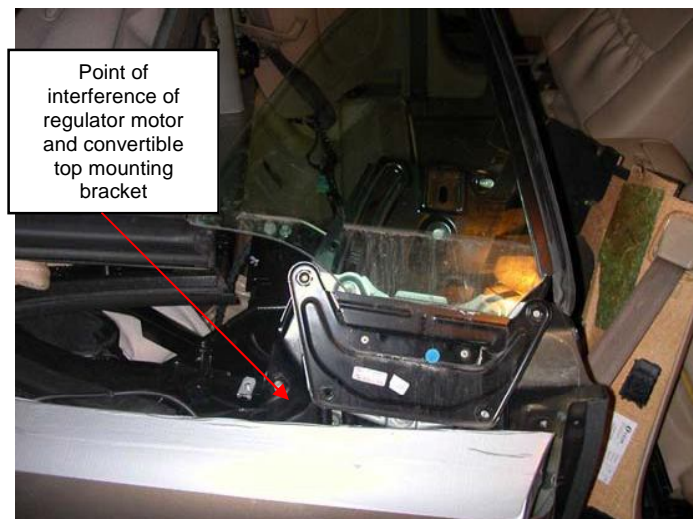
14. Remove the upper and middle nuts holding the regulator in place and undo the lower nut (it will remain in place because the attached washer is held to the body by silicone sealer) (Sec. 86.25.11, Steps 12 and 13) (see Fig. 12 above). Route the feed link and multiplug connector through the water shedder. Once loose, push the regulator outward to free the adjustment bolts from their holes. As I inferred from the Jag instructions re removal of the top, I could not remove the window/regulator due to interference between the regulator motor and the convertible top bracket (see Fig. 19).

Fig. 19 Window/regulator partially removed

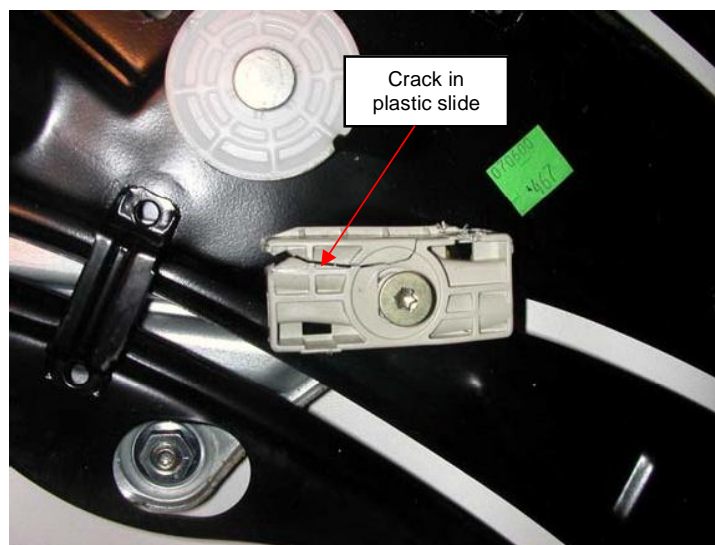
16. The next step is the real time saver. Remove the three bolts holding the convertible top bracket in place. Then push the bracket inward enough to provide clearance for the window/regulator assembly. As you might imagine, I breathed a large sigh of relief when the assembly came up and out.
17. Upon examination, the cause of the failure was evident (see Fig. 21). The plastic slide that secures both ends of the drive cable had split, allowing one end of the cable to come free (accounting for the loud “pop” since the cable is very tightly wound) and preventing further movement. Note that the slide is of two-piece construction plus pivot (not evident in the photo) and has fairly complex internal features that could be replicated, but not easily.

Fig. 21 Failed plastic slide

18. Remove the two bolts securing the glass to the old regulator (if the glass is not included as part of the new unit) and attach it to the new unit.
19. Reinstall the window/regulator in the reverse manner of removal, with one added step, adjustment of the window stop (see below). Positioning the adjusting bolts in their holes on the body proved easier than I thought. Position the regulator in the approximately correct location and then locate the bottom adjuster in the nut/washer attached to the body. Thread the other two nuts of the adjustment bolts. Adjust the unit as described in Sec. 86.25.11, Steps 10 – 22. This adjustment took me about 30 minutes of fiddling to get it right.

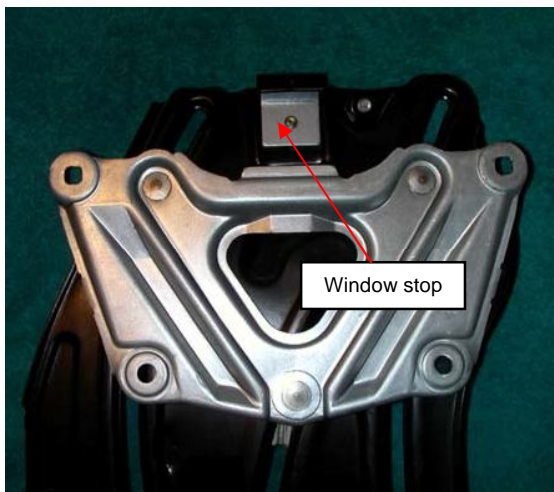
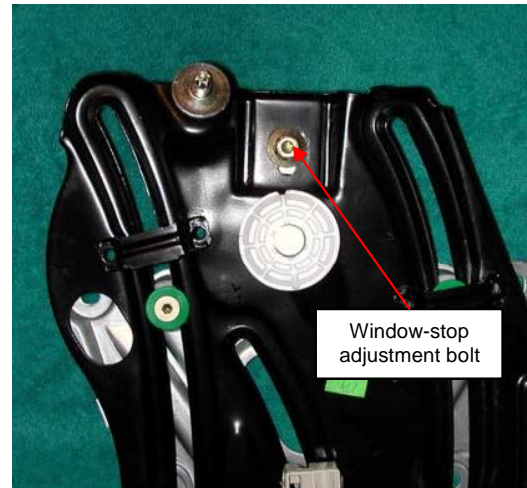
20. One item not mentioned in the manual and that I overlooked at first was adjustment of the window stop on the new regulator (see Figs. 22a and 22b). As received, the stop on the new regulator did not allow the window to rise to a fully closed position in the convertible top rubber seal, leading to wind noise and water leaks. A check of my failed regulator showed the stop had been at its uppermost position, whereas the new unit was at its midpoint. As expected, making this adjustment addressed both the wind noise and water ingress issues.

Figs. 22a and 22b View of window stop and adjustment bolt
