MODEL  
S-TYPE  
XJ, XK

NUMBER  
JTB00070  
Version 1

## **TECHNICAL BULLETIN**

### **Transmission Noise During Gear Shifts – Repair Procedure**

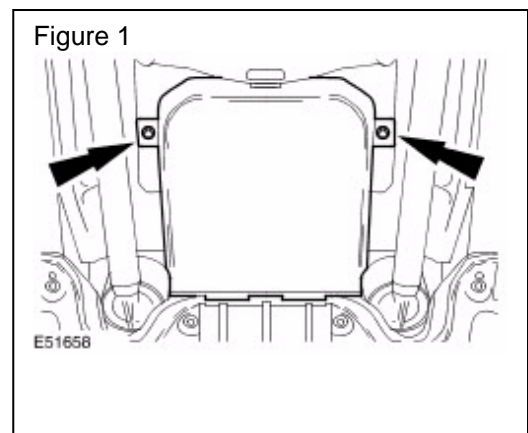
1. Raise vehicle on a four-post ramp.
2. If an S-TYPE vehicle is being repaired, remove the engine undertray. (Figure 1)
3. Place clean drain container under the transmission.

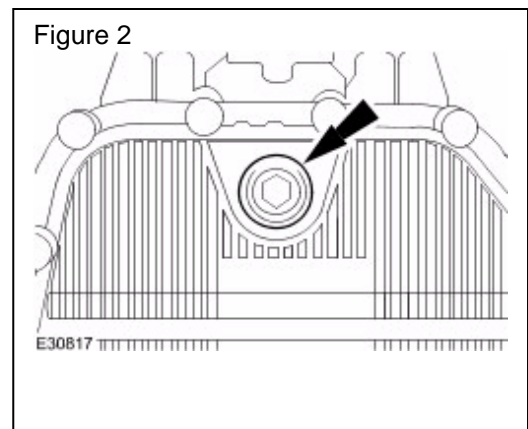
4. Undo and partially remove the transmission fluid drain plug. (Figure 2)
5. Collect one liter (33.8 oz) of fluid from the transmission into a clean measuring jug.
6. Reinstall and tighten the transmission fluid drain plug to 8Nm (5.9 lbf ft).

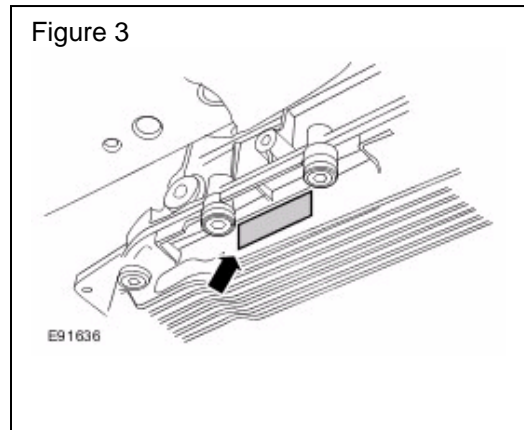
7. Ensure the selector lever is in 'P' and the handbrake is applied.
8. Start the engine and allow to idle.
9. Unscrew transmission **filler plug** and fill with one liter of the additive (C2C 37157) using a clean syringe.
10. Install filler plug.
11. Pull the service fix label off the bottle and apply it to the transmission oil pan near the filler plug. (Figure 3)
12. If an S-TYPE vehicle is being repaired, install the engine undertray. (Figure 1)
