V8 Sedan & XK8

205-03

## TECHNICAL BULLETIN

Oil Leak – Pinion Oil Seal – Replace Pinion Drive Flange/Oil Seal Assembly – Procedure Not In Workshop Manual

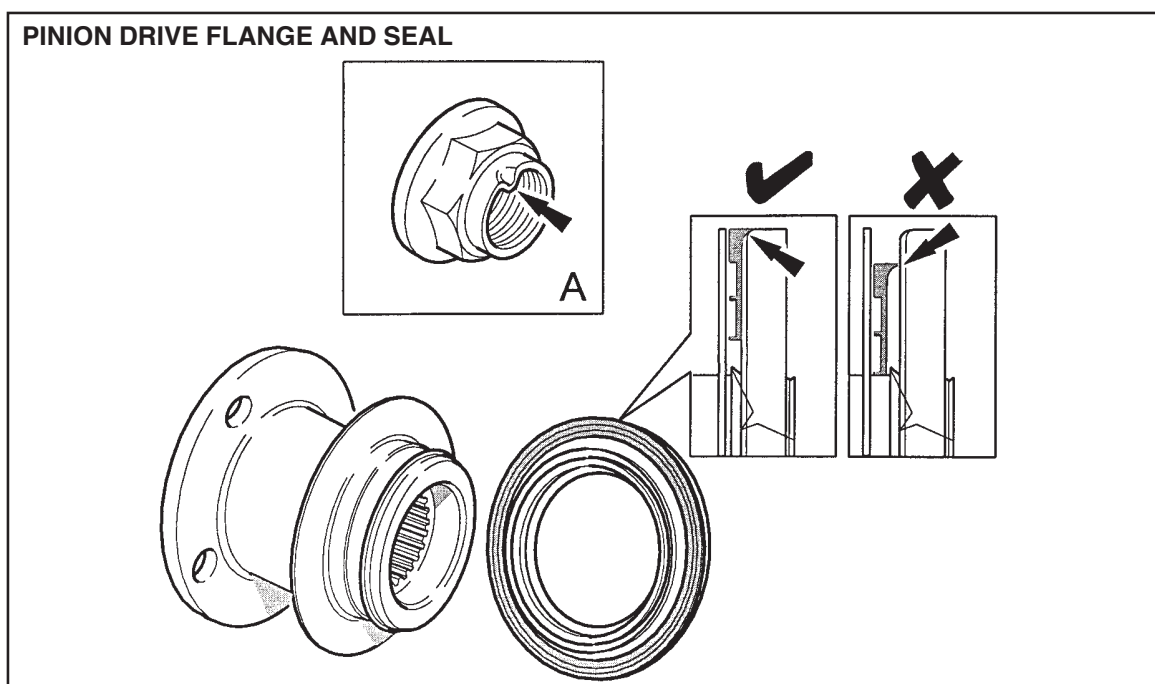
ILLUSTRATION 1

3. Rotate the pinion coupling until the machined slot in the threaded nose of the pinion, and the depressed area of the coupling retaining nut locking collar (A, Illustration 1), are accessible.

**Note:** In Illustration 1, the inset with the check mark shows the proper location of the Ryton ring between the seal and the seal flange. The Ryton ring should be concentric with the seal and the lip on the ring should overlap the edge of the seal. The inset with the X shows the incorrect location of the Ryton ring, i.e. not concentric with the seal and resting on the integral seal sleeve. The Ryton ring **MUST** be handled carefully, as it is easily damaged. If the ring is allowed to drop out of position it can be broken when the seal is inserted into the housing.

4. Using a punch, preferably with a square section nose to fit into the slot, drive the depressed part of the nut collar out of the slot.
5. Place Special Tool 205-053 (18G-1205), Drive Shaft Flange Wrench, on the coupling to prevent rotation and then, using a socket wrench, loosen and remove the coupling retaining nut.
6. Remove Special Tool 205-053 (18G-1205) from the coupling
7. Install Special Tool 100-005, puller, to the coupling, apply the center screw to the pinion nose and then rotate the screw to withdraw the coupling.
8. Remove the Special Tool and discard the coupling/seal assembly.
9. Clean the seal housing area in the differential case.
10. The coupling/seal assembly, shown in Illustration 1 consists of the following:  
Coupling with integral seal sleeve.  
Ryton ring  
Oil seal

13. At this point check that the Ryton ring is in the proper location.
14. Position the 205-053 (18G-1205) wrench, on the coupling to prevent rotation and then, using a socket wrench, lightly tighten the nut until the seal begins to enter the housing.

15. Before proceeding check that the Ryton ring is still in position against the seal and not protruding.
16. Tighten the nut, against the wrench, to the torque setting of 203 - 223 Nm (150-164 lb ft).
