Jaguar XK8/R Clock Repair

By Atlastajag1

Probable cause: clock stepper motor unit.

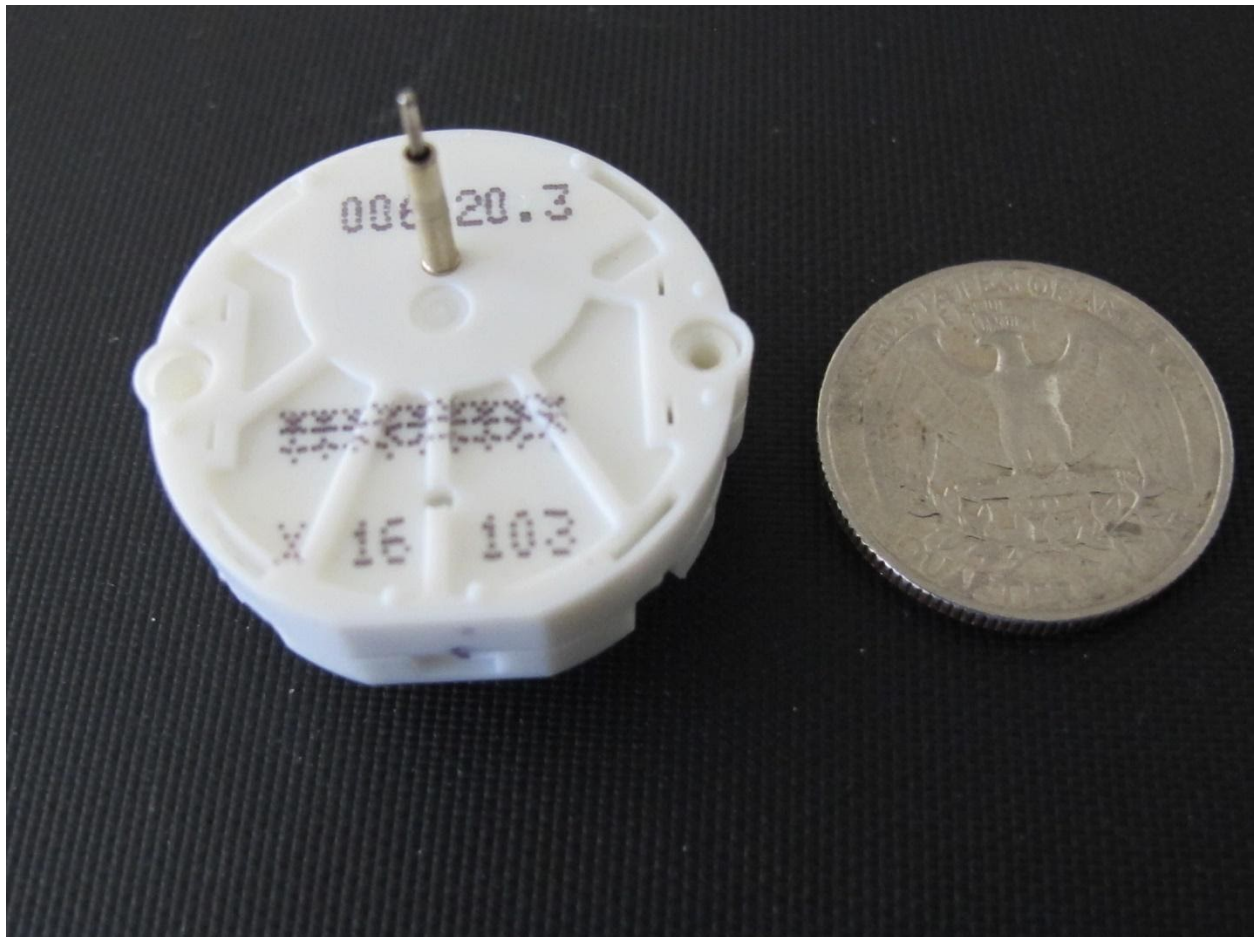
I could find no references anywhere to an X-16 stepper motor. For that matter, I could find no cars with an integral XK8-like clock, either. Possibly the XJ stand-alone clock works the same way. I was able to see, once the MIM was dismantled, that there is no ECM computer involvement with the XK8 clock. There is a quartz crystal and some electronics on a circuit board, and the clock works like a battery operated wall clock, other than the +/- setting buttons.

After dismantling the MIM and the clock stepper – see below – I discovered that the problem was indeed with the driver gear, where two teeth had broken off.

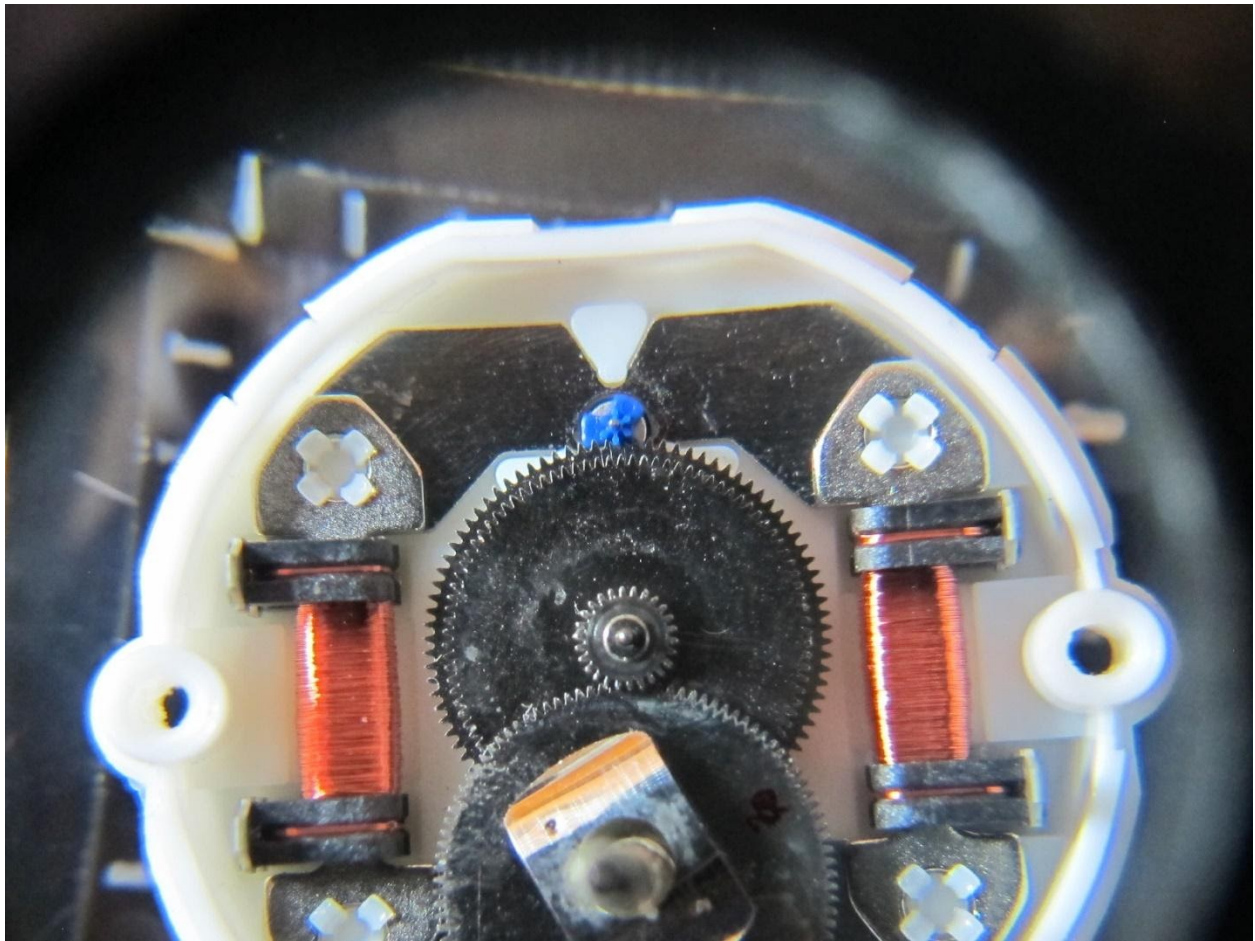
In the unlikely event of a coil failure, it might even be possible to transfer the coils / iron field parts, but the X-16 housing and gearing themselves must be retained. So, the X-27 gets to donate the essential armature part, and then gets discarded. This is the image, as seen through a jeweler's loupe. The blue item is the motor armature / gear, as replaced. Note that the 6-tooth driving gear is nylon.

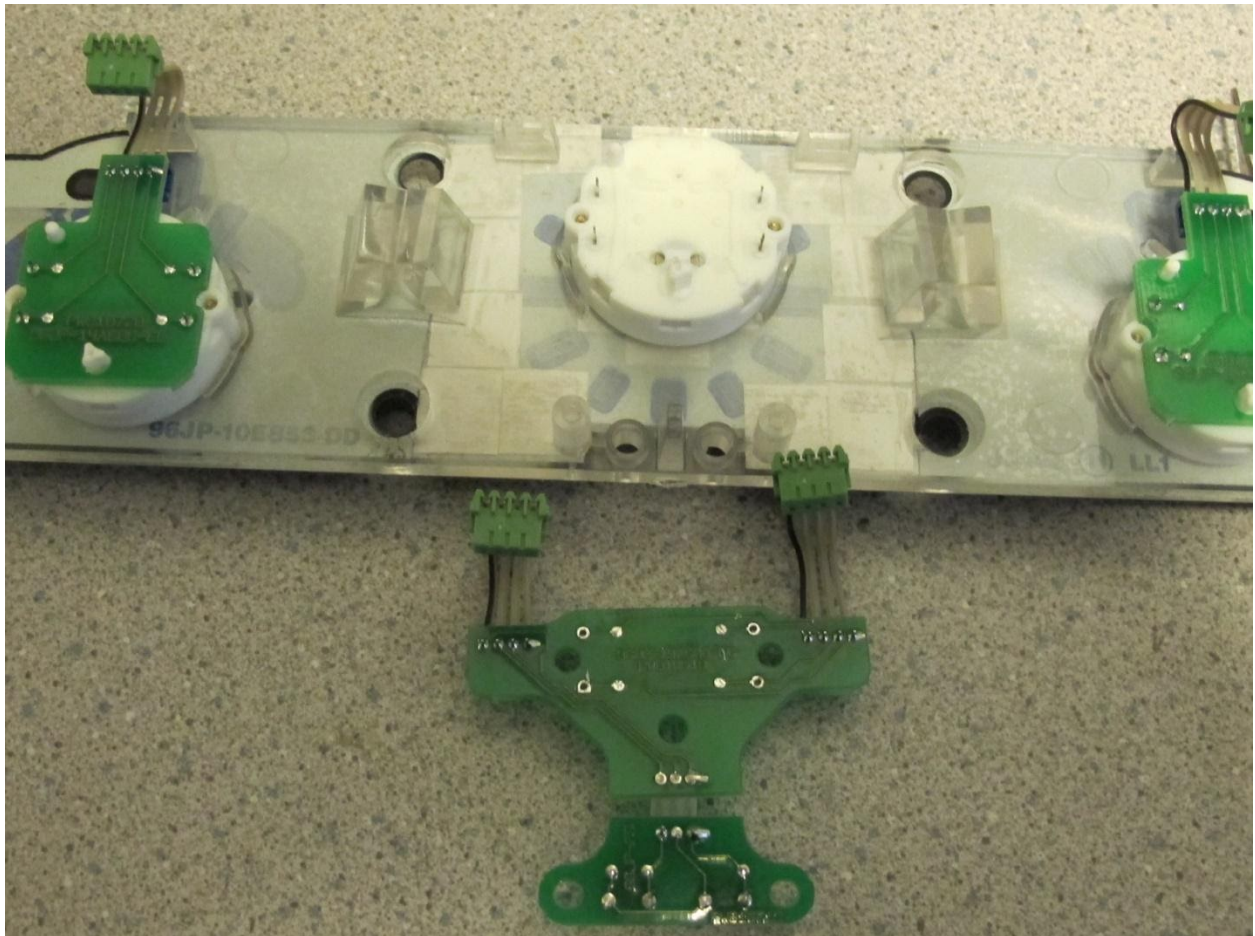
Each gauge is connected to the main PC board by a ribbon cable connector. The clock requires two, via a two-piece extension board. The upper cable board is soldered onto 4 pins from the motor housing, while the lower board – used by the +/- buttons - is held to the main board by two (T7) screws. Gently pry all ribbon connectors free and ease the ribbons out of their grooves.

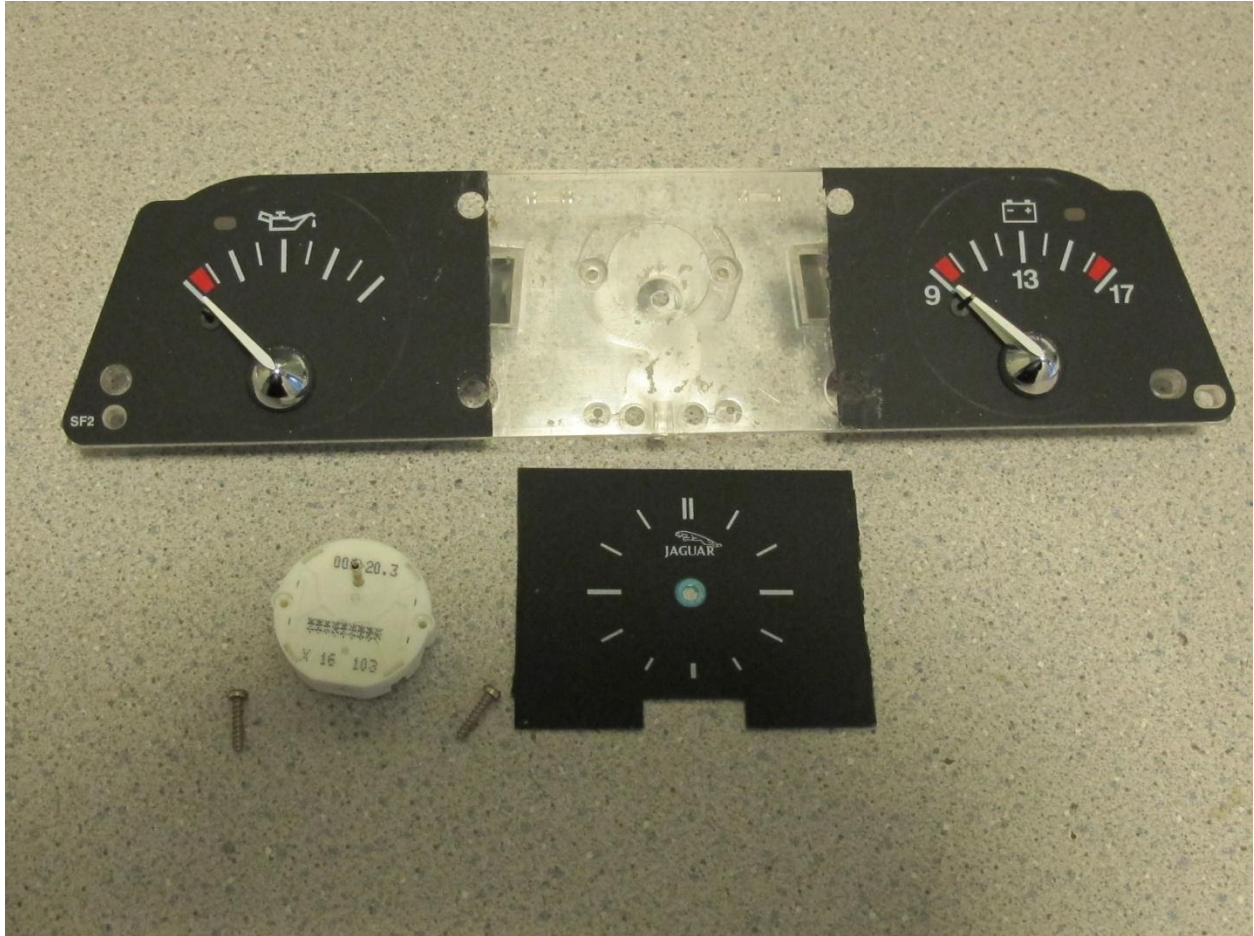
The two T7 motor screws can now be removed and the motor unit released.

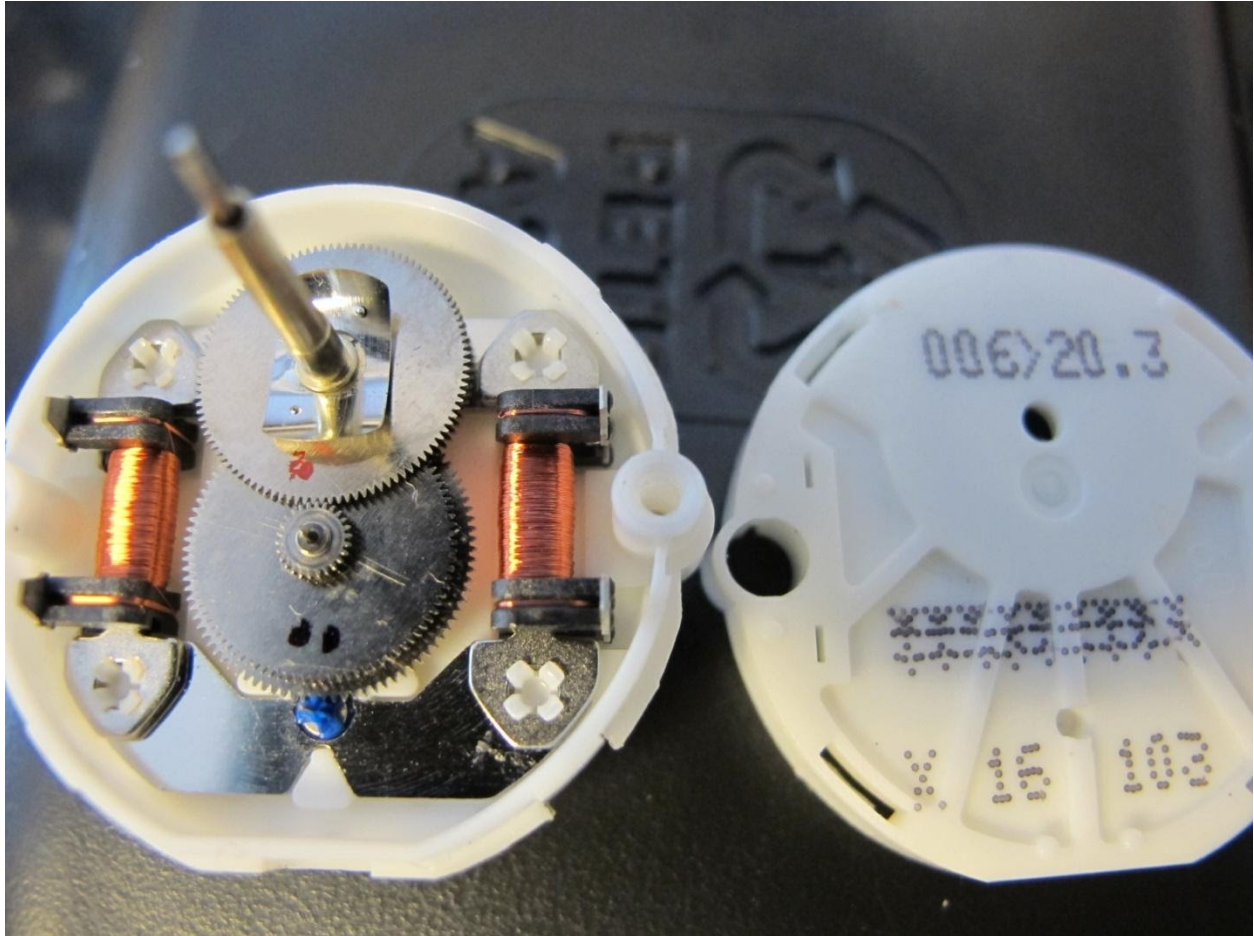
I used fine Sharpies to dot mark the gears: black for the output shaft cluster and red for the other stack. I marked them with dots in the order in which they were removed; the colors make sure you know which stack the gear came from. Note / mark the orientation of the output shaft drag spring. Now you will be able to easily re-assemble the set.

The armature / driver gear part sits on a very thin hair-like pin, fixed at the base but engaging with a tiny hole in the top cover. Using tweezers, carefully remove and discard the faulty armature / gear, similarly dismantle the purchased X-27, remove its armature / driver gear, and place it in the X-16. The two coils of the X-16 motor checked out at approximately 280 ohms each. The remainder of the X-27 can now be discarded.
