V8 XJ Series/XK

419-11

TECHNICAL BULLETIN

Alpine Navigation System – DVD-driven Diagnosis – Repair

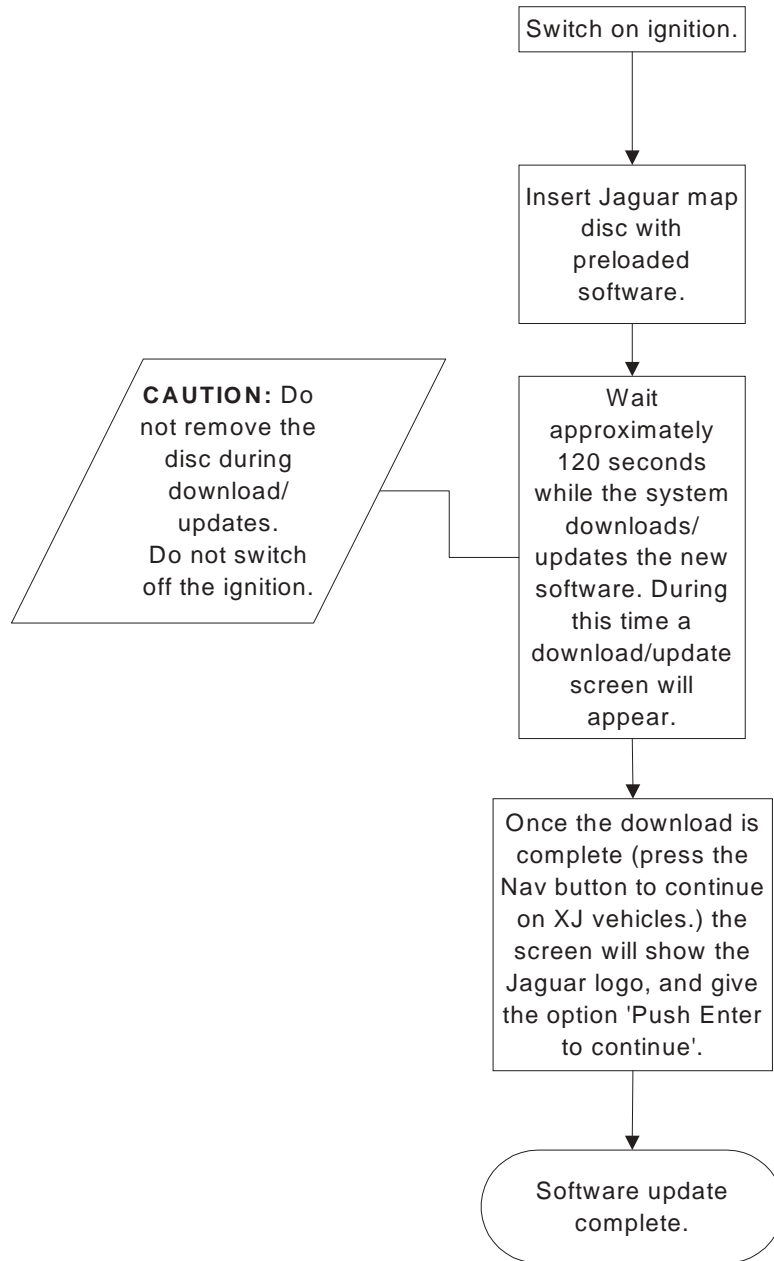
INITIAL LOADING OR UPDATING OF MAP DISC OR SYSTEM SOFTWARE

1. Initial loading or updating of the map or system software is covered in flowchart NAV1.
2. How to use Jaguar 'Wipe' disc (JTP 824) to erase the navigation system memory following system lock up, is covered in flow chart NAV 2.

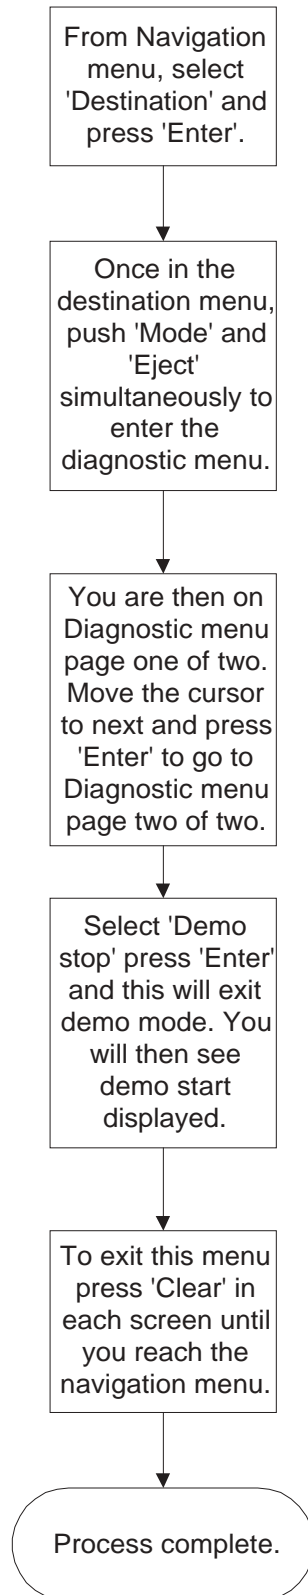
VEHICLE IS STATIONARY BUT SYSTEM GUIDANCE CONTINUES (V8 XJ SERIES)

3. V8 XJ Series 'system guidance continuing while vehicle remains stationary' can be caused by the system being set into demonstration mode. The procedure to return the system to normal operation is covered in flowchart NAV 3.
4. XK series 'system guidance continuing while vehicle remains stationary', is covered in flowchart NAV 4, and can be attributed to demonstration mode being set as with V8 XJ series vehicles.
5. The issue of 'vehicle appearing to be more than 30 meters out of position on the map' can be caused by poor antenna connections at either the antenna fly lead or navigation module and is covered in the workshop procedure following the flowcharts.
