XK

TECHNICAL BULLETIN

**Headlamp Internal Condensation –
Acceptable Levels –
Repair Guidelines**

MODEL 1997 MY-ON
XK Range
VIN 001001-ON

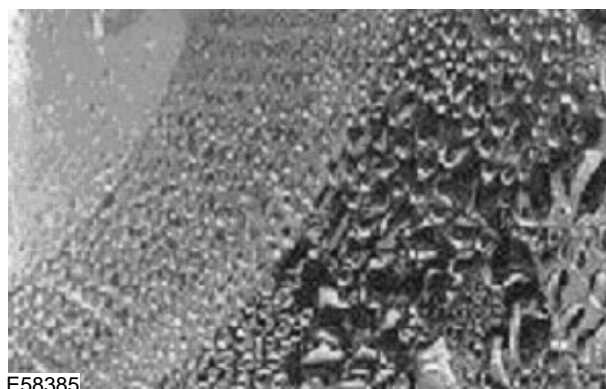
ILLUSTRATION 1

1. Large apparent visible droplets of water on the interior side of the clear glass lens.

VISIBLE DROPLETS OF WATER ON INTERIOR OF CLEAR GLASS LENS

1. Turn the headlamp dip and main beam functions 'ON', and run the engine for 30 minutes.
 - If water droplets still remain on the inside of the headlamp glass, the lamp should be renewed.
 - If there is evidence of standing water within the headlamp unit, the unit will also need to be replaced.For additional information, refer to Global Technical Reference (GTR) Workshop Manual, section: 417-05, Headlamp Assembly.

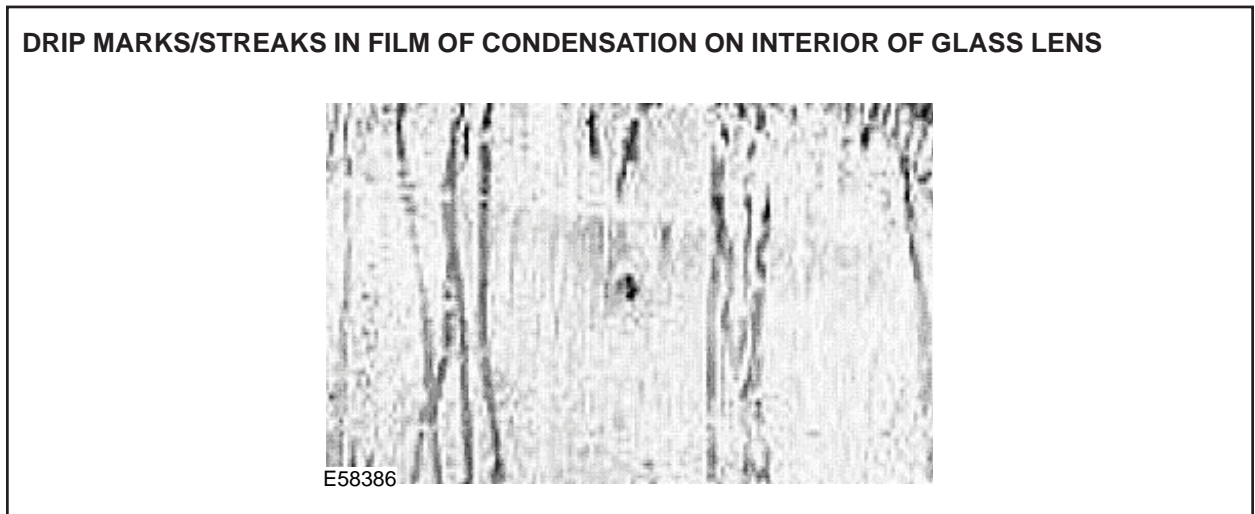
ILLUSTRATION 2

2. Drip marks/streaks in the film of condensation on the interior side of the glass lens.
