**Cooling System Bleed Lines –
Correct Routing – Model Year Differences**

MODEL 1997 MY-ON
XK8 Range
VIN 001001-ON

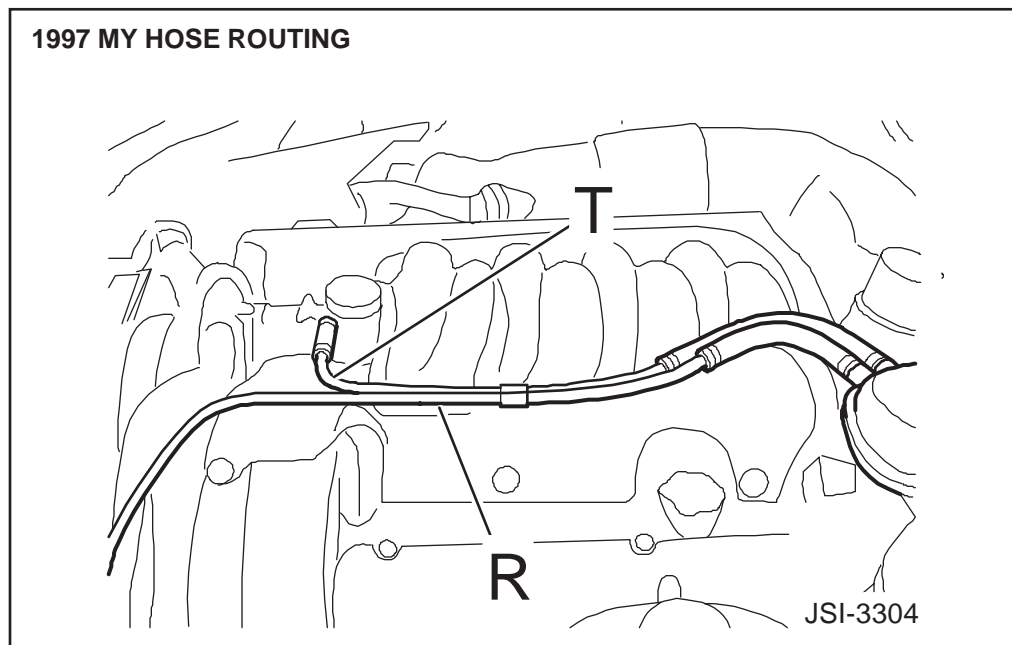
ILLUSTRATION 1

1997 Model Year Condition VIN 001001 - 018107

- Reservoir: Part No. MJA 4400AC for 1997 MY **only**.
- Bleed line R, Illustration 1, from radiator is connected to **front** fitting on reservoir (Illustration 1).
- Bleed Line T from thermostat is connected to **rear** fitting on reservoir.

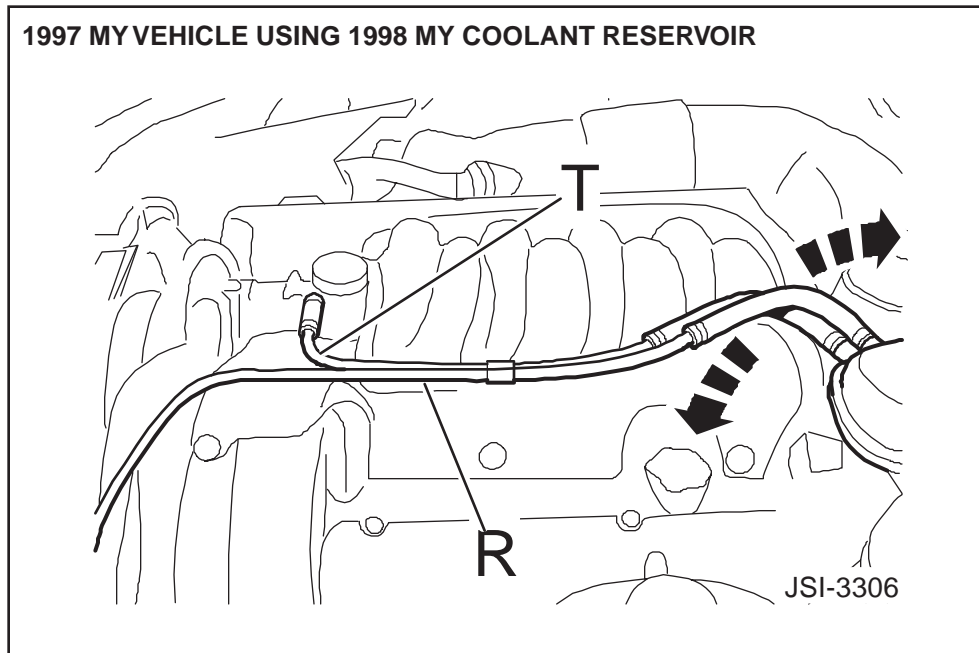
ILLUSTRATION 3

It is permissible to use the 1998 MY Reservoir Part No. MJA 4400AD on 1997 Model Year XK8 Models provided that the bleed lines are reversed at the reservoir from the original layout (Illustration 3) as follows:

- Bleed Line R from the radiator is connected to the blanked-off **rear** fitting on the Reservoir (Illustration 3). (This is satisfactory, since air will vent from the radiator by routes other than this bleed line).
- Bleed Line T from the thermostat is connected to the open **front** fitting on the Reservoir, as in Illustration 3. **THIS VENT CONNECTION IS MANDATORY. Trapped air in the cooling system cannot vent if the thermostat bleed line is connected to the plugged rear fitting.**

In any case of high coolant temperature/coolant loss, check that the bleed line from the thermostat is always connected to the correct (**open**) fitting of the reservoir, especially if a 1998 MY Reservoir may have been installed in a 1997 MY vehicle.
