Wiring Change –
Driver Seat Control Module –
Modification Instructions

MODEL 1997 MY
XK8 Range
VIN 001001-003300

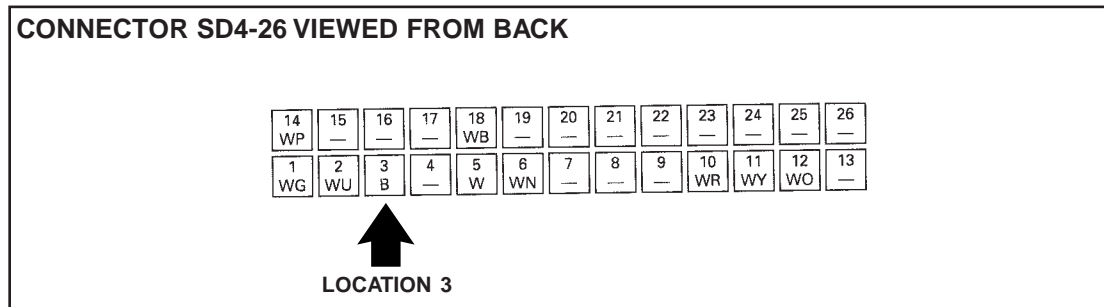
ILLUSTRATION 1

Early 1997 MY XK8 vehicles (up to VIN 003300) have a ground wire for the Driver Seat Control Module (DSCM) at location 3 of connector SD4. This ground circuit enables the control module to function as a DSCM instead of as a Passenger Seat Control Module (PSCM). On vehicles after VIN 003300, the ground wire was moved to location 1 on connector SD5. Since the early DSCM (LJA 2160AE/001) supersedes to LJA 2160AG/001, the wiring must be updated to the later configuration for the later DSCM to operate correctly. Without the ground, the control module will operate as a PSCM meaning that memory settings will not function and the key chime will not sound. Refer to Fig. 12.1 of the 1997 MY XK8 Electrical Guide for further information.

2. Disassemble the SD4/26 center connector to remove the black wire from location 3 (Illustration 1). Verify that the black wire is connected to body ground.
3. Reassemble the SD4/26 connector.
4. Remove the terminal from the black wire. Splice on a lead with a molex connector terminal already crimped on (part no. 418-083 supplied in the wiring harness repair kit 418-S065).
5. Pull out the red lock on connector SD5/10 to unlock the terminals.
