Engine Hard Starting – DiagnosisMODEL 1997 MY-ON
XK8 RangeVIN
001001-ON**Issue:**

This bulletin provides a diagnosis procedure to follow in case of a customer complaint of poor or hard starting.

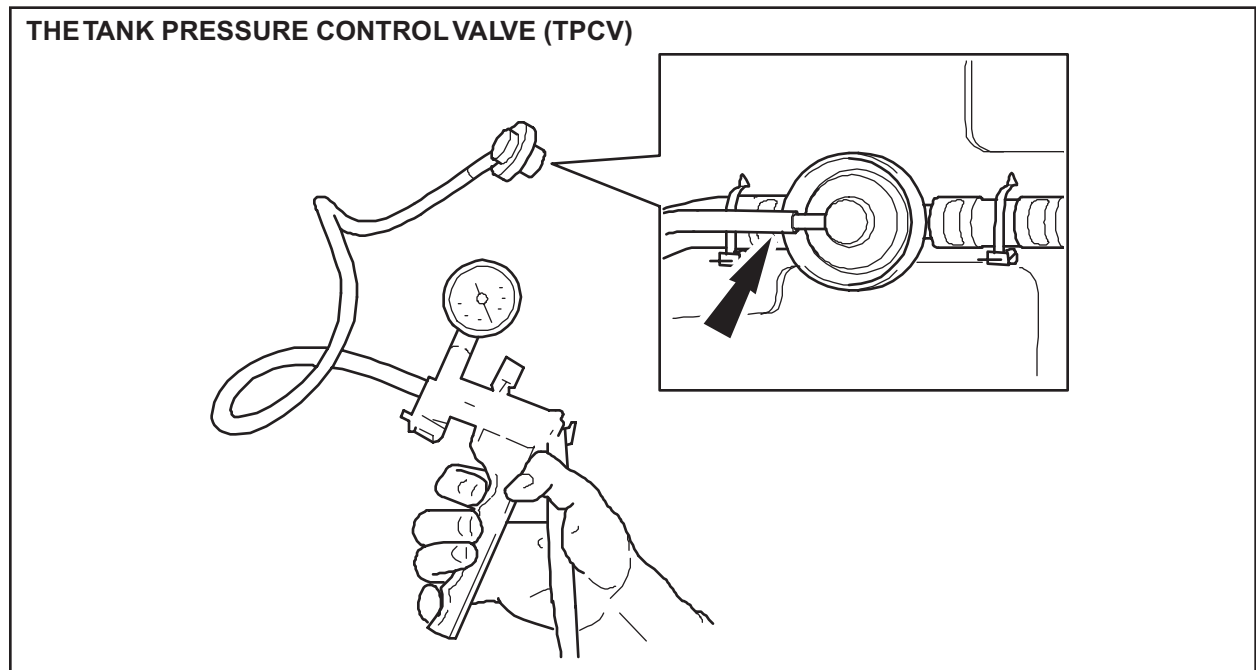
ILLUSTRATION 1

TANK PRESSURE CONTROL VALVE, (TPCV)

Connect a hand vacuum tester to the TPCV vacuum port, as shown in Illustration 1 and follow the flow chart below.
