JTB00344NAS1

TECHNICAL BULLETIN

501-00

Earth Stud Repair on Aluminum Body

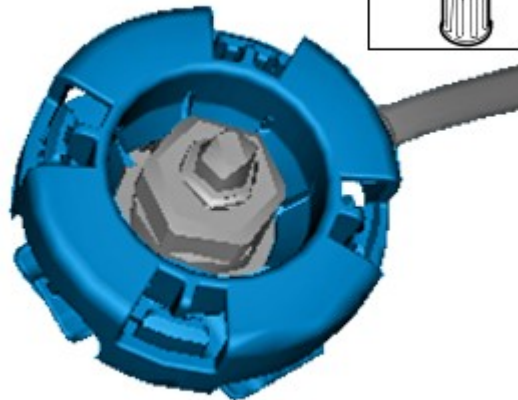
E161219

The plastic earth protection cradle is not compatible with the new stud.

When fitting the repair earth stud, remove the harness cradle from the harness before re-attaching the eyelet to the stud and tightening.

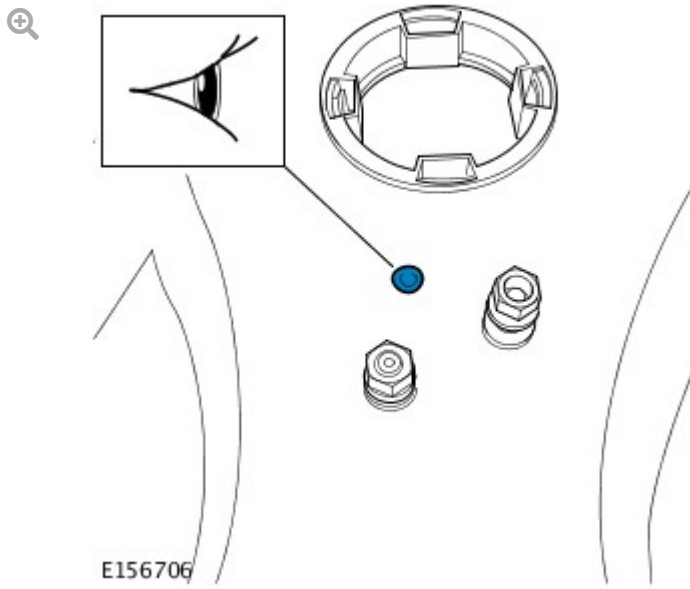
Locate broken/cross threaded earth stud.

3. Dress/file the broken stud to a safe and acceptable repair standard.

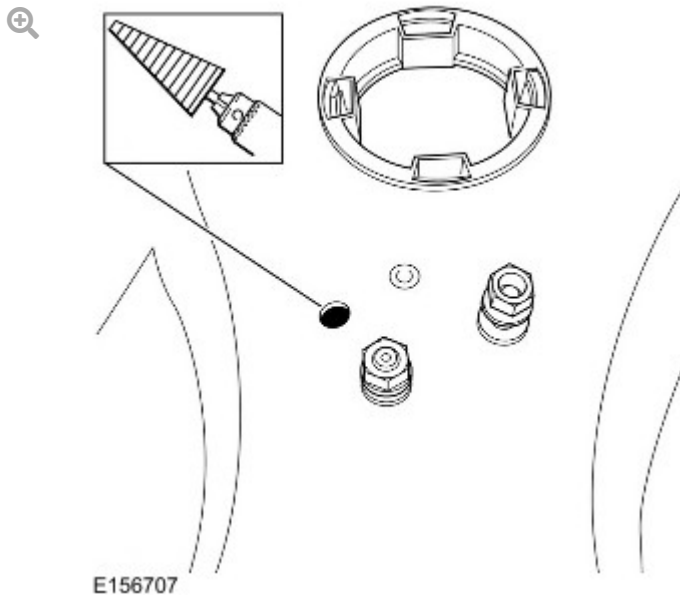
Using the stepped cutter supplied in the kit (MRPK4072), drill until you achieve a 15mm diameter hole.

- Cleanliness is important to avoid galvanic corrosion.
- Make sure any swarf is removed/cleaned away.
- Carry out drilling in close proximity to the broken/cross threaded stud.
- The stepped cutter should not be used for any other procedure to avoid galvanic corrosion.

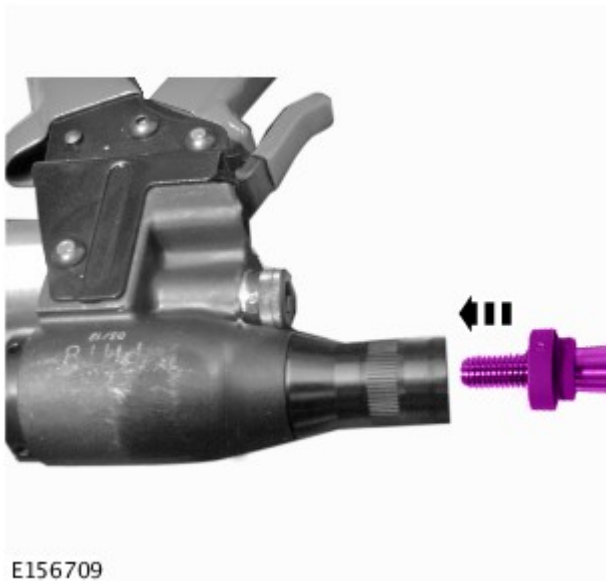
Load the new earth stud into the stud applicator gun.

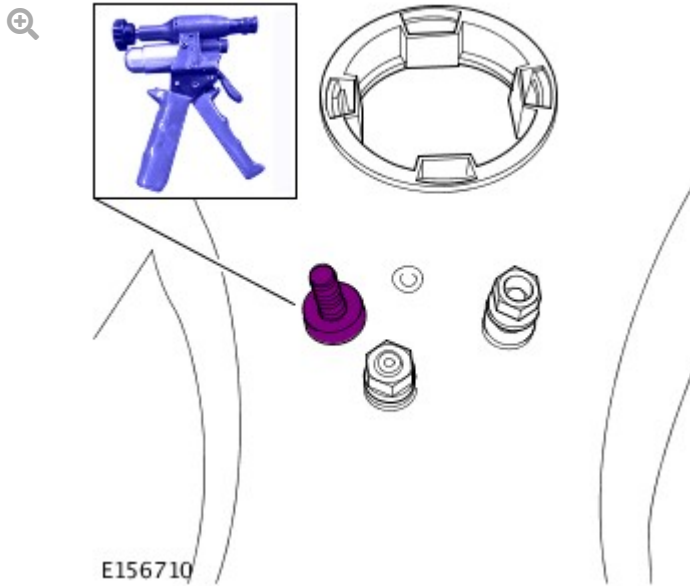
Install the new earth stud: Apply pressure to the trigger of the applicator gun until the pressure reduces, this will indicate the applicator gun has reached the end of its cycle.

The earth stud bond is totally self-sealing and watertight; there is no need to dress the hole with any primer before fitting.

- Place the new stud into the drilled hole.
- Apply pressure to the trigger of the applicator gun until the pressure reduces, indicating the applicator gun has reached the end of its cycle.

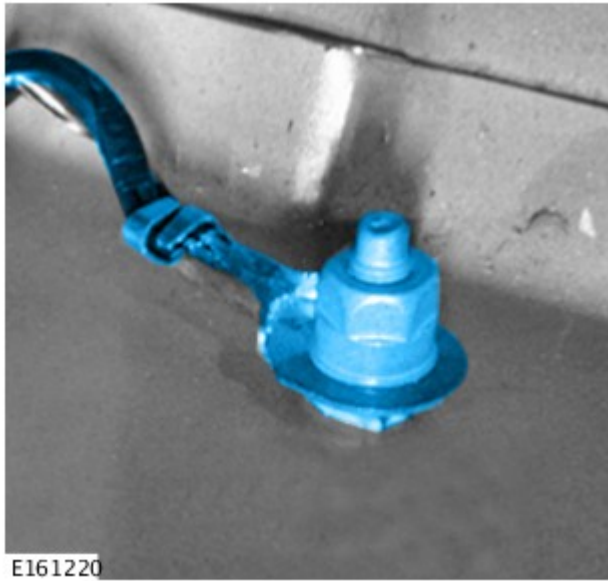
Repaired earth stud with harness fitted.

- Torque 9Nm
