Watch out for these pitfalls when replacing the clip 2000 Jag S-type LH rear window regulator clip New and old (broken)

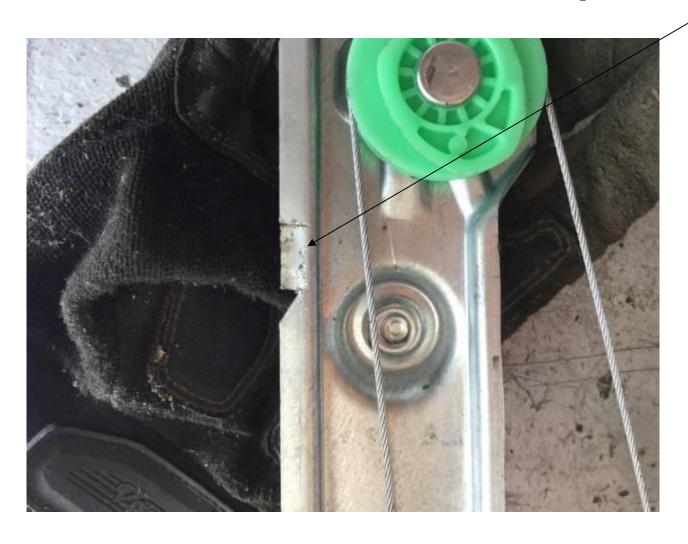
- Rollers on rail are staked in and can not be removed without drilling out rivets
  - Clip can not be installed without removing roller
  - I had to notch out the rail to slid clip onto the rail, see next
- Top roller has an integrated 'cam' to assist in installing the cables
  - Once cables are installed place cable into cam
  - Then rotate main roller this will rotate cam and position cable into top roller (see after next).

## Notch, bend back into place -
