XF 12 MY Correct Location of Front Number Plate / Plinth

Issue: Incorrect location of the front number plate and/or the plinth.

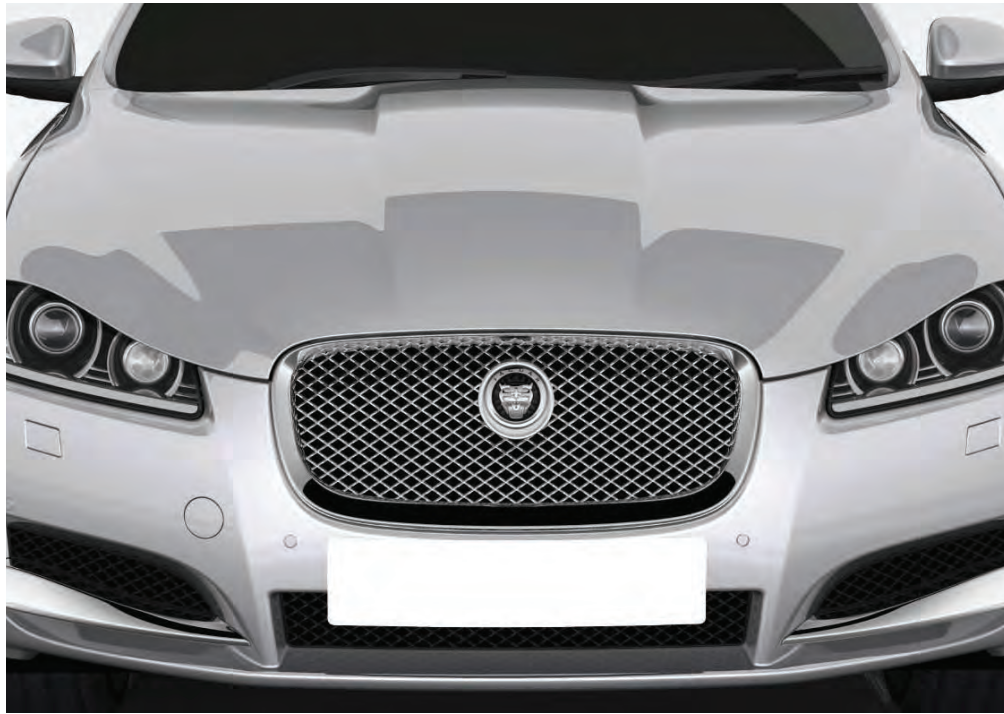
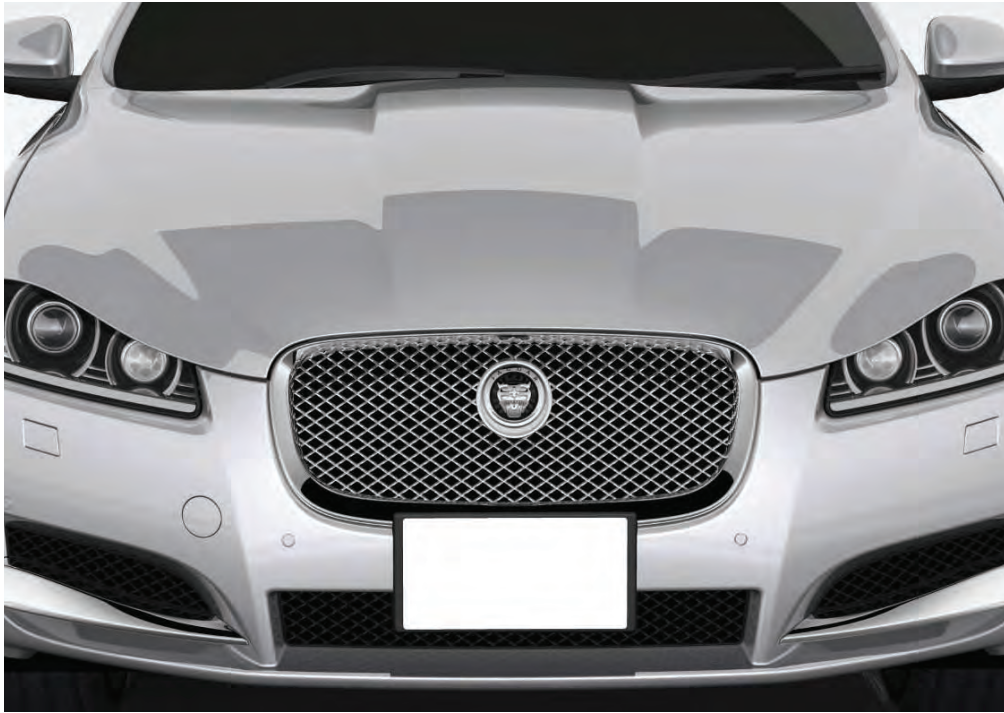
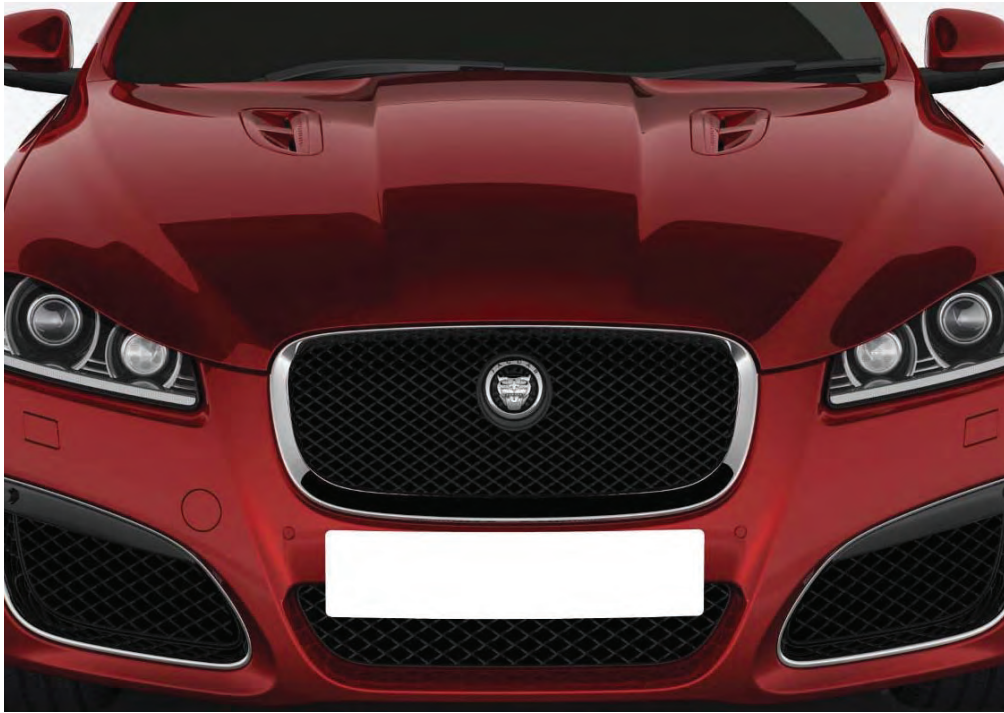
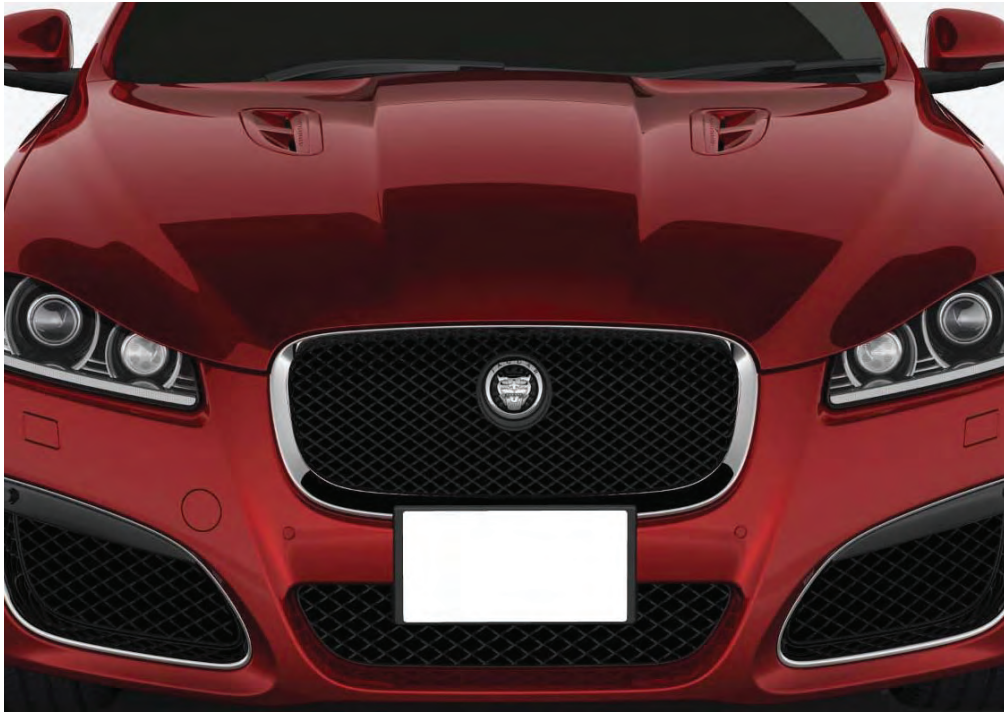
Non ACC

For non Adaptive Cruise Control (ACC) - If the front number plate is not located / aligned correctly on the front bumper cover, this can generate customer concerns of poor visual appearance / reflection of the number plate in the upper grille chrome surround trim.

☒ Pictures 1-3-5 and 7 show NA and SC non ACC variant.

Action: For ACC and non ACC - please refer to the PDI manual and the PDF doc attached to this document for correct location and fitting instructions.

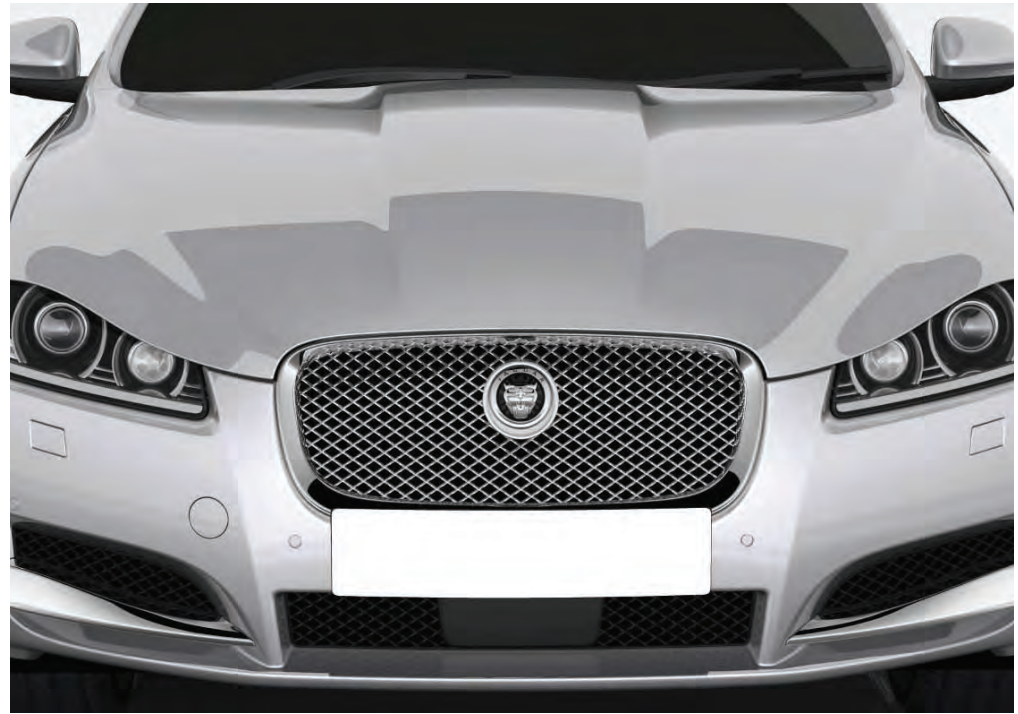
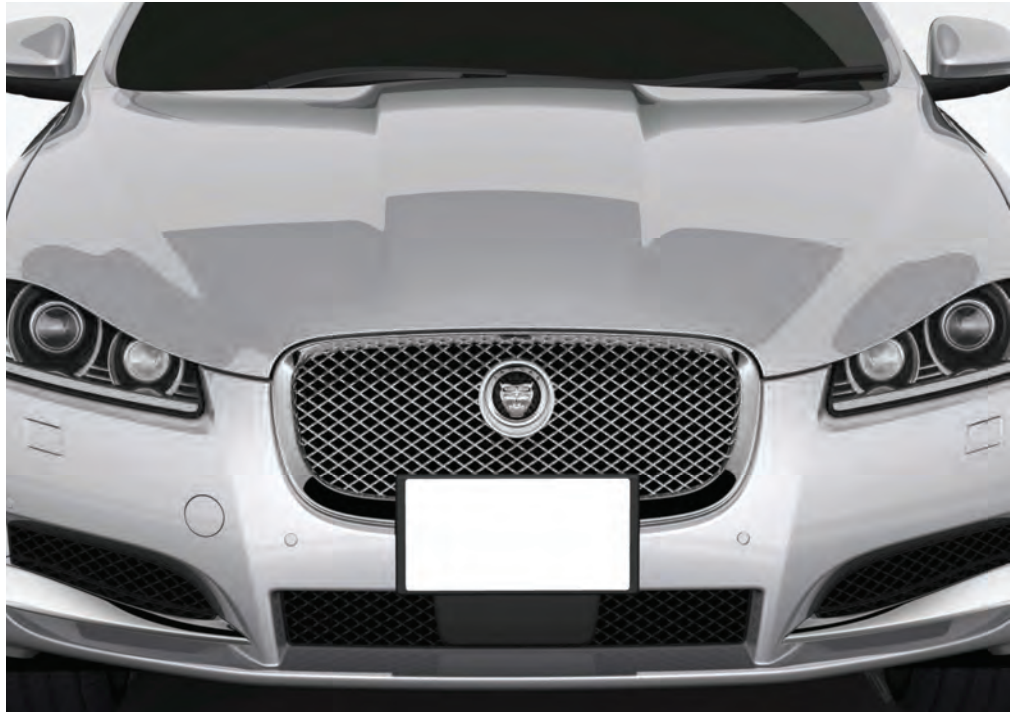
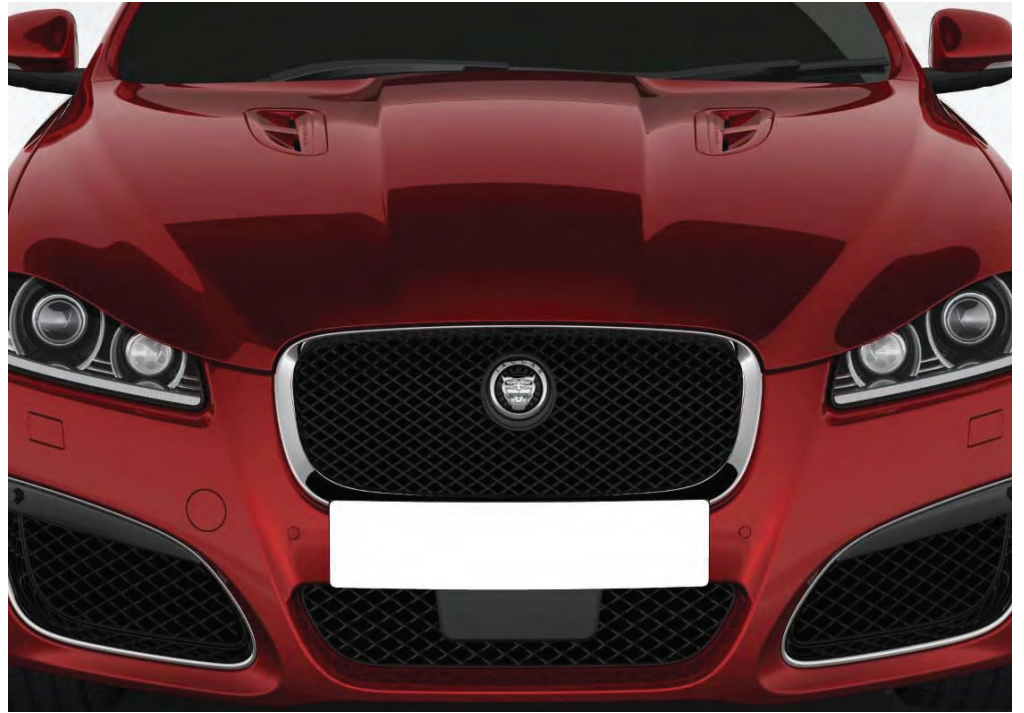
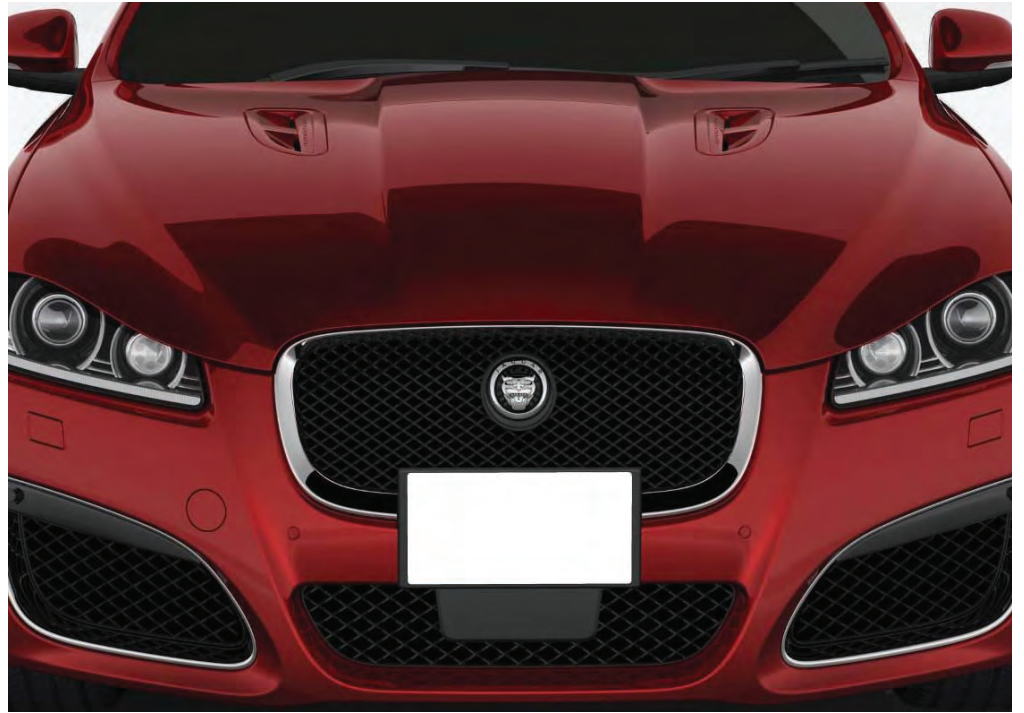
Cause: For ACC - If the front number plate / plinth is not located / aligned correctly on the front bumper cover, this can generate customer concerns of incorrect operation of the ACC system by blocking the radar signal.

☒ Pictures 2-4-6 and 8 show NA and SC ACC variant.

Note: European market vehicles with ACC will be supplied with the number plate plinth already fitted by Jaguar.
