# **A Guide to replacing the Water Outlet Connector on a XF250 3.0L Diesel**

This guide covers the replacement of the Water Outlet Connector, as shown on the front cover, on the V6 3.0 Litre Diesel engine X250.

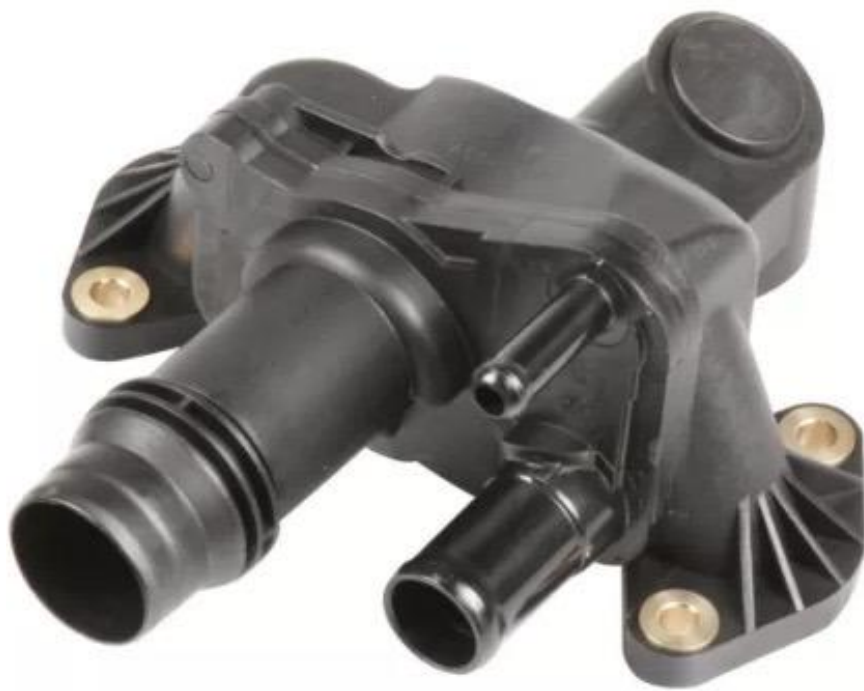
The usual failure of the component is that it splits along the seam that joins the front part to the rear part. This results in the loss of coolant and a subsequent warning of "Low Coolant Level" in red, in the message centre on the dash.

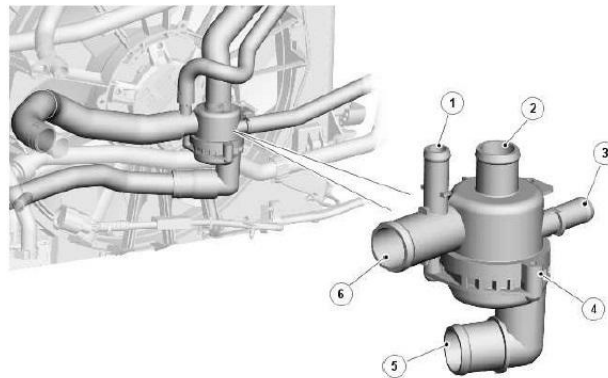
E115003

This component is sometimes **incorrectly** referred to as the thermostat (even by some suppliers!). It is not. The thermostat is located below the expansion tank next to the radiator.

**This is the thermostat**

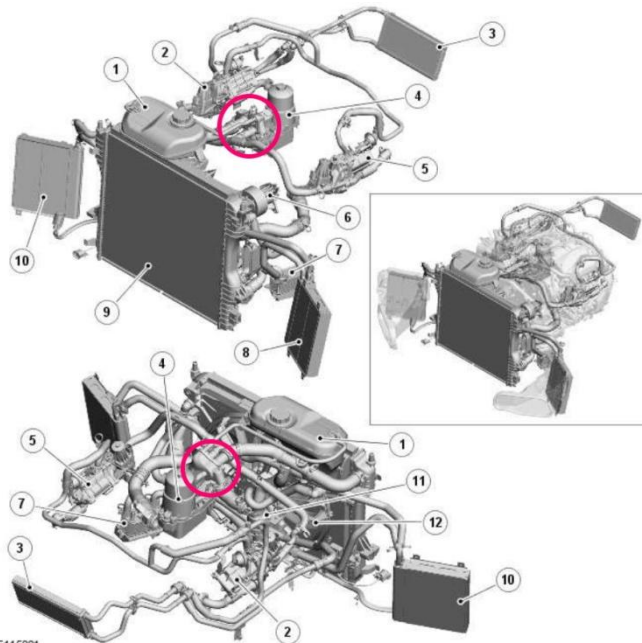
E115001

The Water Outlet Connector is located in the 'Vee' of the engine, under the throttle body housing and sits on the engine oil and fuel cooler.

**Water Outlet Connector indicated by the red circles**

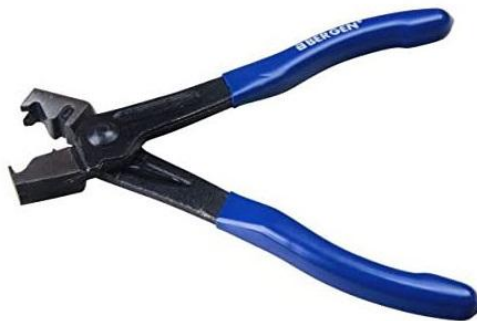
I found these Clic R pliers on Amazon and they certainly made life easier

**Clic R pliers**

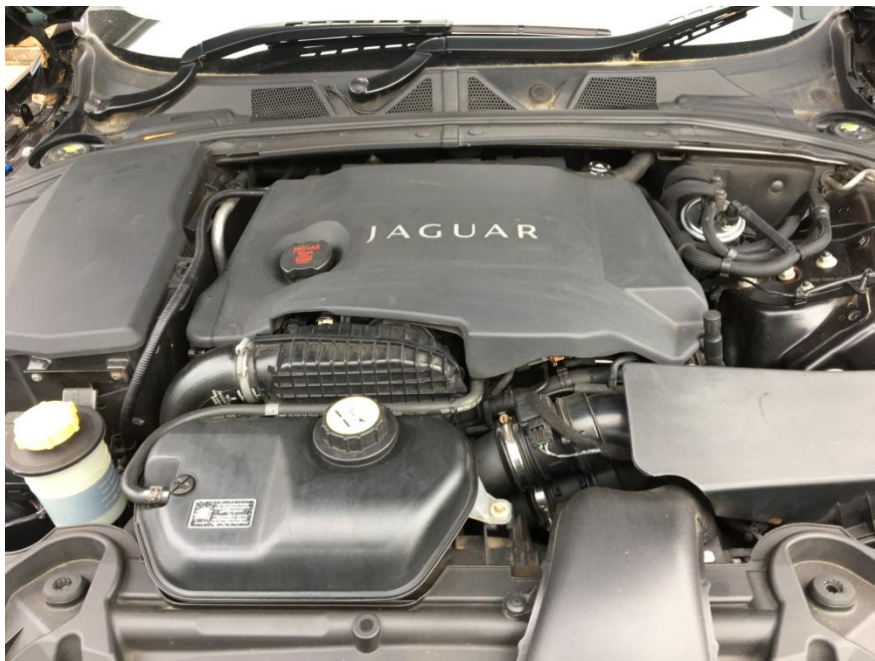
**It's under there somewhere**

First, start by removing the engine cover. Remove the oil filler cap and the cover simply pulls off. It is secured on four 'pegs'. Replace the oil filler cap to guard against foreign objects falling into the engine.

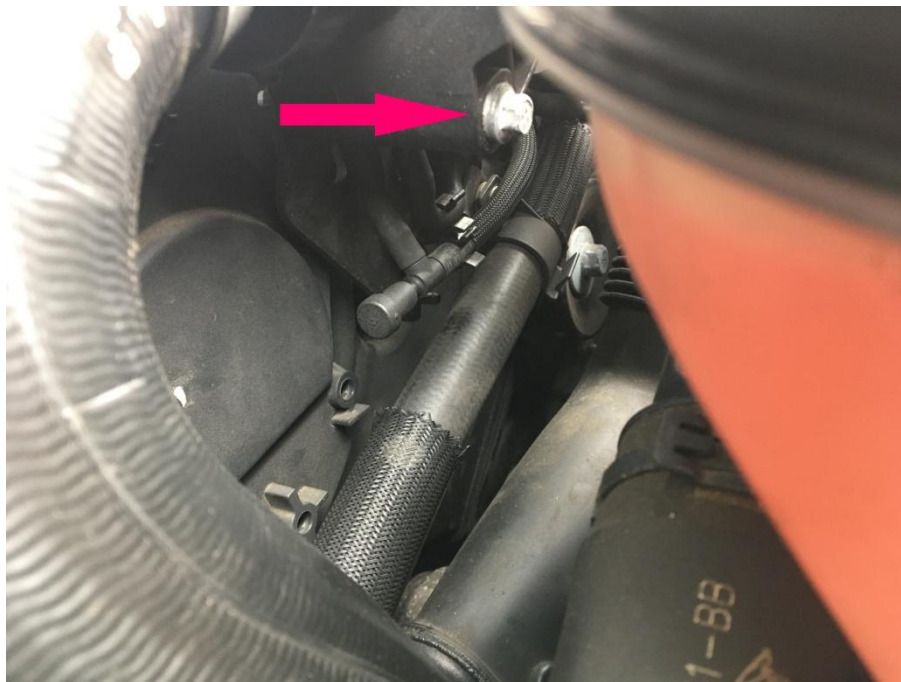
**Location of bolt holding the air box on**

Next remove the bolt located behind the expansion tank holding the air box on. This is quite a long bolt and seemingly cannot be removed fully because it fouls on the expansion tank as you pull it out. But if you wiggle it to the left, it is possible to get it out.

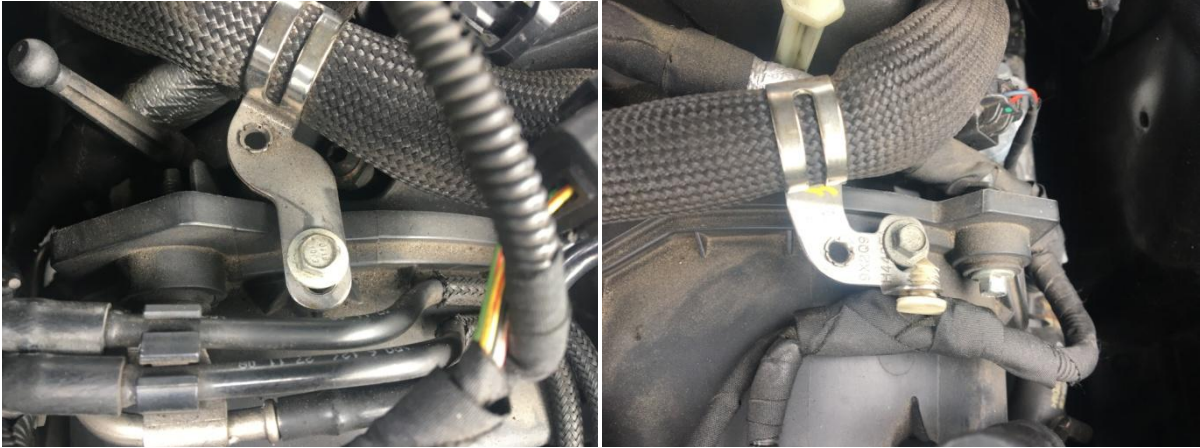
**EGR valve outlet tube securing bolts**

There are two securing bolts on each tube which must be removed to allow the limited amount of movement in the tubes to be exploited.

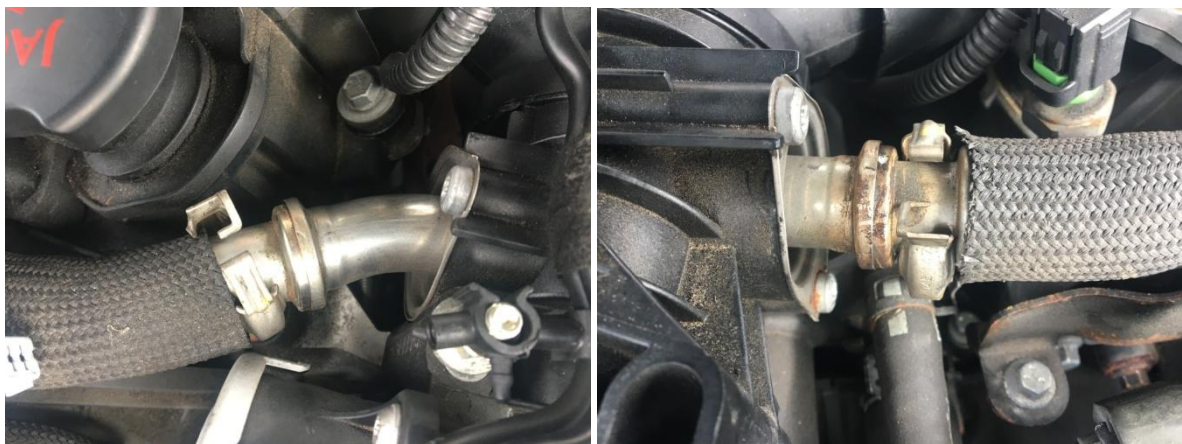
**Clic GR clamps removed**

Next the clips securing the tubes to the throttle bottle need to be undone.

If you damage these clamps such that they cannot be reused, the part number is JDE 3754

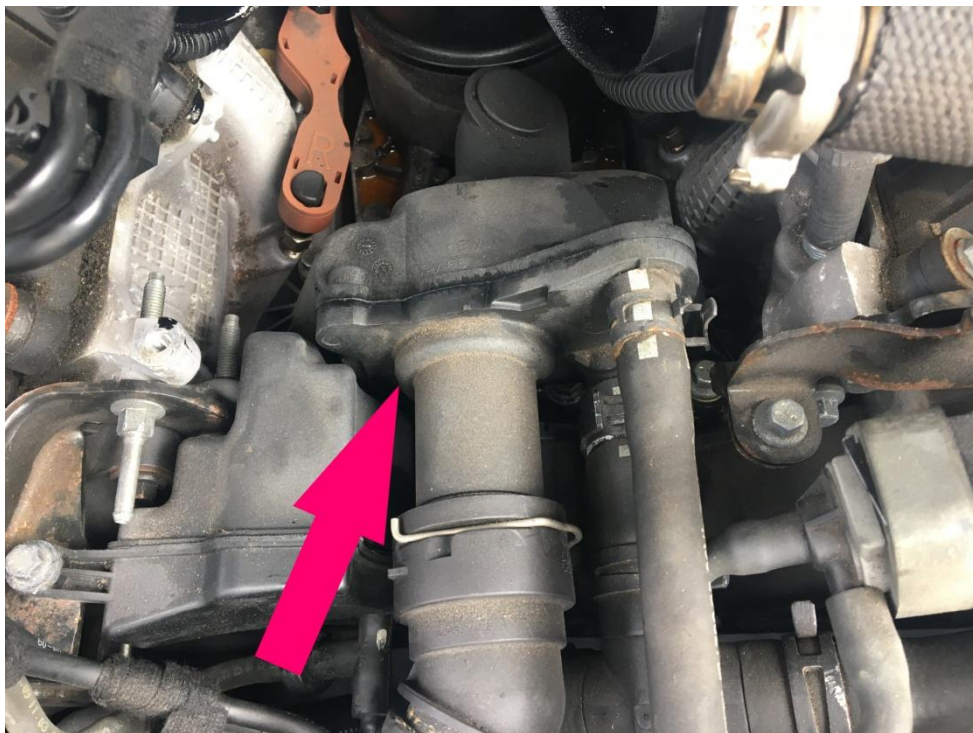
You will then be able to see the part that needs removing, as indicated by the arrow in the picture below.

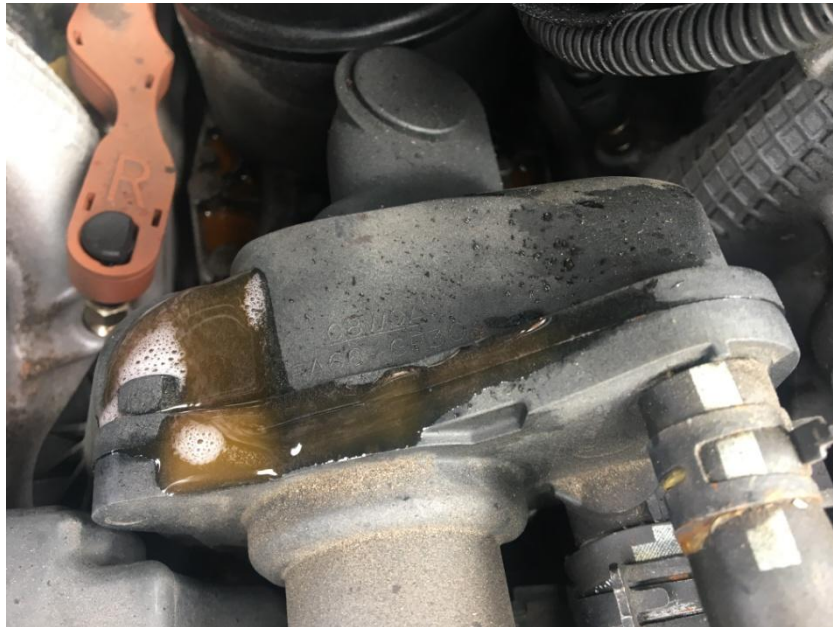
Prior to doing this, I did a pressure test, just to confirm where the coolant was leaking from and the picture below shows the coolant weeping out from the seam in the failed water outlet

**Thar she blows!**

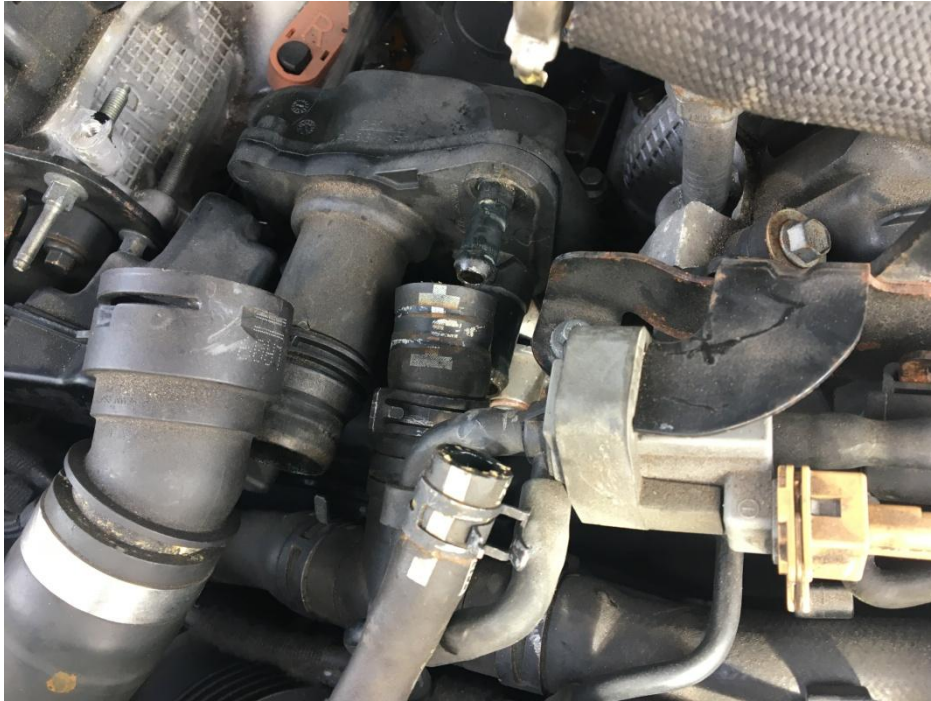
Then pull the hoses off.

You are now in a position to remove the water outlet. This is secured by four bolts. Once these are removed the component can be removed by lifting it up and wiggling it from side to side to free off the connection at the rear.

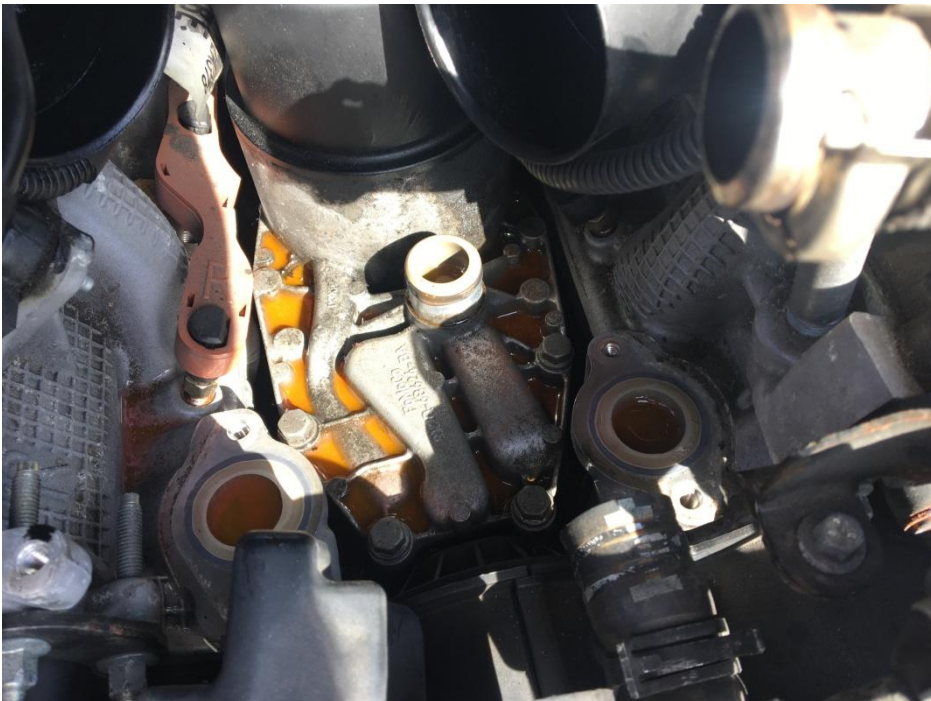
**Water outlet removed**

Refitting is, as they glibly say in the Haynes manuals, the reversal of removal. One tip about refitting the throttle body is to insert the right hand pipe first, then wiggle the left hand pipe in, line up the throttle body with the bolt hole and insert the securing bolt.
