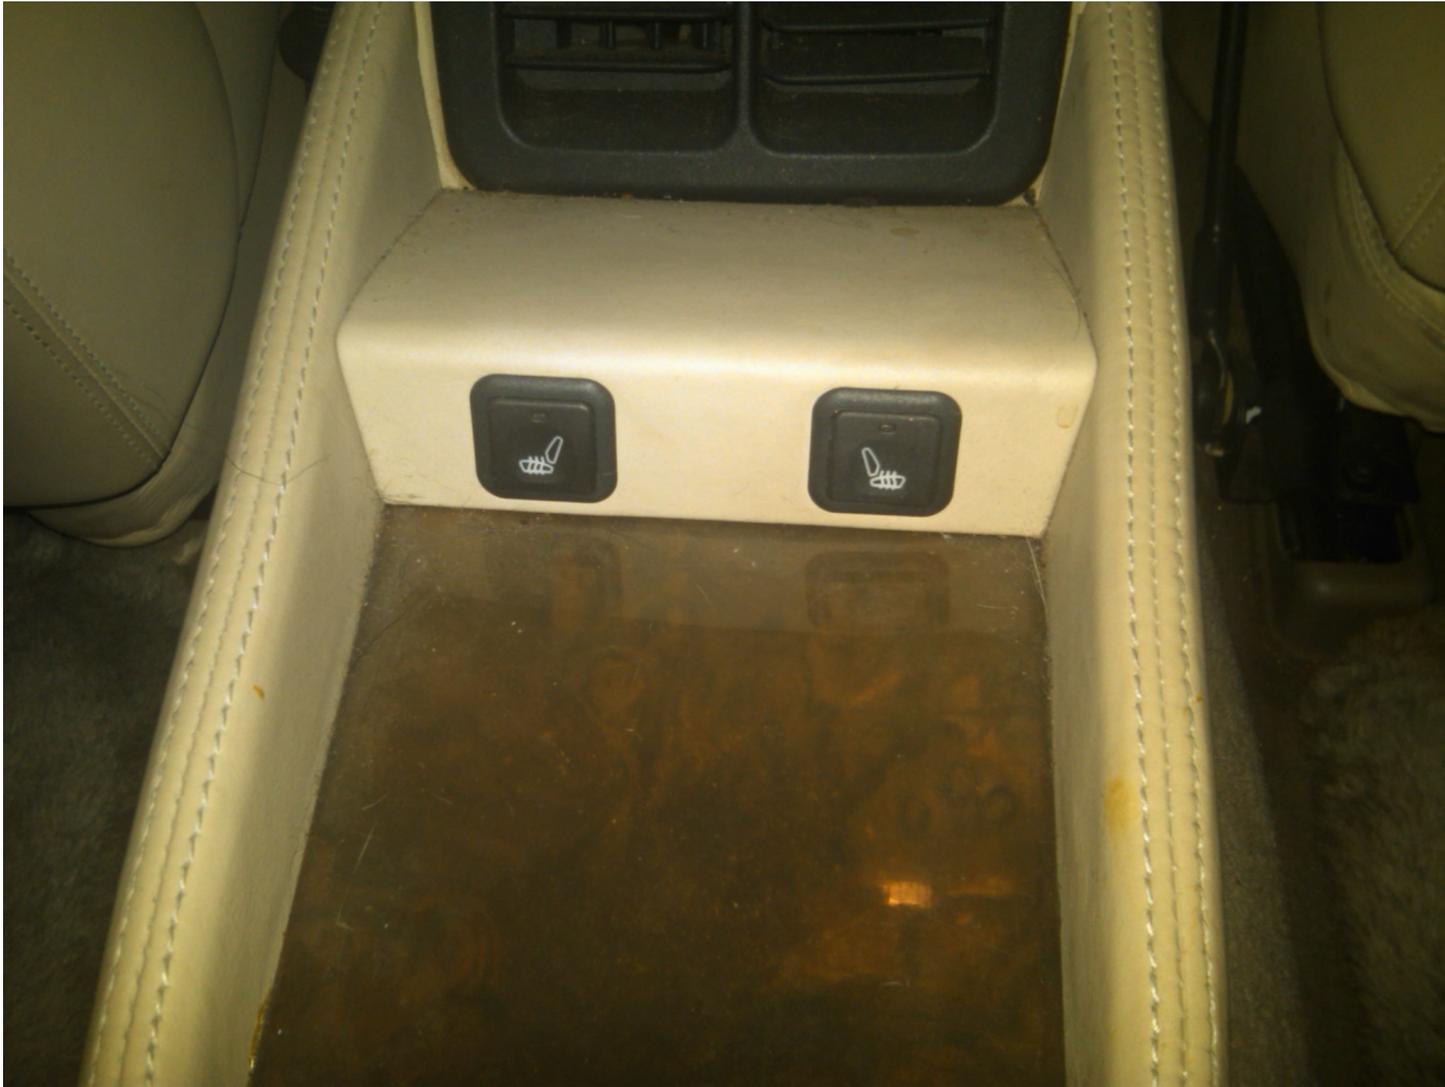
STEP-1 Get into the backseat (alone) with a good work light

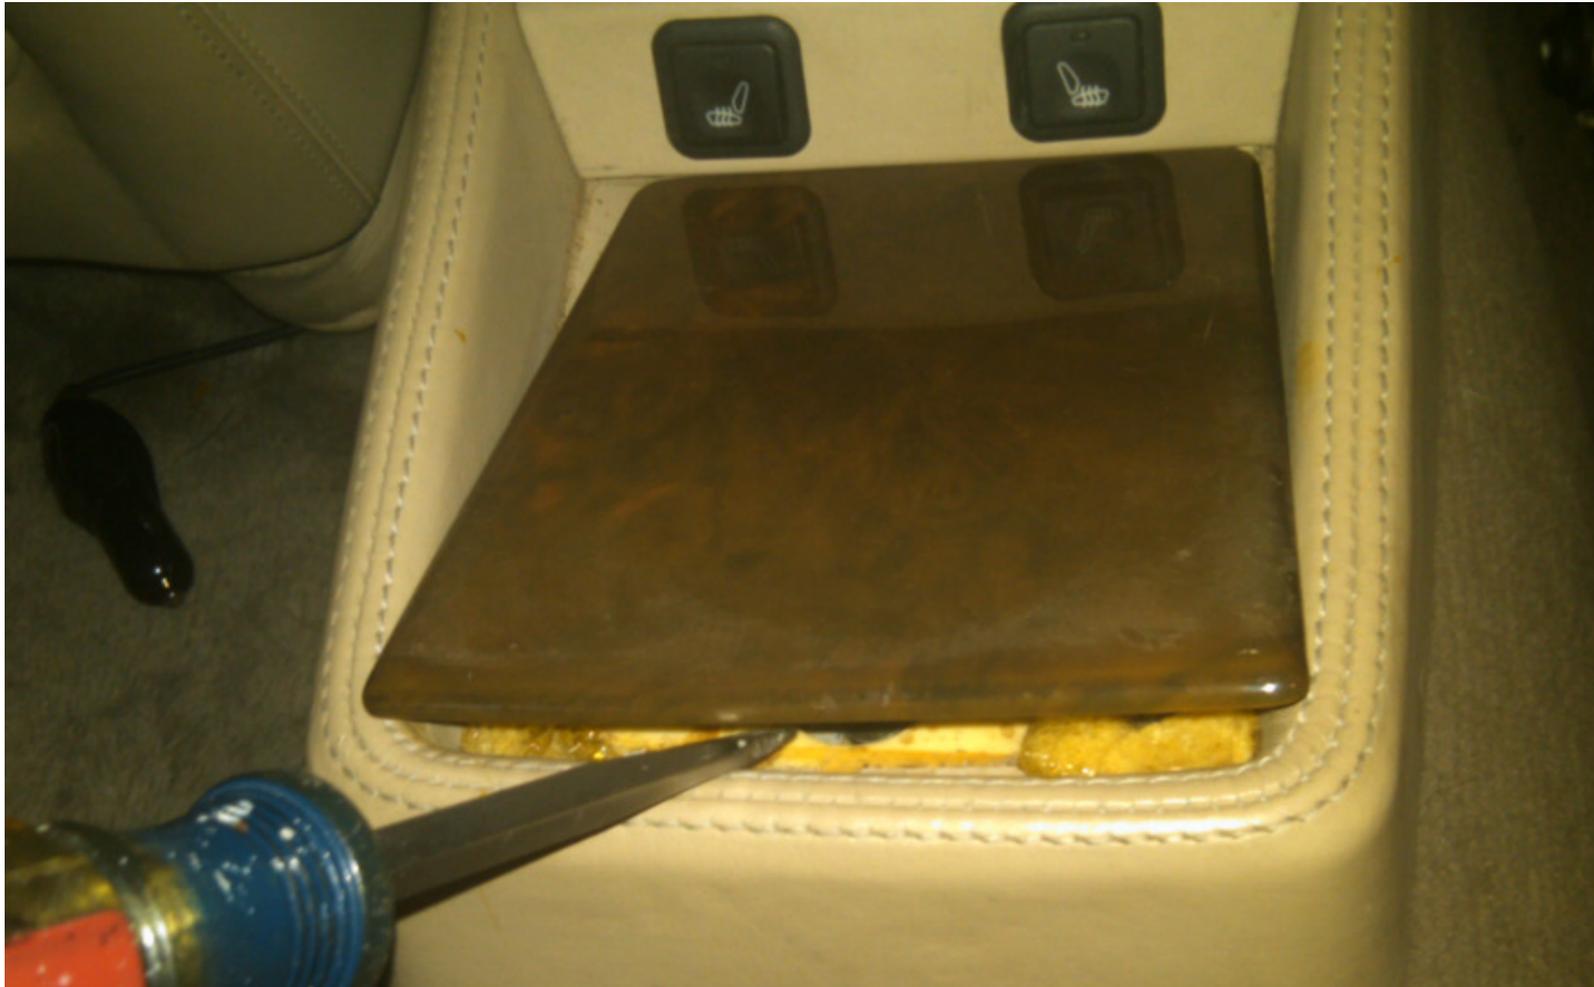
STEP-2 Pry the FRONT edge of the shelf plate and pull forward-out

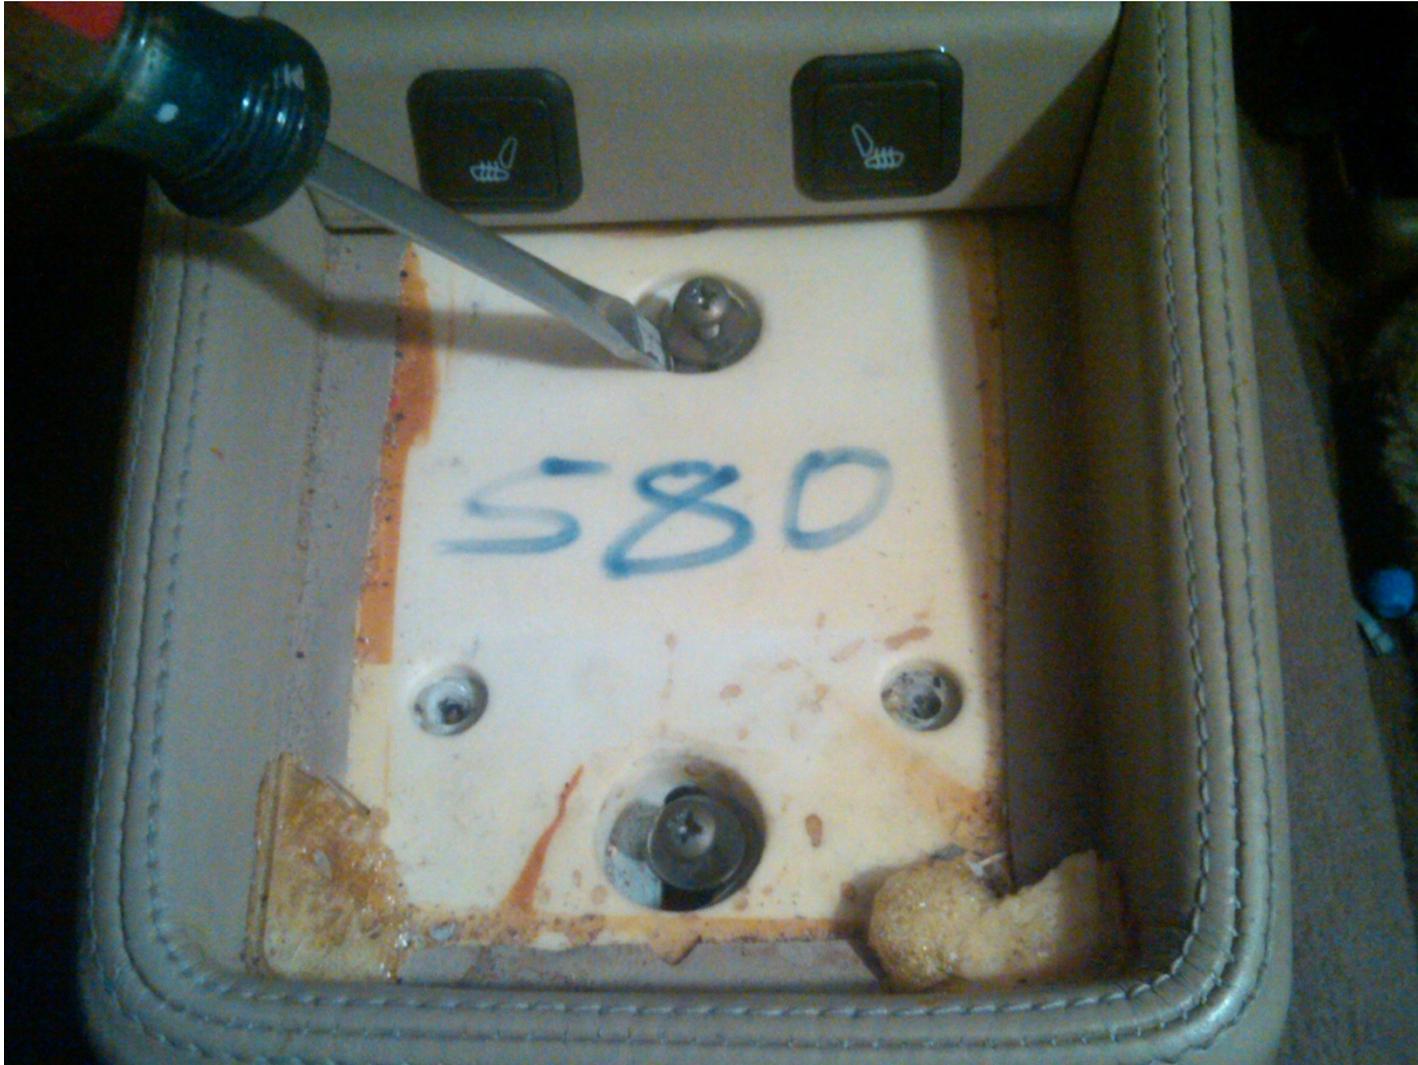
STEP-3 Remove the 2 phillips screws and remove the console

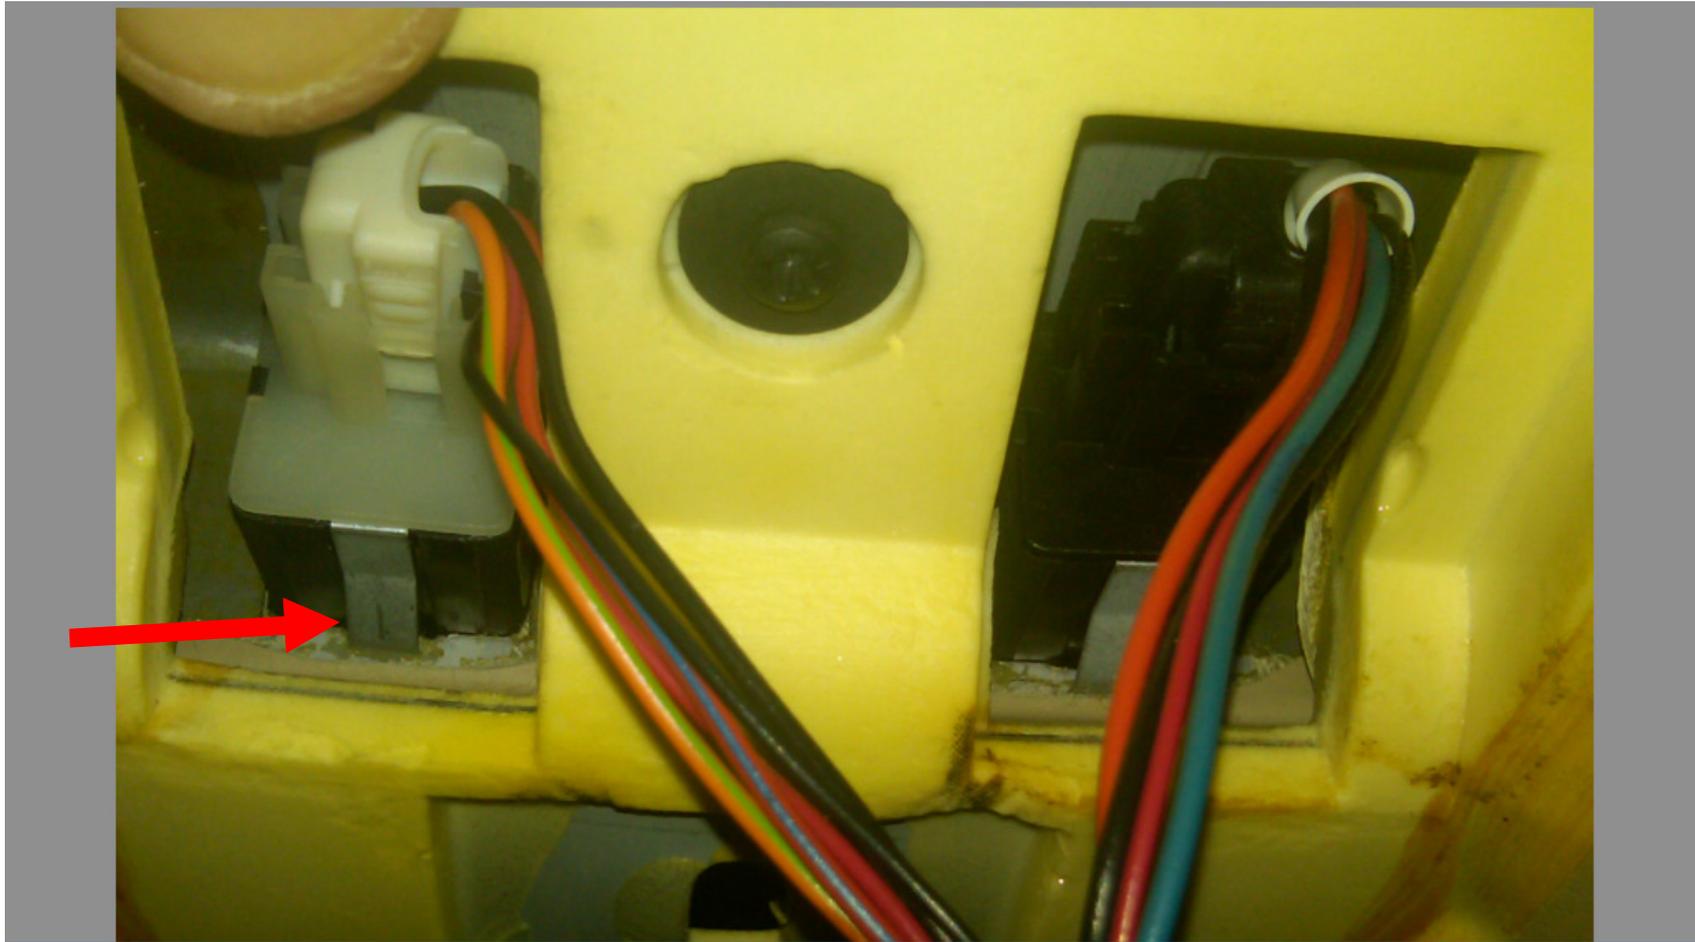
STEP-4 Push the retaining clip in an push the entire unit out the front

You can now determine the source of the problem:
-- Usually a stuck switch slide that is remedied by removing and replacing
