Cup Holder Repair

1995 X300 VDP

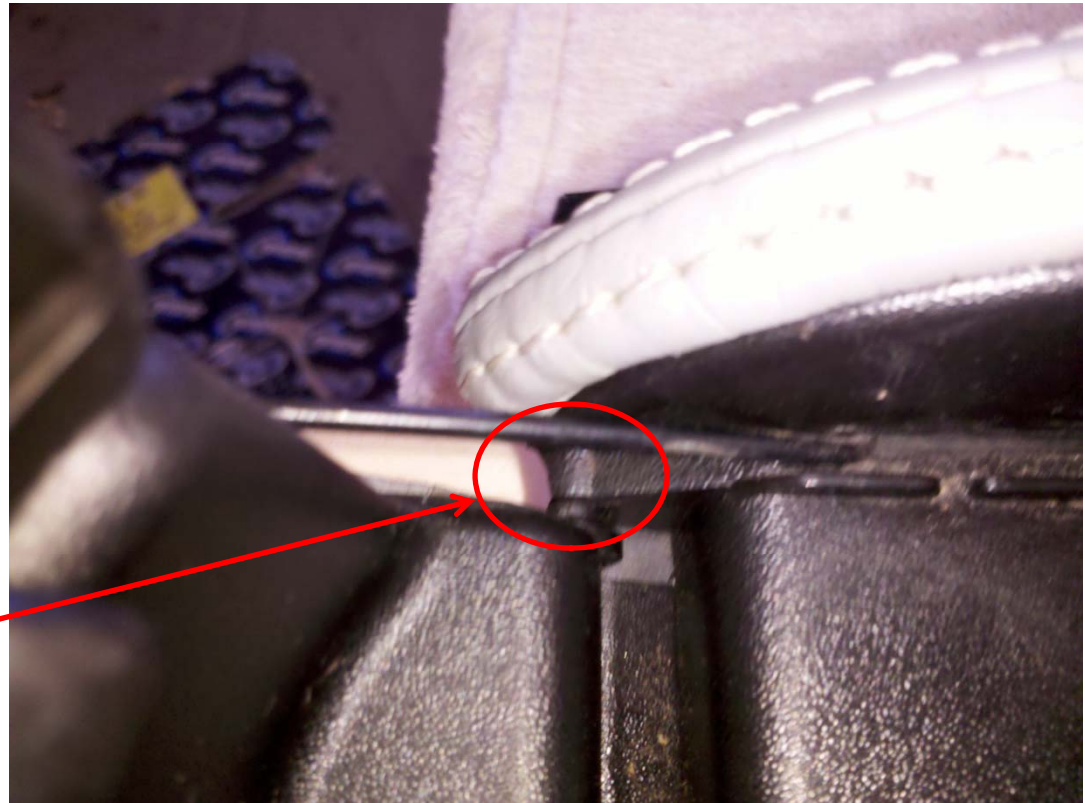
Broken Hinge Pin Receptacle

Unfortunately, I didn't do a bang-up job in focusing when photographing the failed state. This is the best of the lot.

The bottom is broken out of this little receptacle for the hinge-pin, allowing the cup holder to shift forward under spring pressure, which prevents the latch from engaging, causing it to flip open.

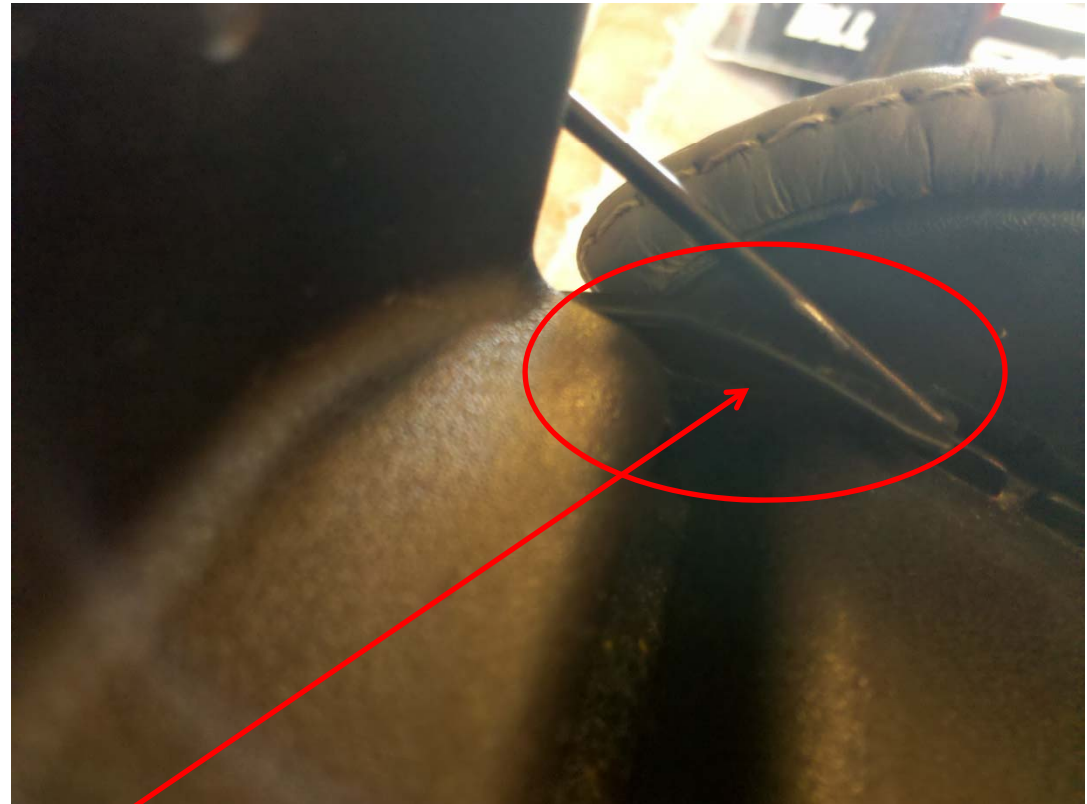
Idea Generation

I could see that I needed a mechanism to retain the hinge-pins in proper position in order for the latch to engage.

I have experienced very limited success in past ventures getting adhesives to bond with plastics. Casting about in the shop wondering what to do, I spied a cut-off from a zip tie on the floor. At the time, my thought process was to somehow utilize the safety wire I had obtained to complete the rear brake job to stabilize the hinge. However, there were absolutely no holes or other features I could tie off to. It occurred to me that I may be able to complete the loop with the spare piece of zip-tie and possibly have a large enough bonding surface to endure.

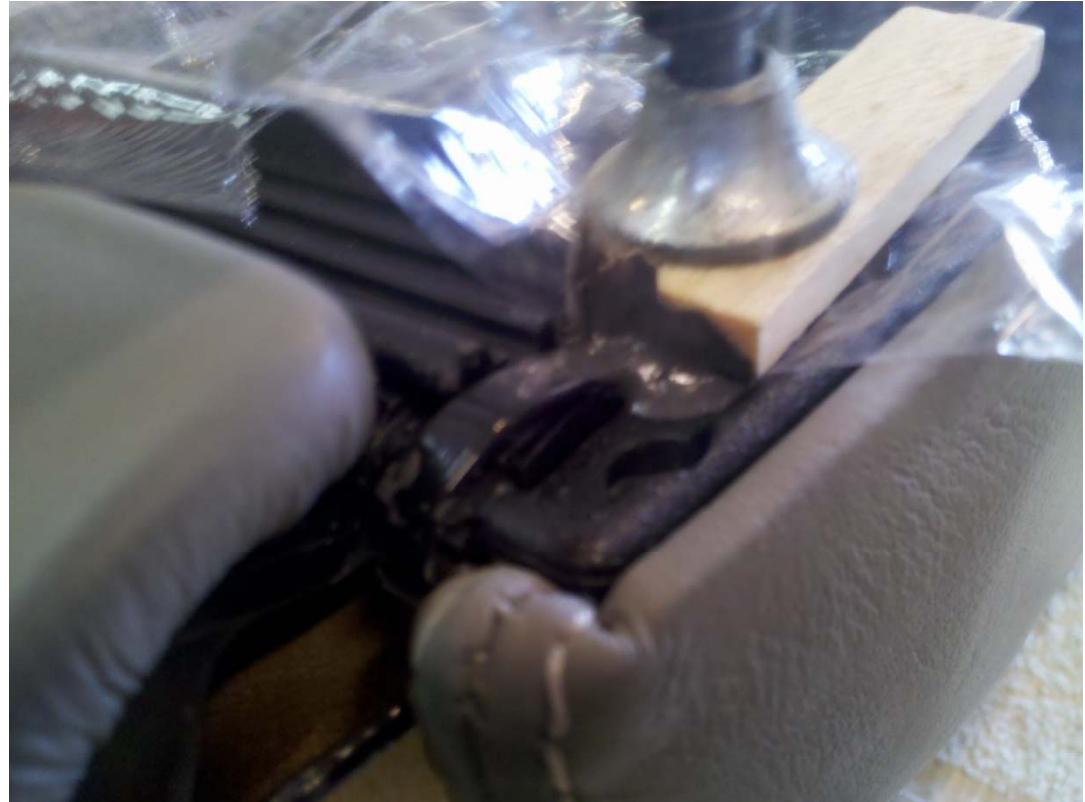
Best laid plans and all that...walking away I feared I did not have sufficient tension on the zip-tie to achieve success.

Here is a view with the plastic wrap lifted up, just before I left it all to cure.

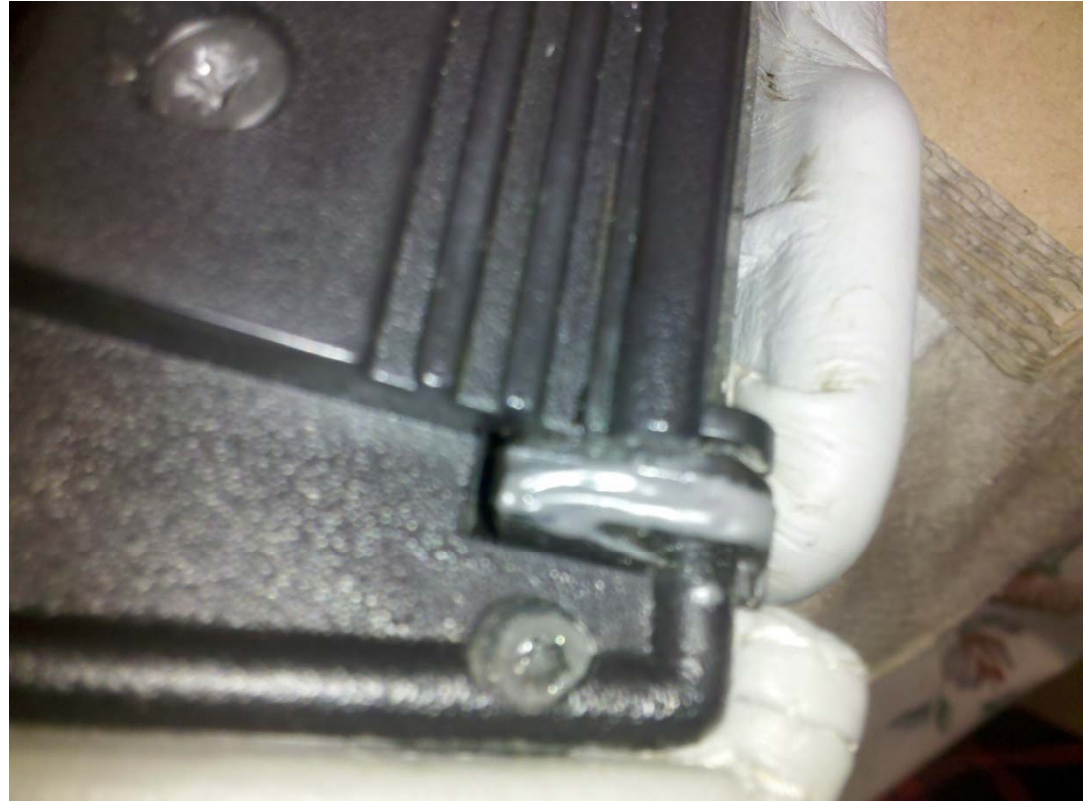
Preventative Actions

While inspecting the opposite hinge under magnification, I noted some telltale markings indicative of stress cracks. I elected to “paint over” same with the leftover epoxy in hopes of forestalling the next break

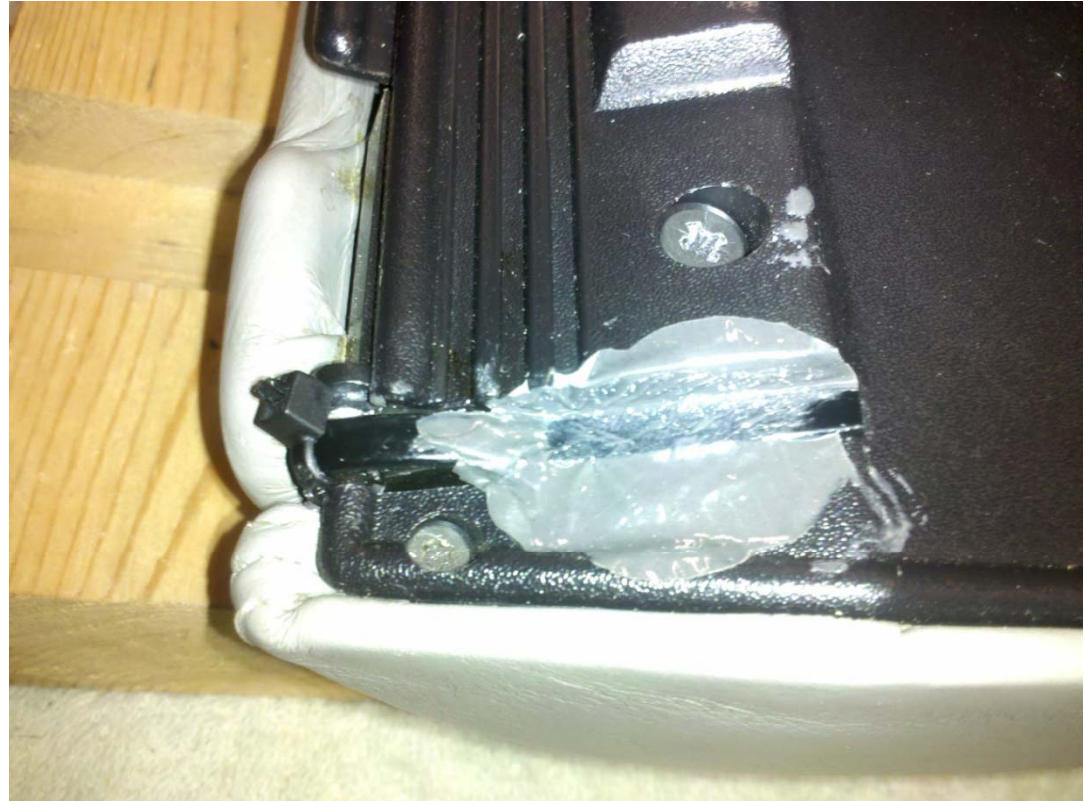
This is (almost) the view that greeted me upon removal of the clamp and plastic wrap. (Ignore the extra piece in the photo for now)

And ignore that I already cut the excess tail off the zip-tie before I took the pic.

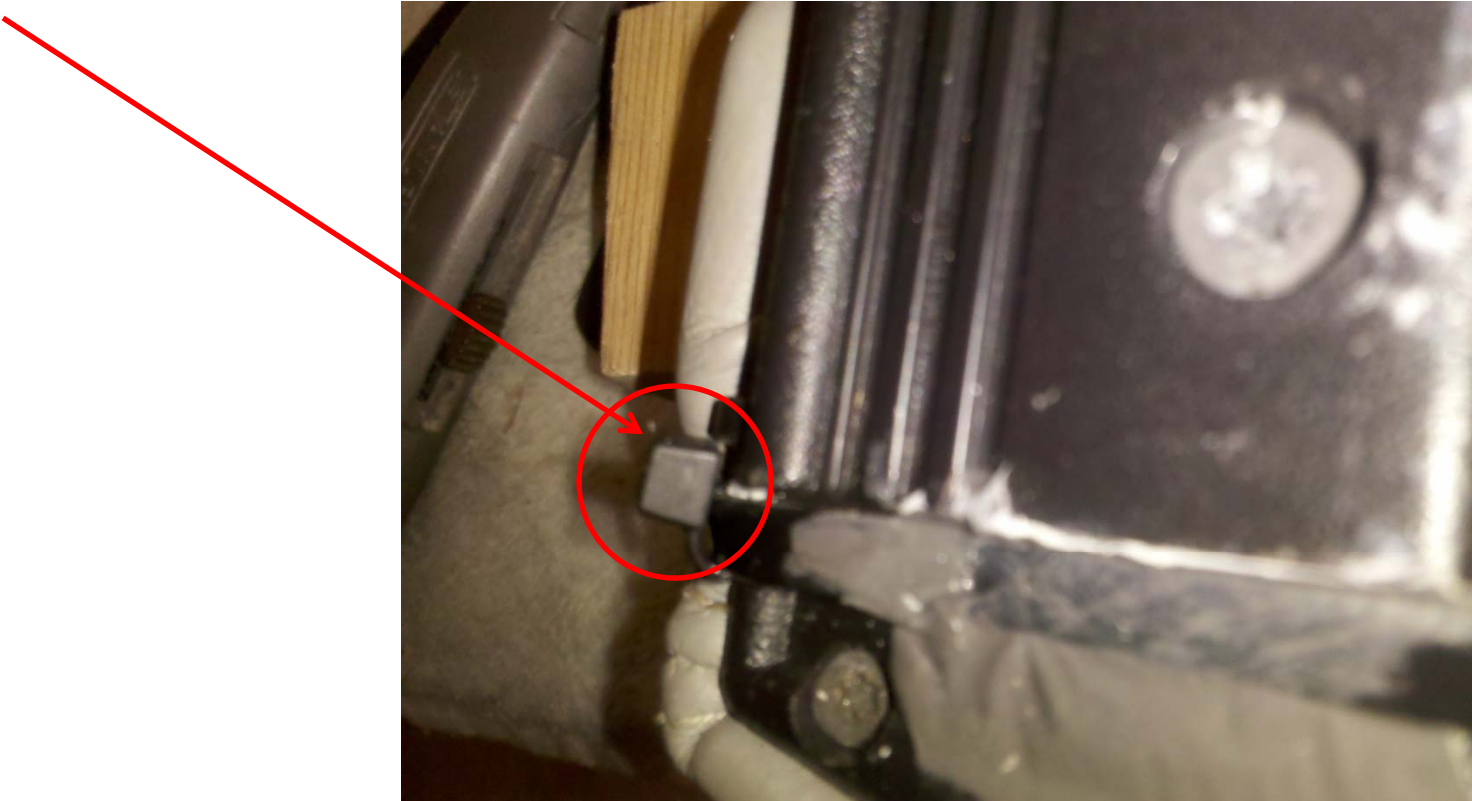
Tuning

Testing confirmed my fears that tension was inadequate to reliably engage the latch. I used a much smaller zip-tie around the glued-on scrap at the hinge pin to take up the extra space. (Also shown in previous photo)

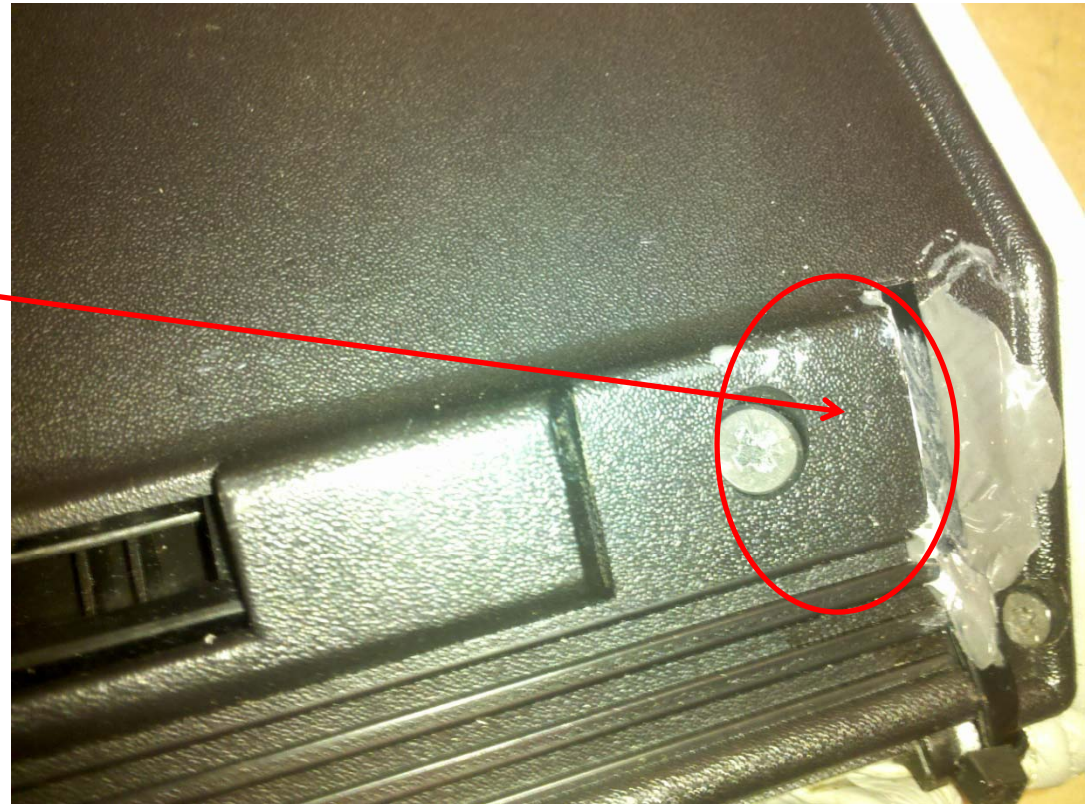
Cleanup

I'm concerned about the durability of my fix given the ease with which I removed this bit of excess epoxy. I simply scored it along the edge, and as soon as I slipped the tip of the utility knife under the edge, the whole piece flaked off cleanly

I placed it in-service Monday night, and it was still working 4.0 as of Friday evening. So far, so good!
