Heater Hose Renewal

1995 XJ-6 4.0L NA

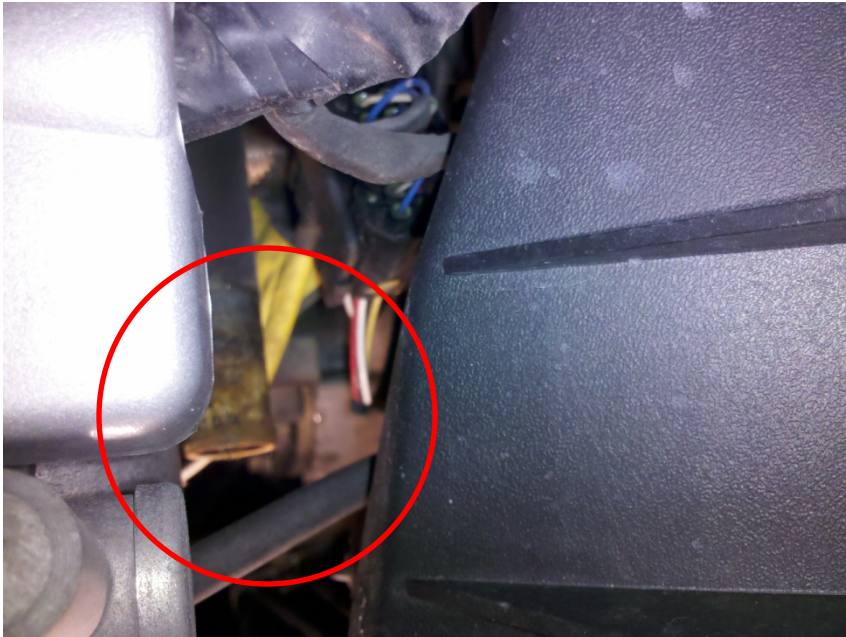
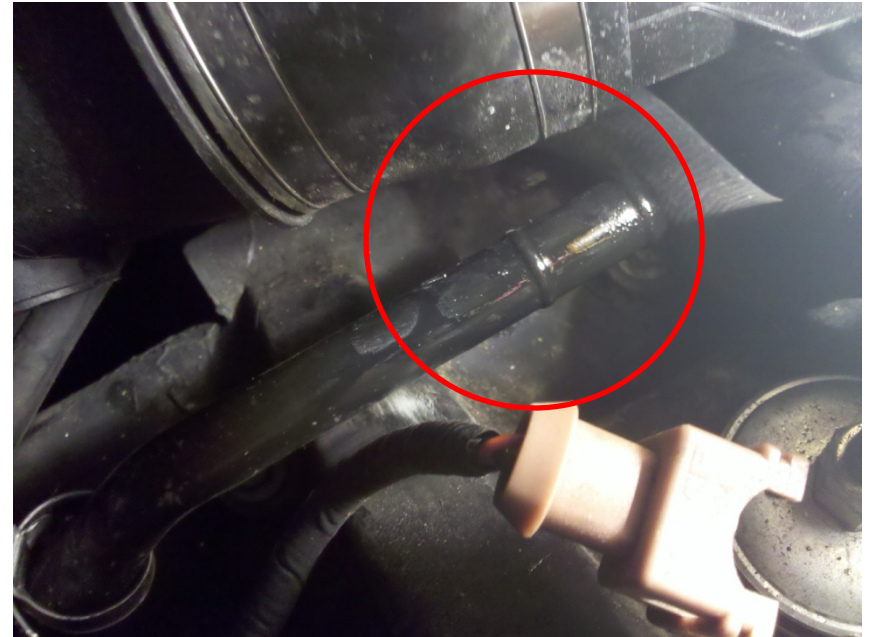
Need to Bypass your Heater?

If any of your heater hoses (or the pump or valve) spring a leak and you need the car whilst you await parts, you can run a hose from the supply port on the head (Left Pic) to this one under the air-intake tube (Right Pic) and be back on the road, albeit sans heat. Not sure but I believe 5/8" ID X 36" would be sufficient.

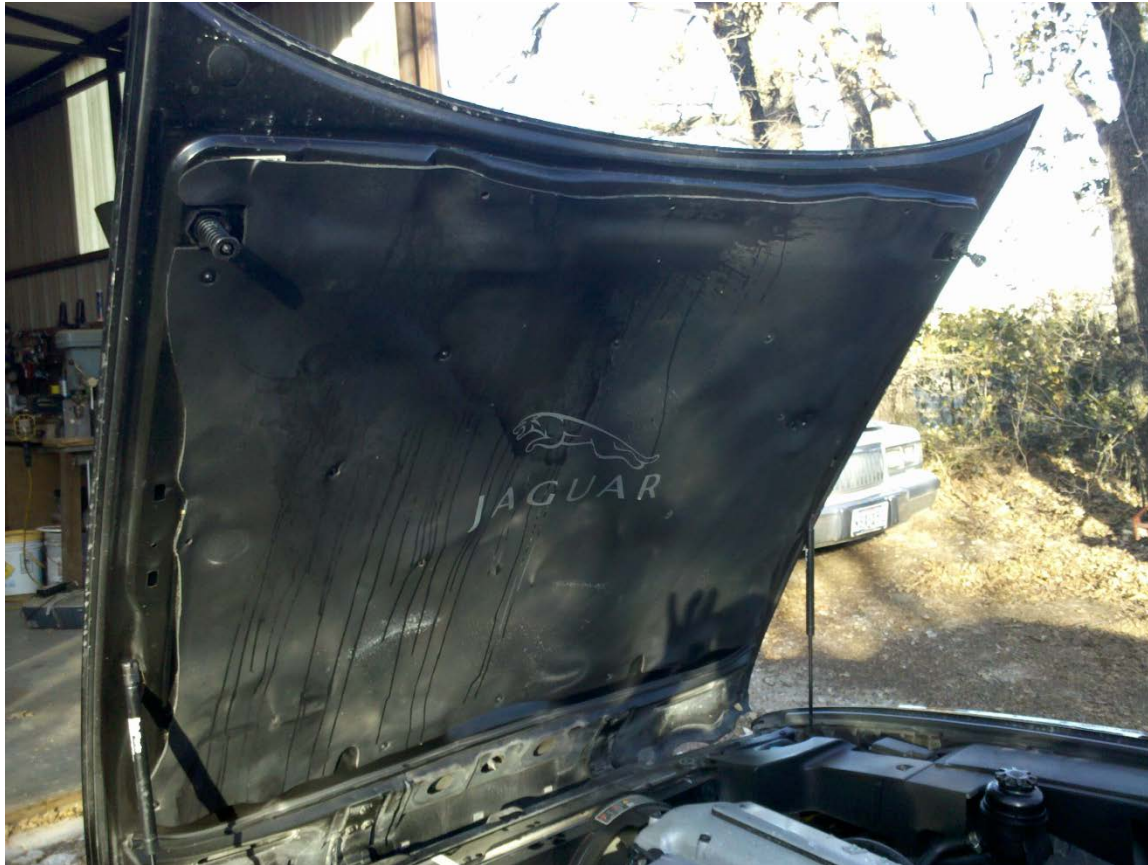
Ruh Roh!

The leak is clearly in the aft engine bay area. Quite a tangle of heater hoses back there, but it seemed more toward the center.

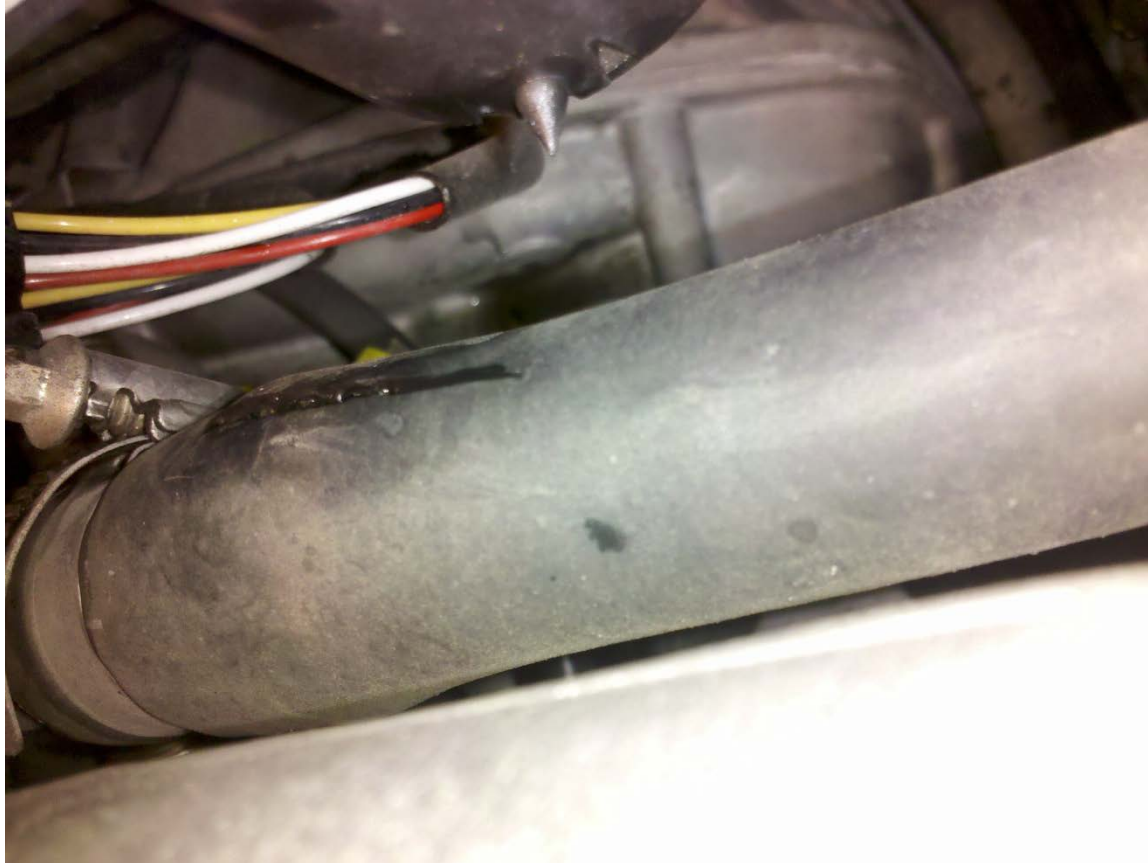
Found it!

Actually never saw this, but took a bunch of pictures with my phone of the area where I believed the leak to be. Standing in the sunshine looking at the phone-screen, I thought I may've seen a problem here. Once I brought it in and downloaded it to the computer, it was obvious.

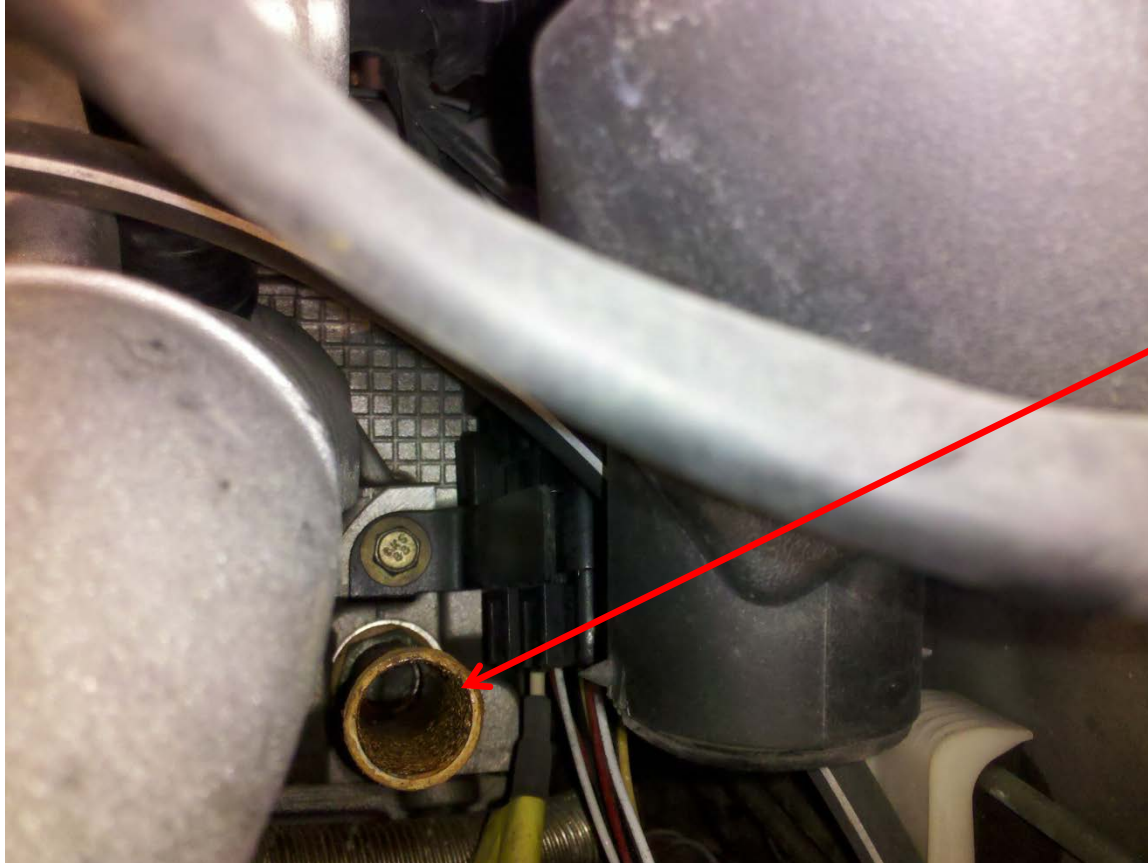
LHS of the head, aft

The breached hose was attached to this port on the head that supplies the heater matrix.

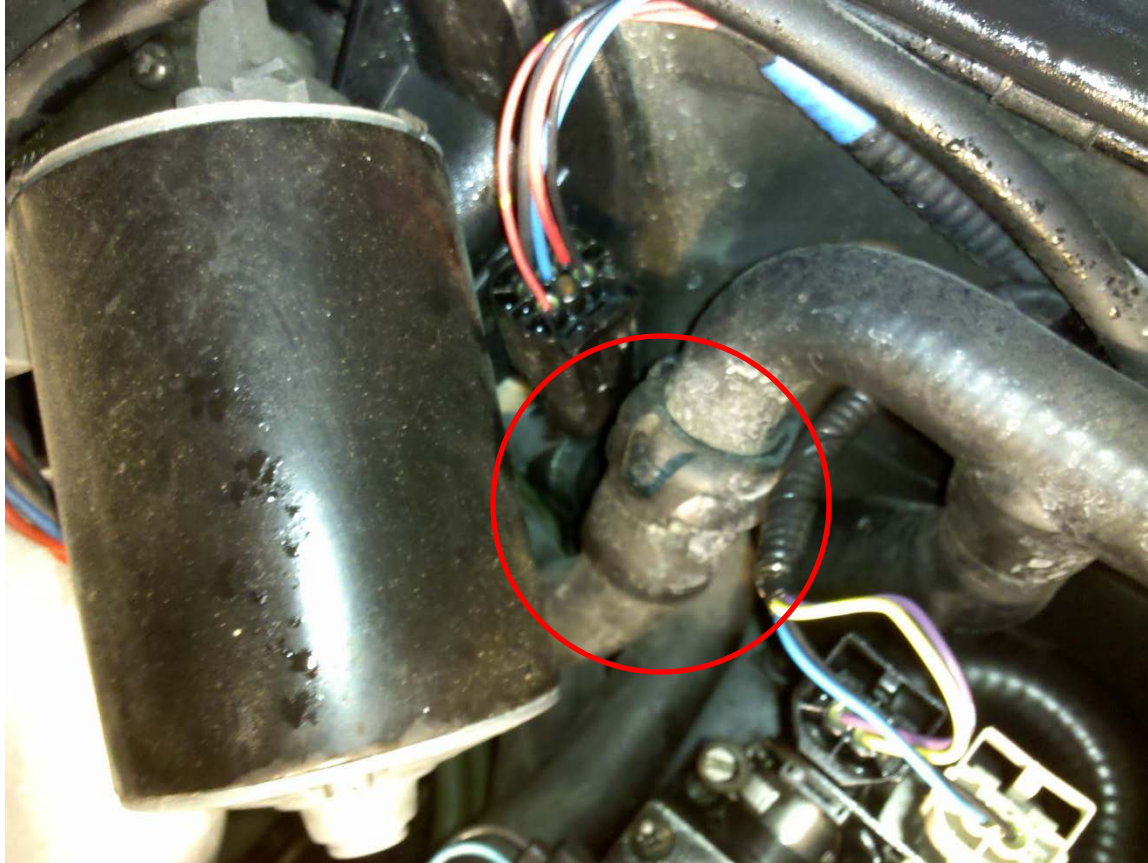
The other end of the busted hose terminates in this puzzling connection to the strange hose with 4 endpoints.

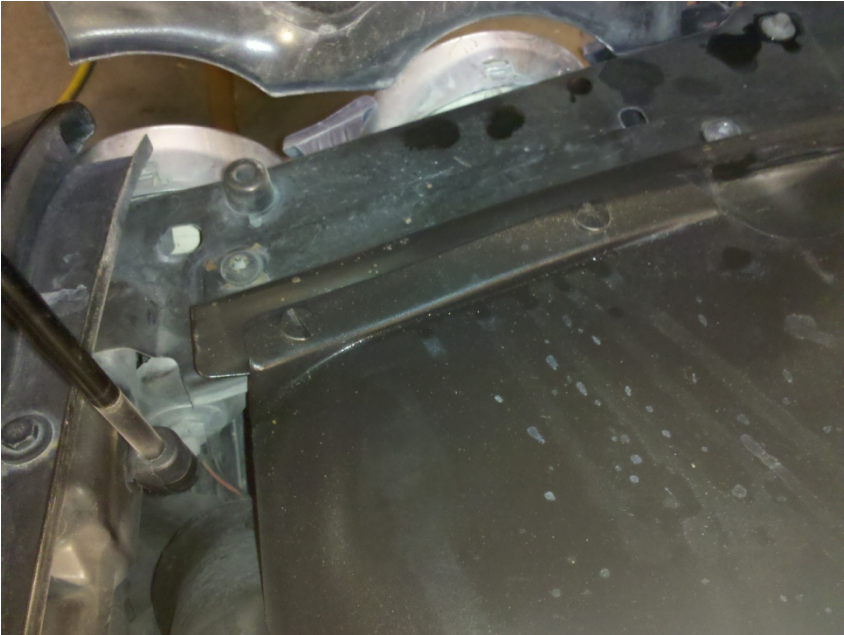
Remove Aesthetic Cover

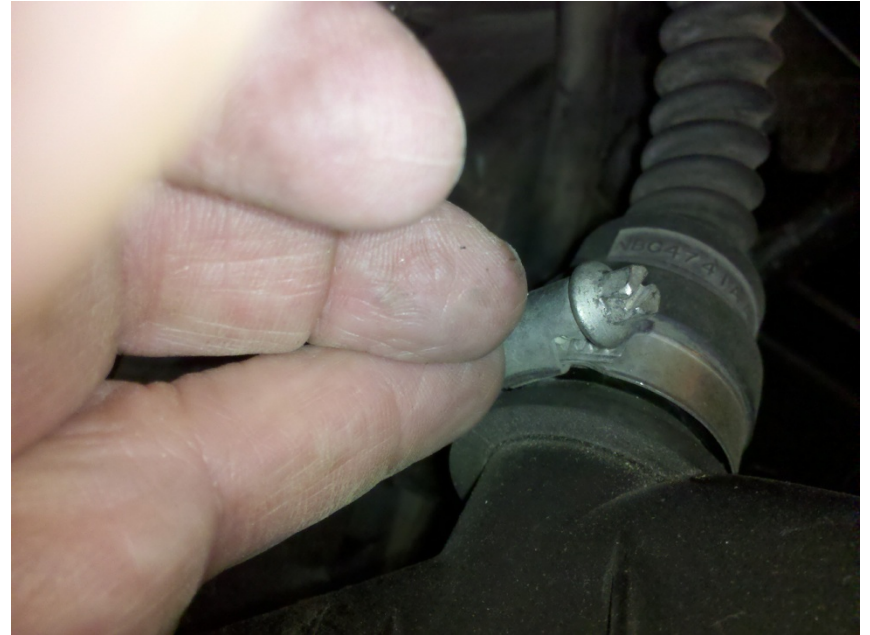
Remove Air Pump Hose

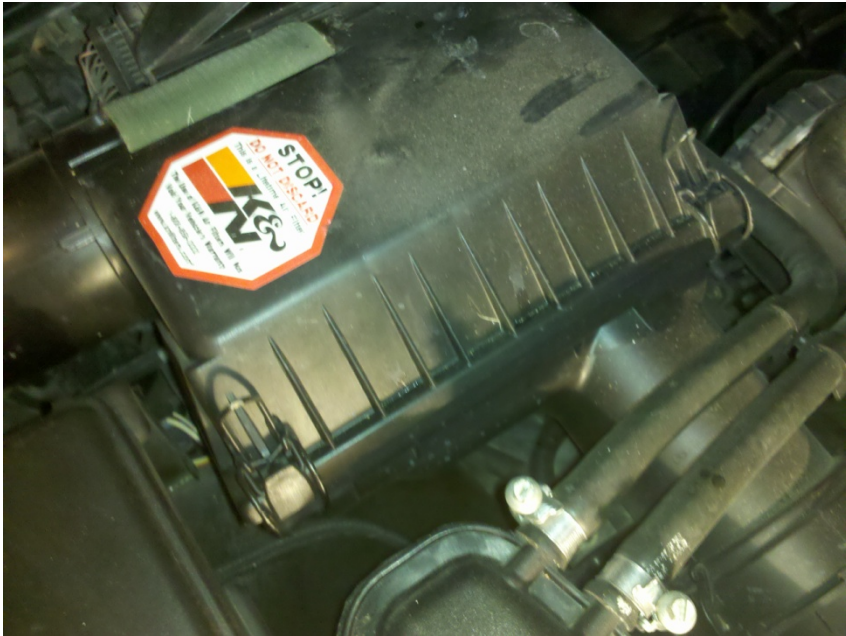
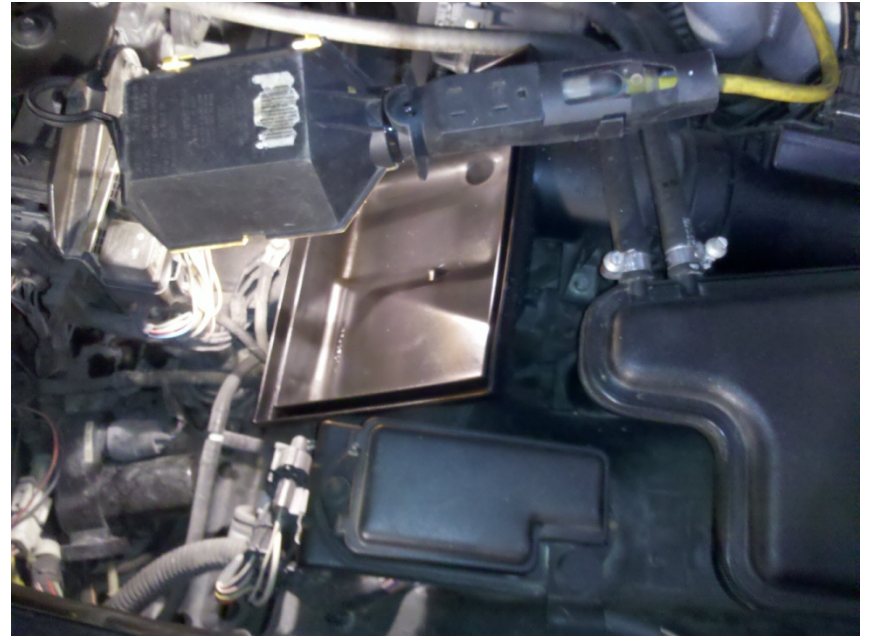
Disengage Spring Clamps

Remove Cover and Filter

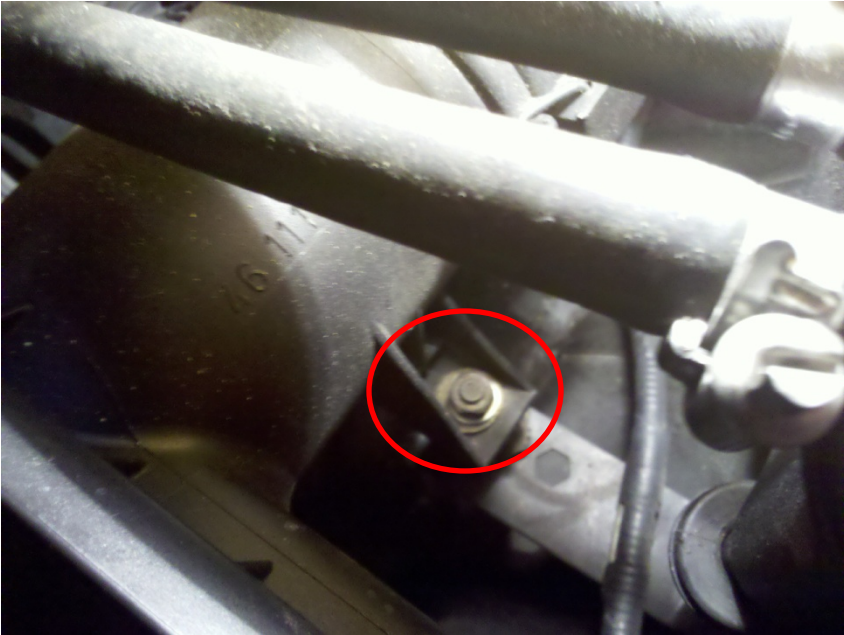
Remove Fixing Nut

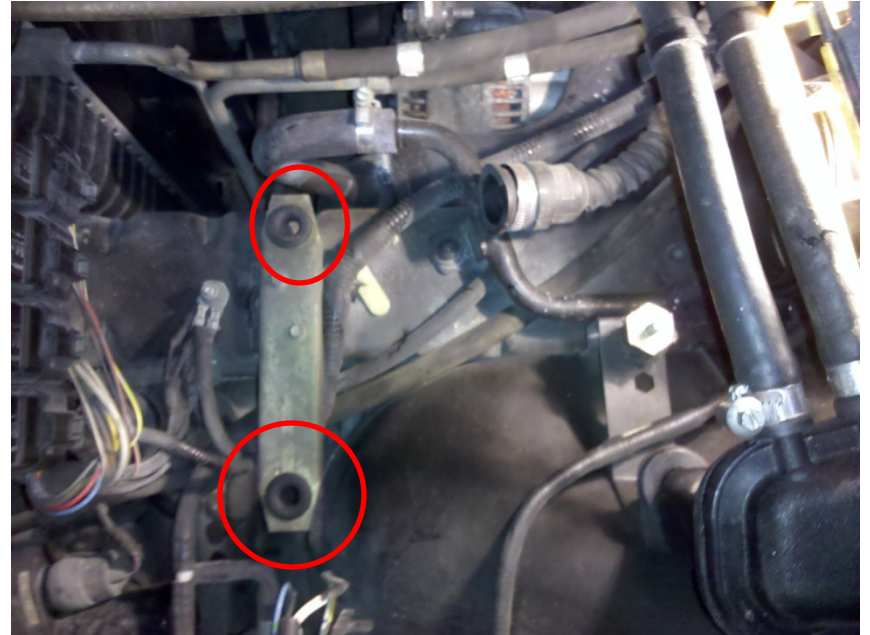
Work Box out of Rubber Grommets

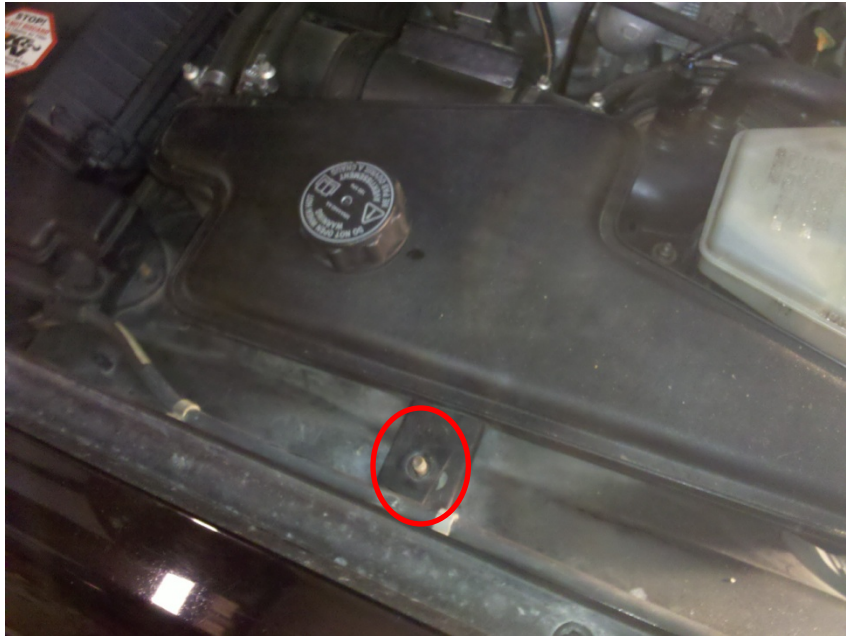
Pull WxStrip, Plastic cover, and remove fixing nut

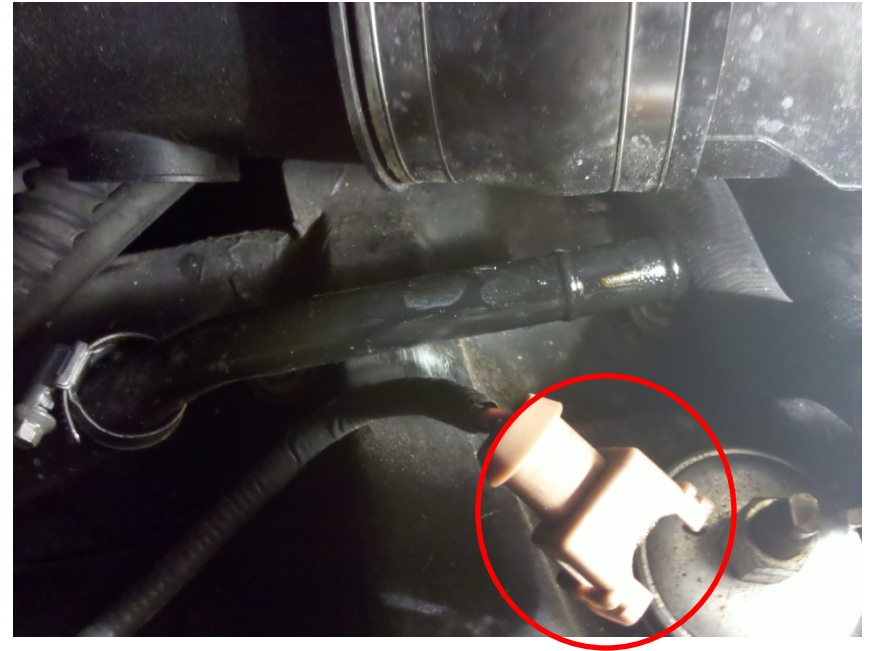
Remove locking clip and disconnect low-coolant sensor connector

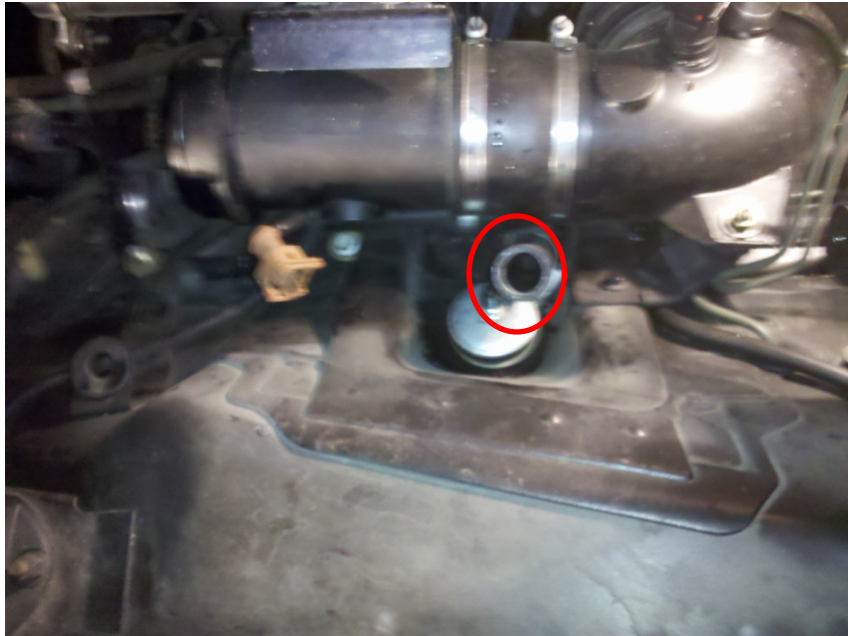
**Lift Reservoir enough to
Disconnect this hose**

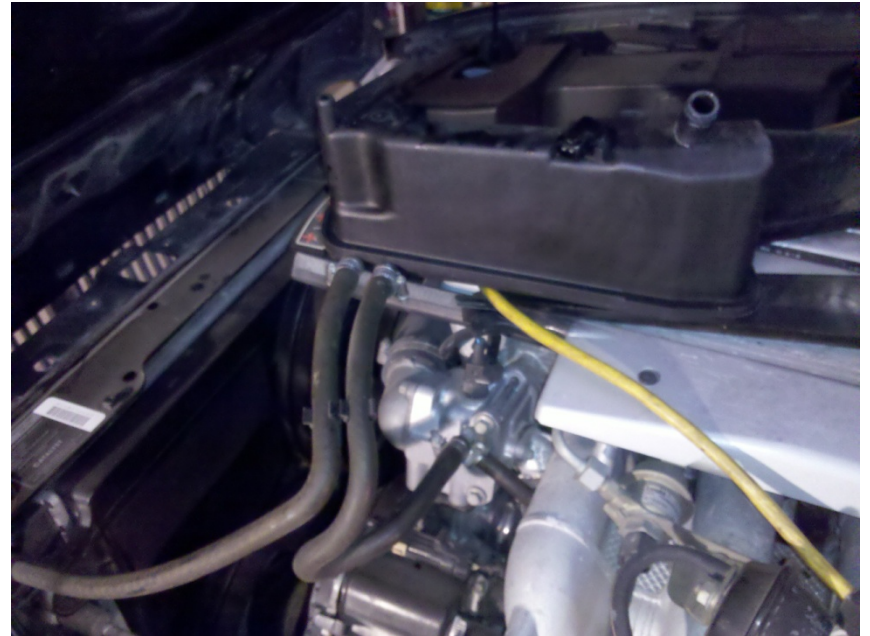
**I left the overflow hoses attached
and set it aside on the cam-cover**

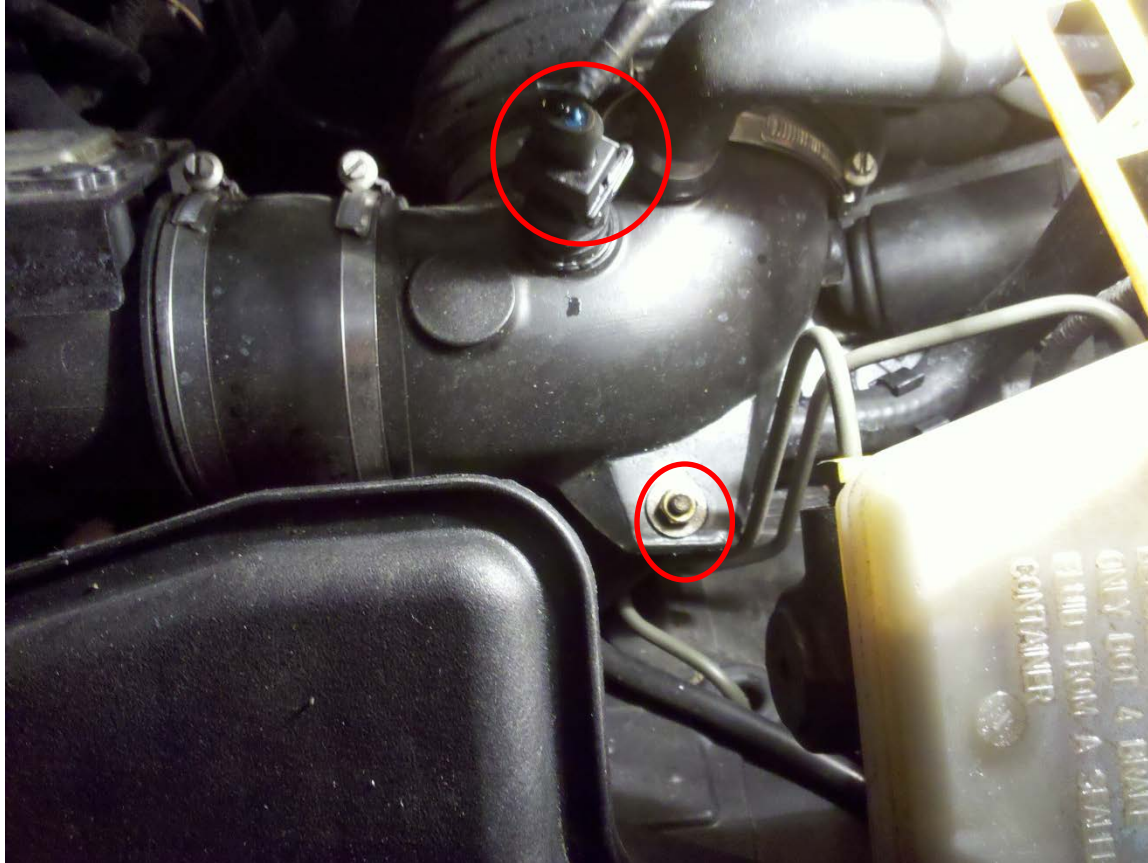
Displace MAF Sensor/Air Intake Tube Assy

Disconnect electrical connector, remove fixing nut, and loosen clamp at bellows/intake manifold interface. I rolled the entire assy up and over onto the intake manifold/cam-cover, leaving CCV hose attached.

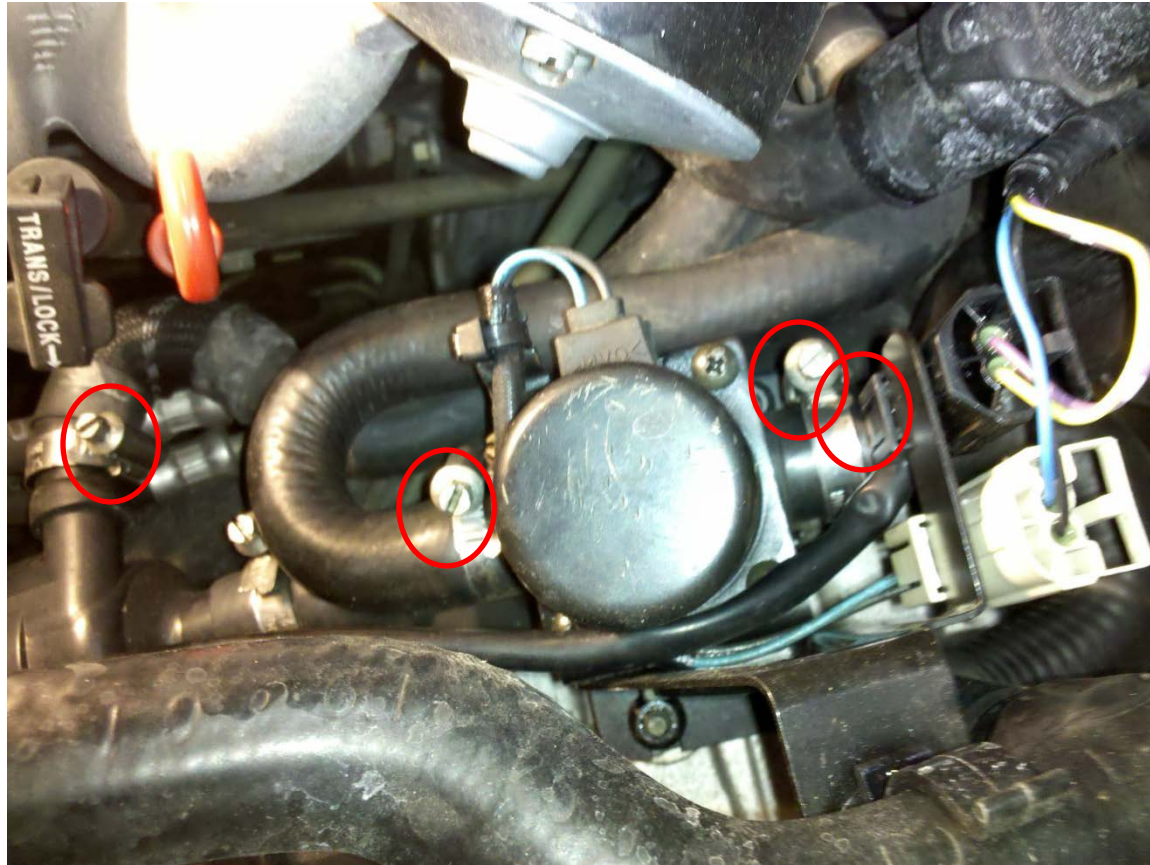
Since I had replaced the Pump-to-valve hose last summer when I replaced the radiator and bypass hoses, and flushed & renewed the coolant, I was keen to leave that in place as an asy and just disconnect the affected hoses. After loosening the affected hose clamps, I determined that to be an unworkable plan

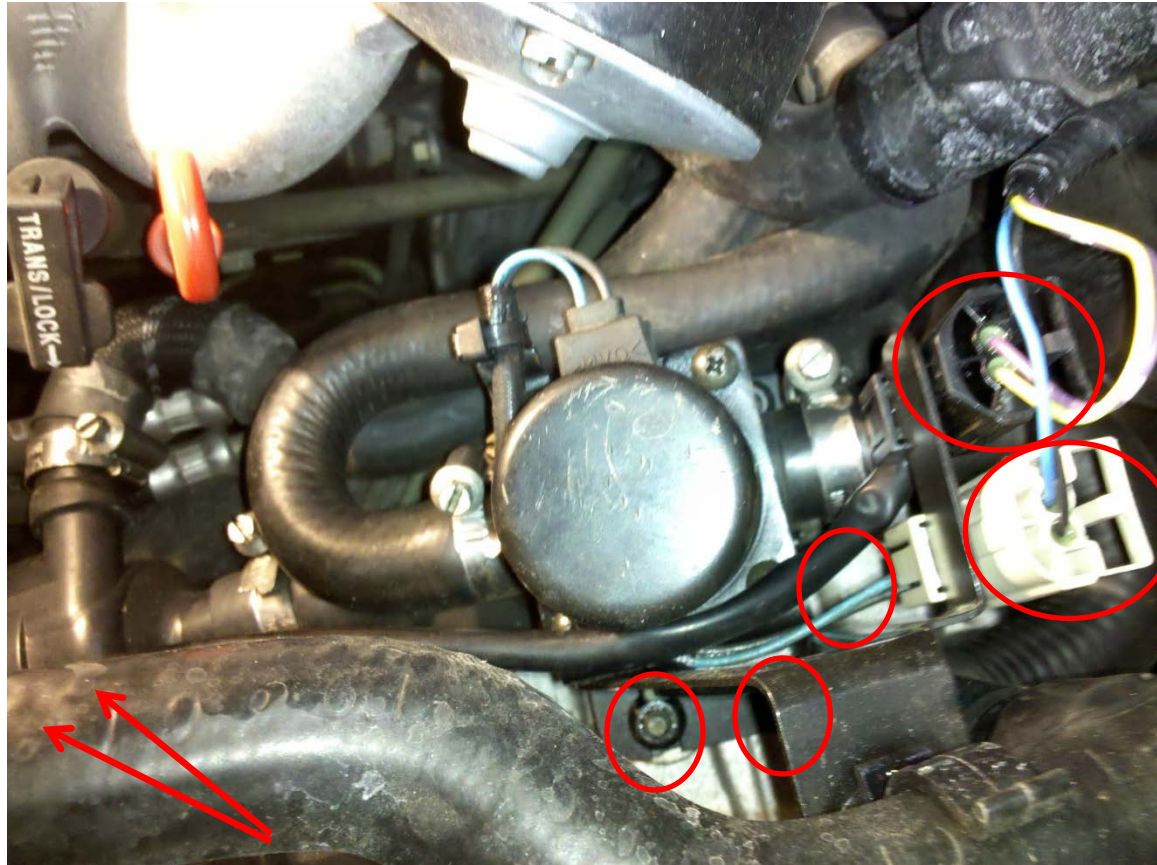
So I disconnected the electrical connectors and removed 3 fixing nuts from the valve bracket and two from the pump mounting (not shown) and removed it as an asy, connected by the hose.

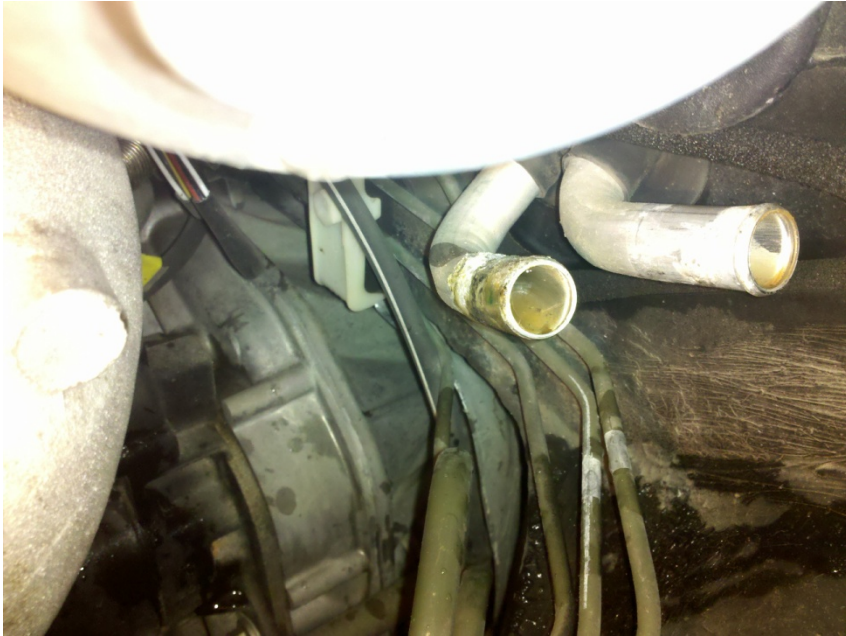
Both sides of Heater core

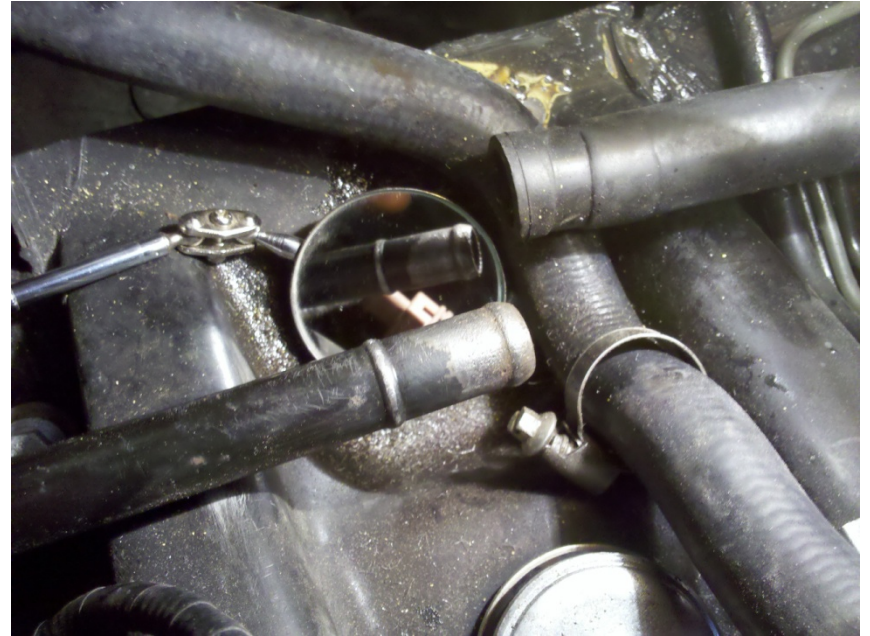
Forward end of 4-ended hose

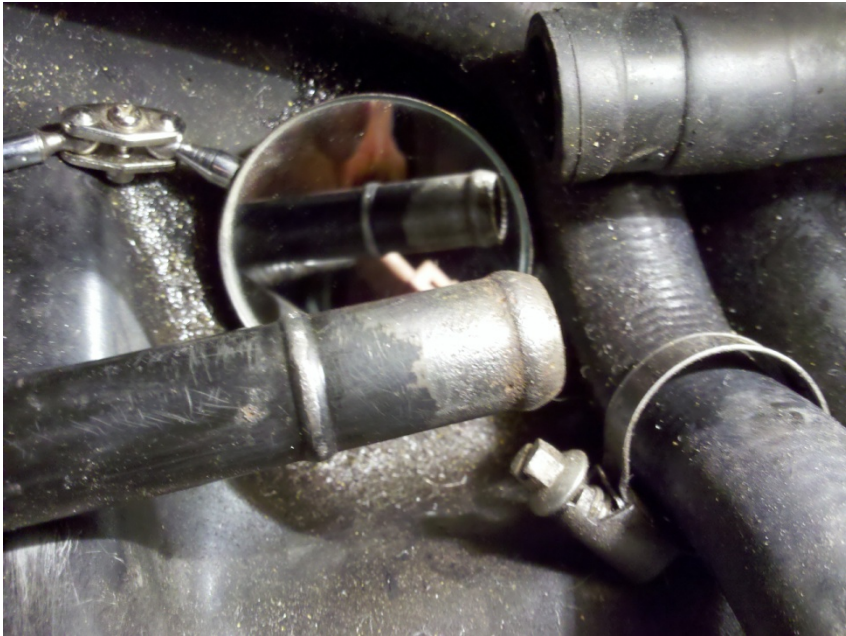
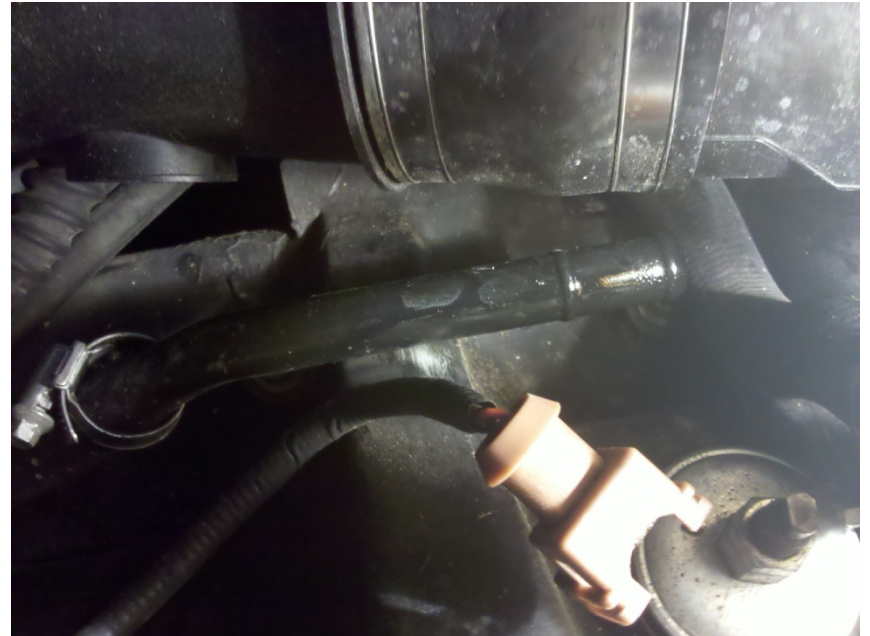
Corrosion

Didn't snap a "before" but found the end of this tube well-rusted just like the other end of it last summer when I replaced the lower rad. hose

Mended it with a bit of 60-grit, then some 150, then steel wool followed by paint

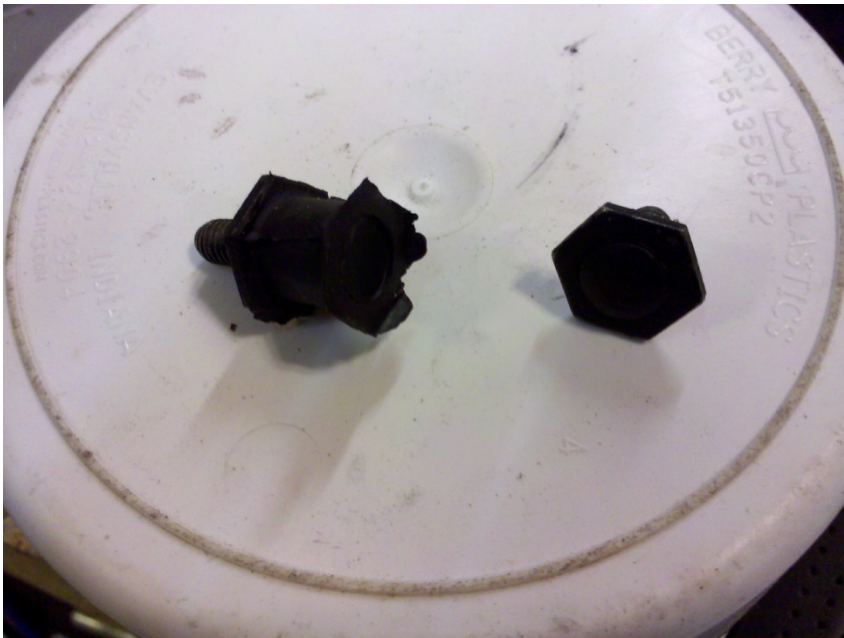
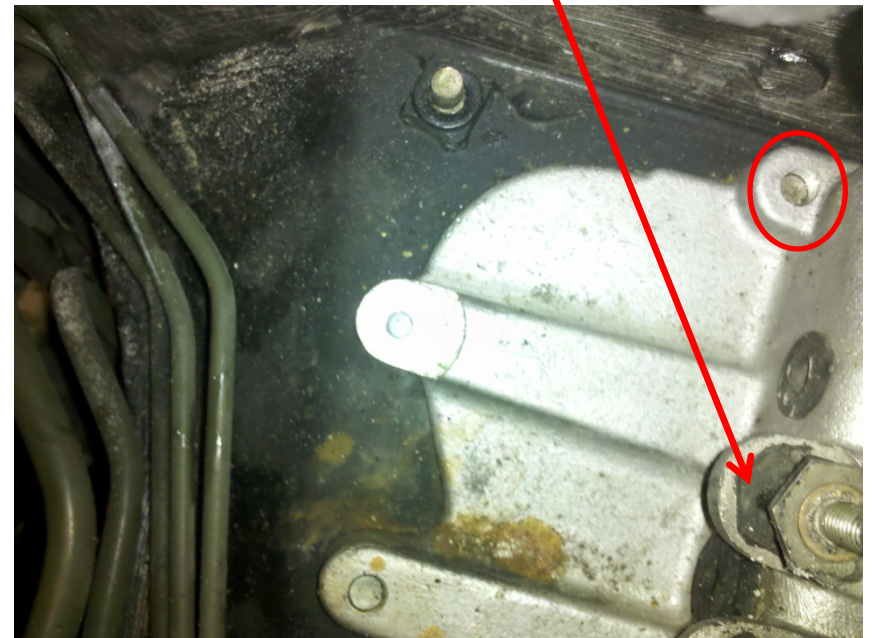
Water-Valve Iso-Mount

Found the large piece on the left adrift on the inner fender Wed. evening when I thought I just had a put-it-back-together and refill coolant task.

I retrieved the smaller piece from here using the 15mm socket. No ratchet nor other means of mechanical advantage was required. It should've looked like this:

I mixed up a bit of 2-part epoxy, carefully clamped both pieces together, then suspended it over the kerosene heater I was using to make the shop habitable for middle-aged man work. Eventually, I had gone as far as I could without remounting the WV, so I took the heat gun to it all 'round and cured it up quickly
