REMOVAL OF HEATER/EVAPORATOR CORE – 2003 JAGUAR XJ8 (X308)

2003 Jaguar XJ8 Vanden Plas (X308)

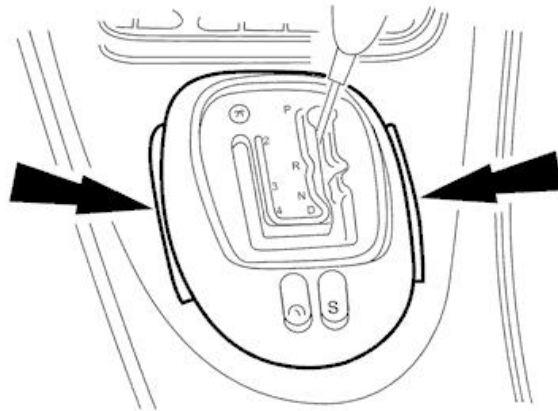
E36213

<<76.25.24>> <<501-12>> Apply protective tape on the wood around the finisher (trim). Then, remove the 'J' gate (shift column cover) finisher by gently prying with a plastic knife and pulling evenly and straight up, or the tabs will break (E36213). There is one slot at the top, front of the trim to assist in lifting up on the gate.

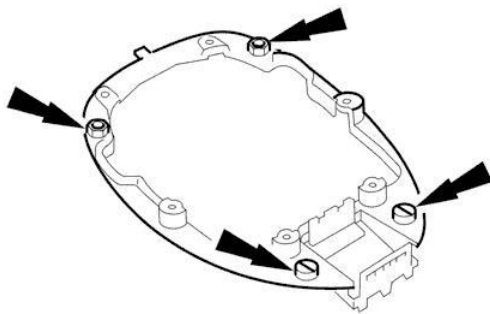
E36214

<<76.25.26>><<501-05>> Use a 7mm socket to remove the 'J' gate finisher bracket (E36214). Remove the cruise control and sport mode switches from the bracket (E36215).

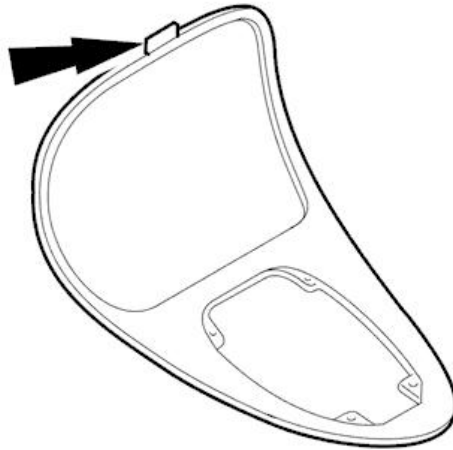
E36334

<<76.47.26>> Remove the wooden console veneer finish panel by gently lifting from the bottom (rear) and lifting up and over the two studs at the ‘J’ bracket mount (E36334).

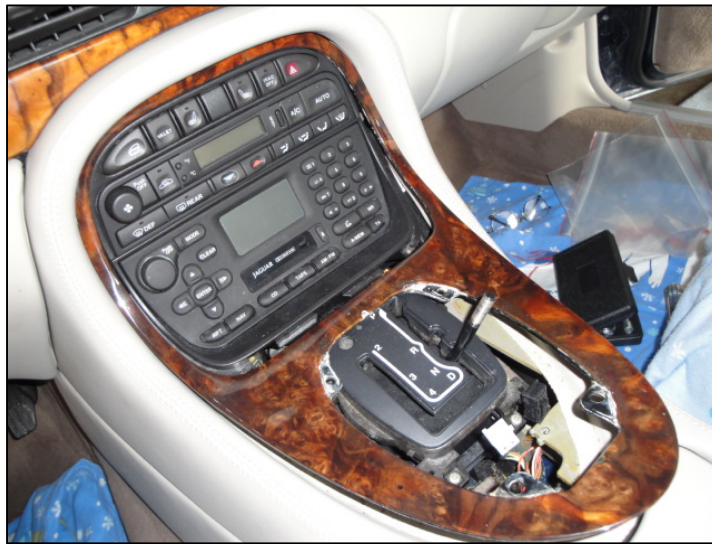
Console wood finish “ski slope” trim detached from the console.

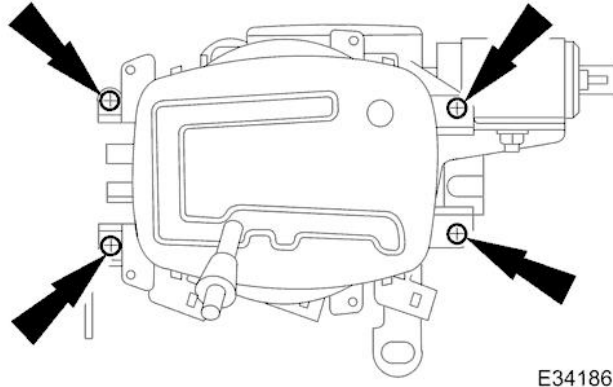
E34186

<<44.15.14>> Remove the four Phillips head screws holding down the transmission selector housing module to gain access to the radio (E34186).

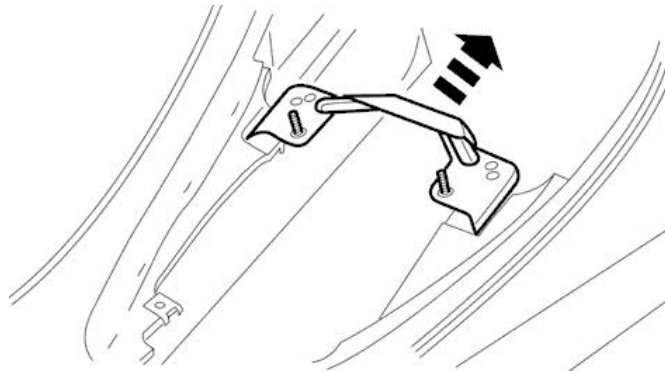
E35517

<<76.25.24>> Remove the stud mounting plate off of the console (E35517).

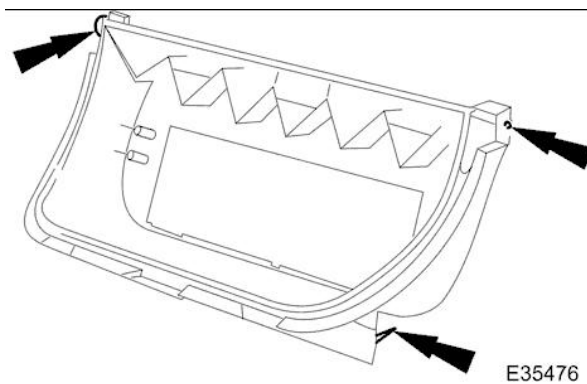
E35476

<<76.25.15>> Remove two Phillips head screws from the top of the radio housing; then remove the radio by pulling it straight out. There are two dowels/tabs at the bottom rear of the radio console (E35476).

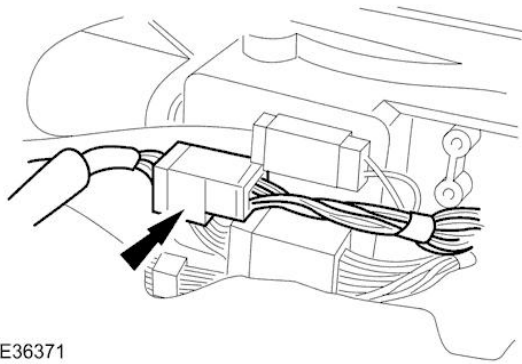
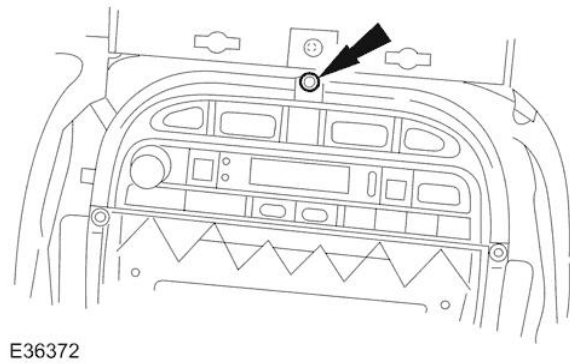
<<501-12>> Remove the climate control assembly housing by disconnecting the blue electrical connector at the left of the gear selector switch (E36371). Remove one screw at the top of the assembly (E36372). Reach in behind and push the assembly out (towards the rear of the car).

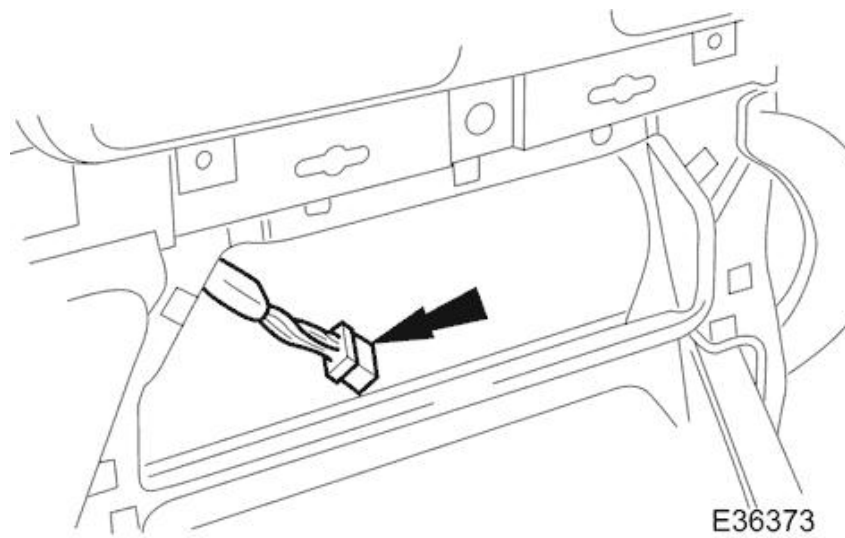
Disconnect its electrical connector (E36373).

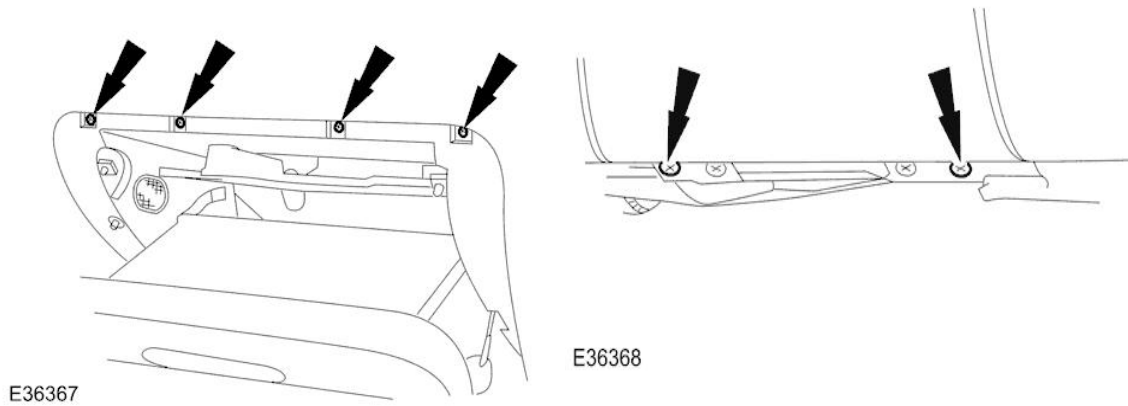
<<76.52.03>> Remove the glove box by removing four Phillips head screws at the top (E36367) and two Torx screws (T-30) at the bottom (E36368).

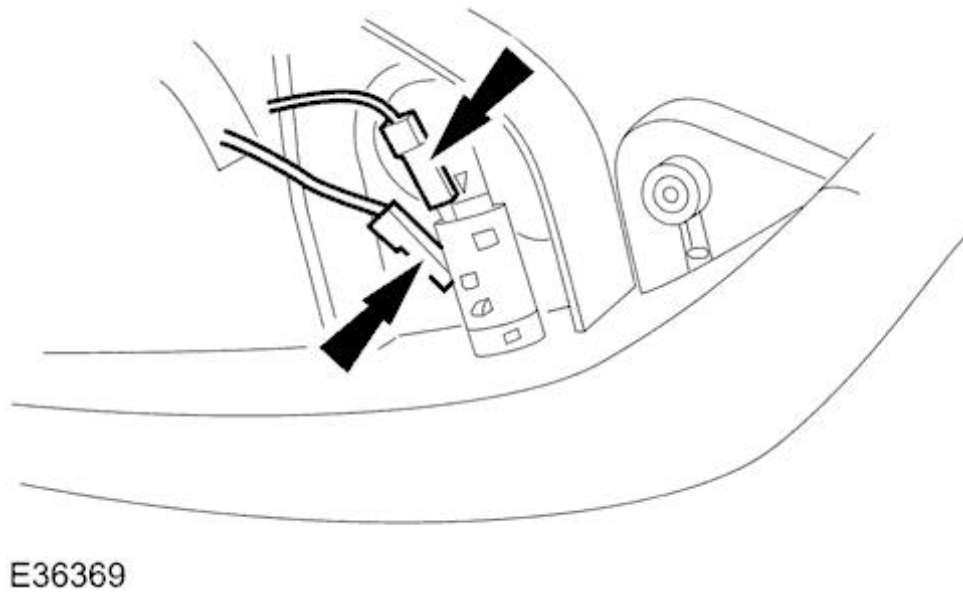
Unhook the electrical connections (E36369) and remove the glove box from car. The black plug is connected to the ground of the bulb socket.

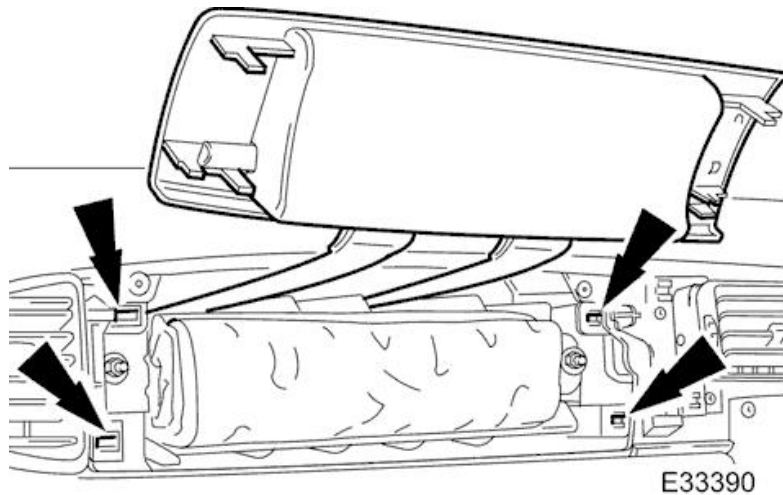
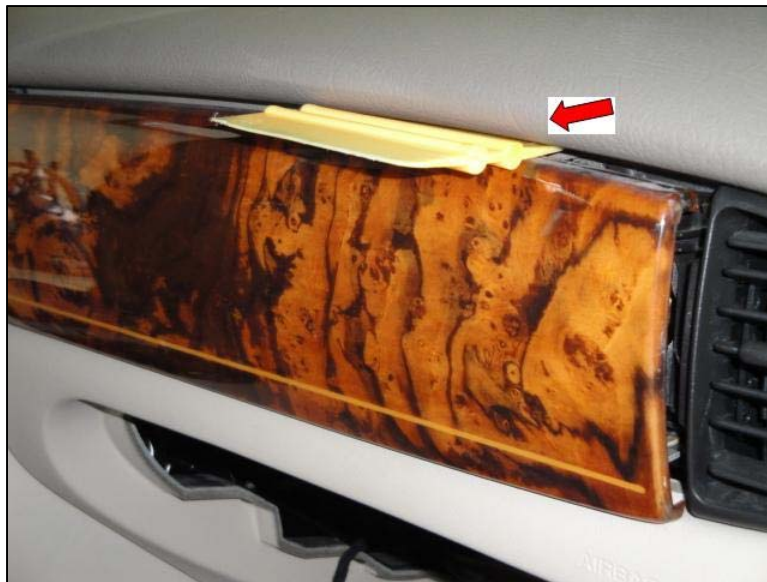
<<76.46.01>><<page 16-17>> <<76.47.06>><<page 1>><<501-12>> <<76.73.37>>
Remove the passenger air bag. Take off the wood veneer panel by gently prying with a plastic knife or other plastic tool. The panel is held in place to the dash by four tabs (E33390).

Detachment of the wood trim panel using a plastic tool

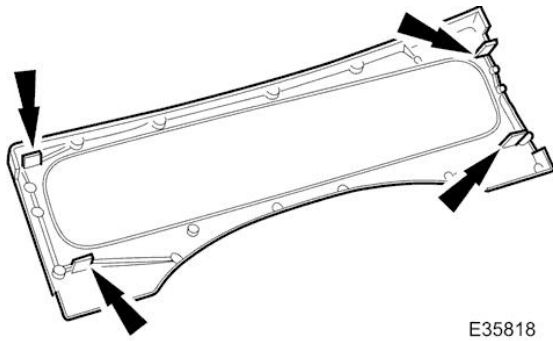
E35818

<<76.47.06>><<501-12>><<page 2>> Remove the center wood veneer around the center vents (E35818) to provide access for removal of the passenger side airbag. Use a thin plastic knife and gently pry away the wood veneer from its four holding tabs (E35819). This will also enable access to the center floor console top mounting bolts for later removal of the console.

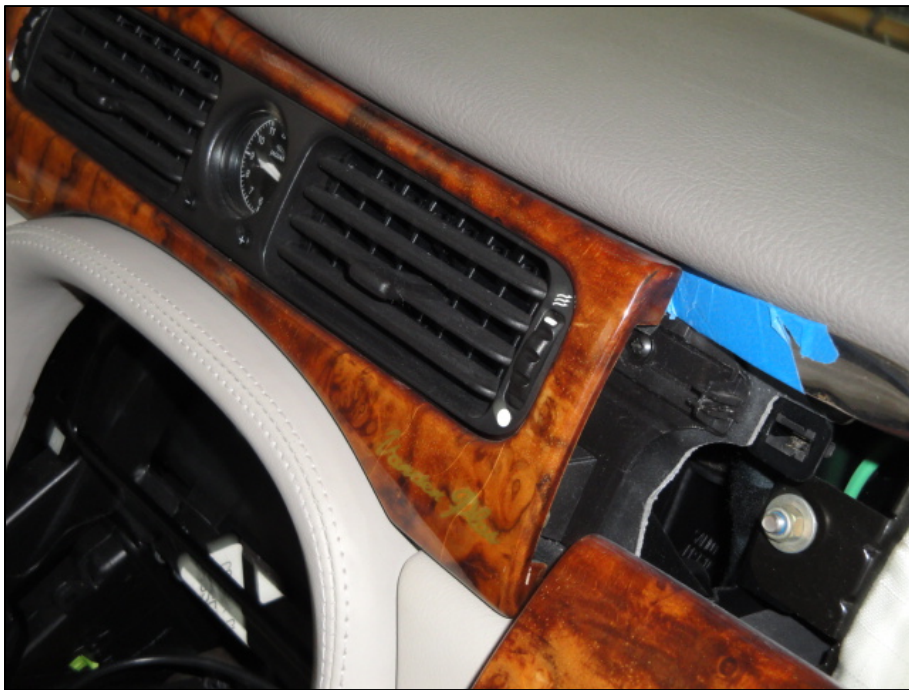
Remove the center wood veneer around the center vents with a plastic tool.

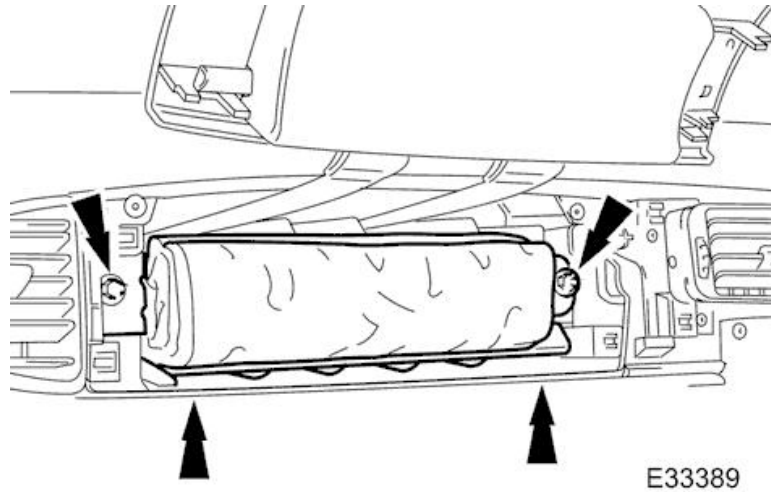
Remove four nuts (10 mm socket) that hold the air bag in place. Two of the nuts are mounted underneath fastened vertically and two are in the front (E33389).

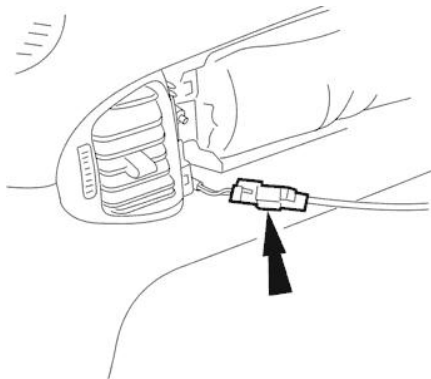
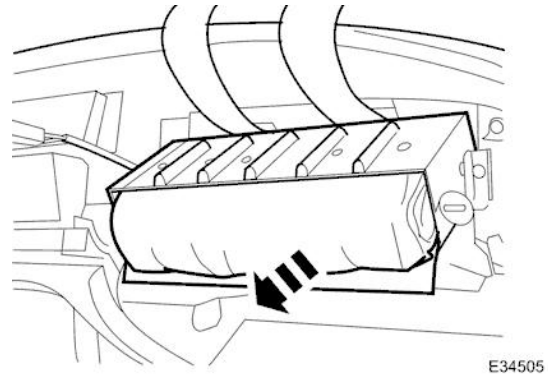
Partially withdraw the airbag and unhook its electrical connector (E35813). Remove the air bag assembly from the car (E34505).

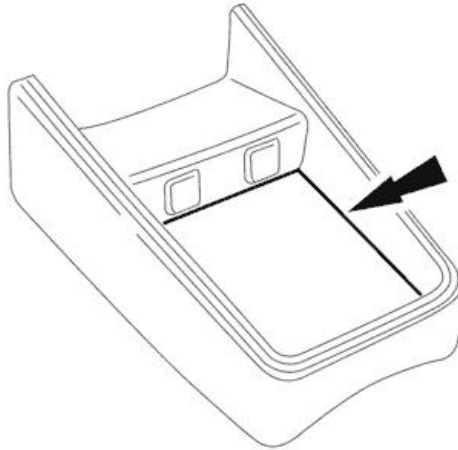
E36362

<<76.25.05>> Remove the center console rear extension that is located behind the front seats. To do this, gently use a thin plastic knife and pry up the veneer wood (E36362). Do this by prying up the wood from the rear and once the wood is dislodged, pull it rearwards, sliding it from under the seat heater switches.

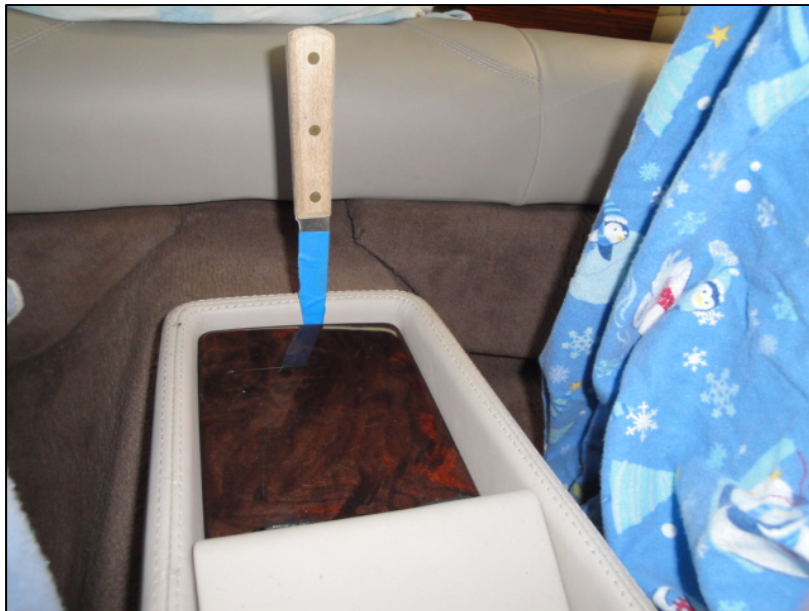
Detaching the wooden console rear extension with a knife wrapped in tape.

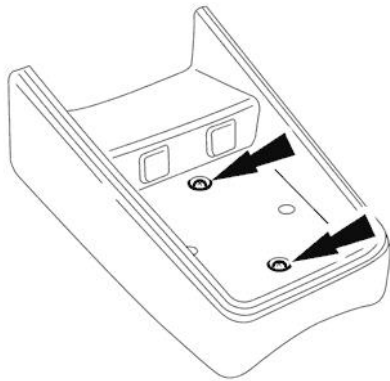
E36363

Next, remove the two Phillips head sheet metal hold down screws (E36363). Finally, remove the Phillips head screw holding in the heater switches (E36364). Unhook the heater switches.

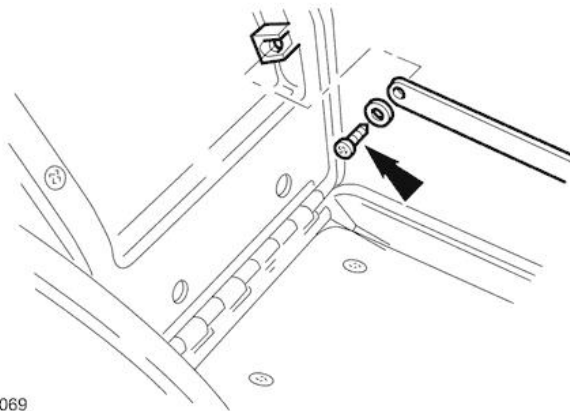
E36069

<<76.25.18>> Remove the floor storage box (glove box in center) console. Do not remove the glove box lid stay (E36069) since there is no need to do this.

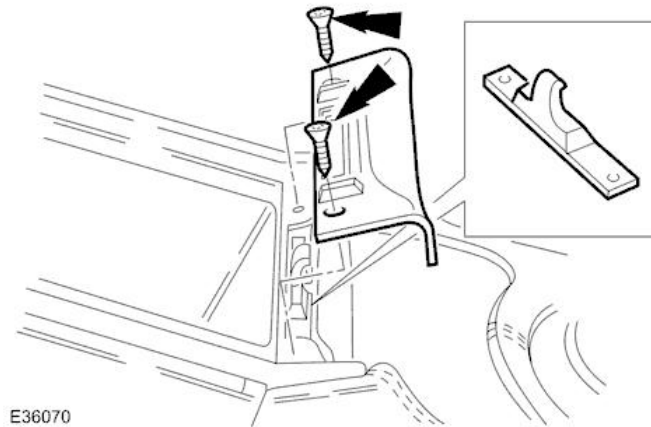
Remove the two Phillips head screws from the front latch and remove the latch (E36070).

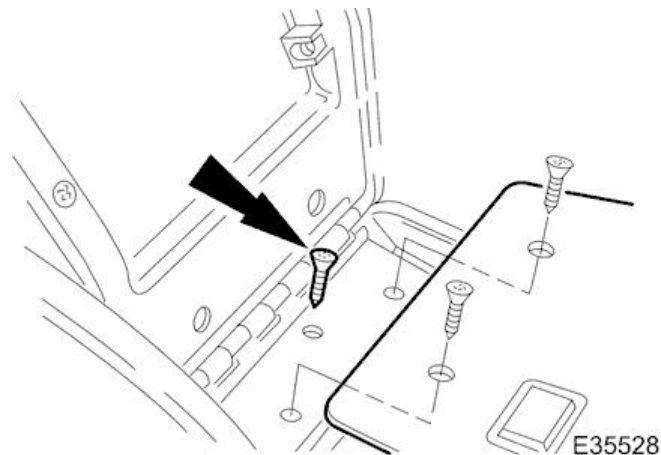
Remove the rear Phillips head securing screws at near the hinge and the third remaining hinge screw (E35528).

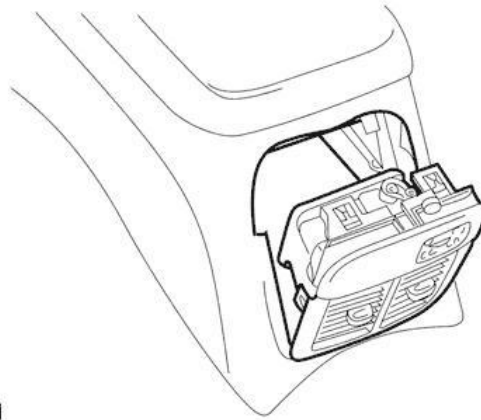
E36211

<<76.25.01>> Using a thin plastic lever or knife, carefully release the rear air distribution panel tabs (tang) at the very top and two other tabs at the sides (near the bottom) (E36211). This will at first seem difficult, but it will eventually pop out. Unhook the cigarette lighter and lamp plugs.

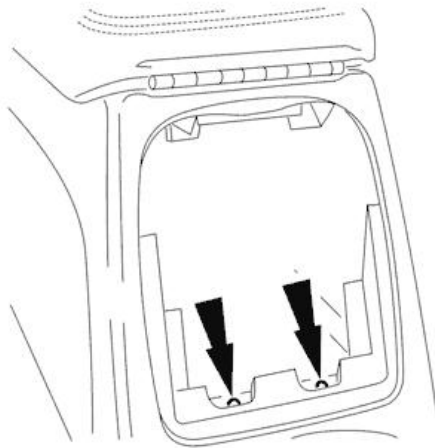
E36216

<<76.25.01>> Remove the two rear console Phillips head mounting screws (E36216).

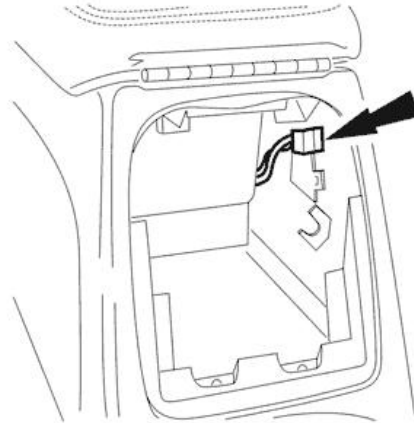
E36212

Disconnect the electrical connector (white plug) to the driver's cigarette lighter and ash tray illumination lamp (E36212). This connector is at the rear of the center console.

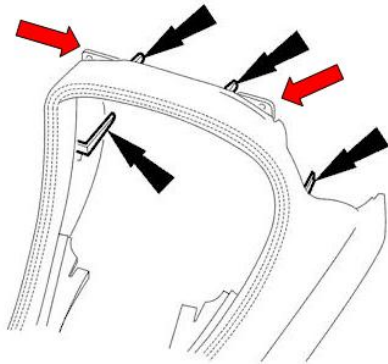
<<76.25.01>> <<501-12>><<page 3>> Remove the two center console Torx mounting bolts (T-30) at the top of console. **NOTE:** Figure E35490 of the JTIS is incorrect in that it shows removal of the wrong mounting bolts. Do not remove those bolts depicted in illustration E35490 at this time. The correct mounting bolts for the console cannot be seen in this illustration (E35490). Remove the center console mounting bolts at the topmost left and right tabs of the console. The correct tabs are visible in diagram E36217 (red arrows). These tabs can also be seen in diagram E35819 (red arrows). Remove the two Torx (T-30) bolts at the red arrows at this time.

Remove the center console from the car. Make note of the alignment tabs and their entry positions during reassembly. The tabs can be seen at the black arrows in the above diagram (E36217).

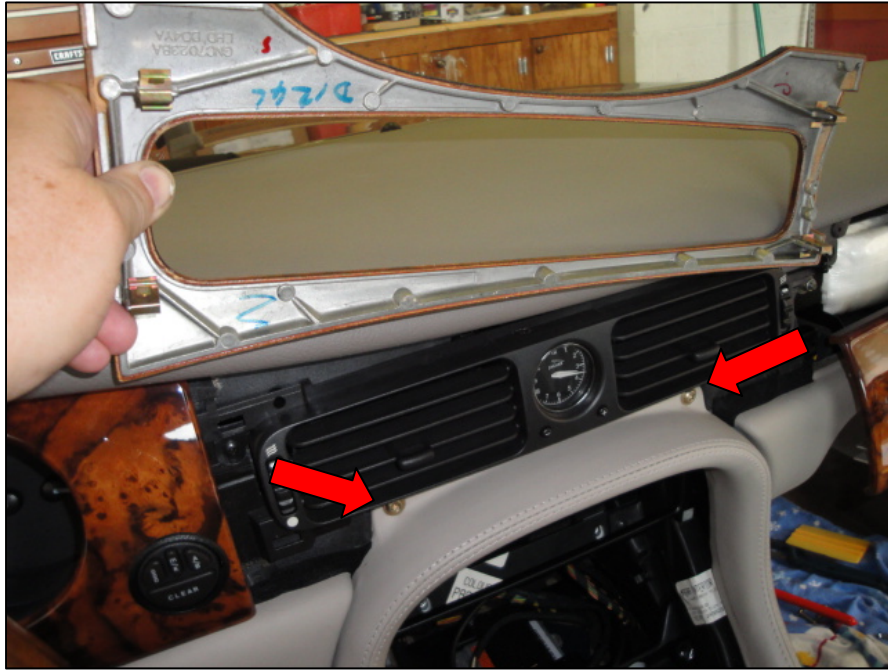
Actual location of the top mounting bolts for the center console

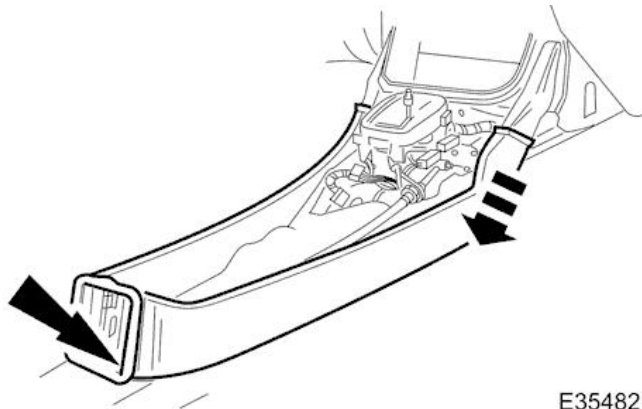
<<76.46.01>><<page 2>> Remove the center floor console air ducts, there is one Phillips head screw holding the plastic assembly in place at the rear (E35482).

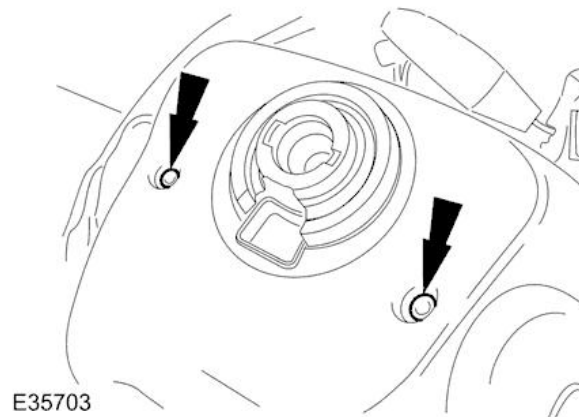
<<76.73.39>> Remove the driver air bag that's located in the steering wheel by loosening two Torx screws (T-30) from behind the steering wheel. The steering wheel must be turned to enable access to each screw one at a time from the top, 12 o'clock position from the rear (E35703). Note: The diagrams and procedures in the JTIS for removal of the air bag are unclear.

Note: The above diagram shows the location of the air bag retaining screws from the rear of the steering wheel, without the steering column and upper and lower steering column cowls in place.

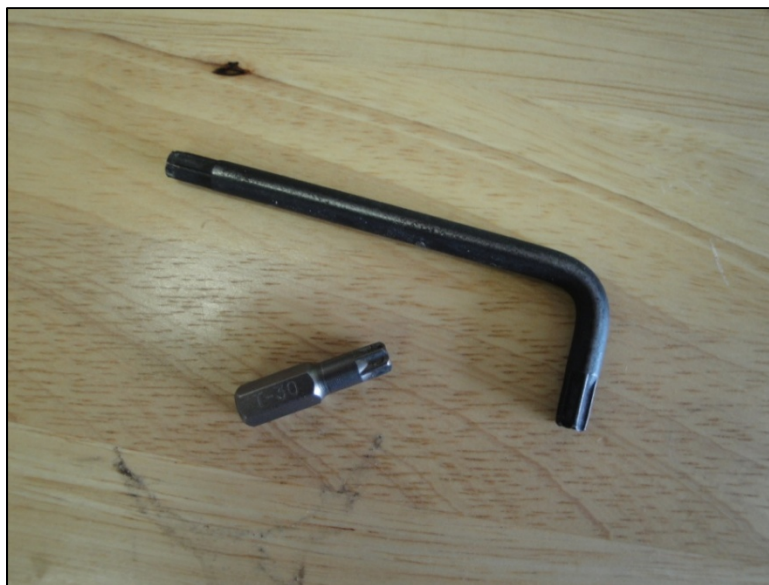
Use the short end of a Torx wrench (T-30) to loosen the screws and a Torx driver bit after the screws are loosened to assist in removal.

Use a Torx (T-30) wrench and driver bit to remove the driver's air bag.

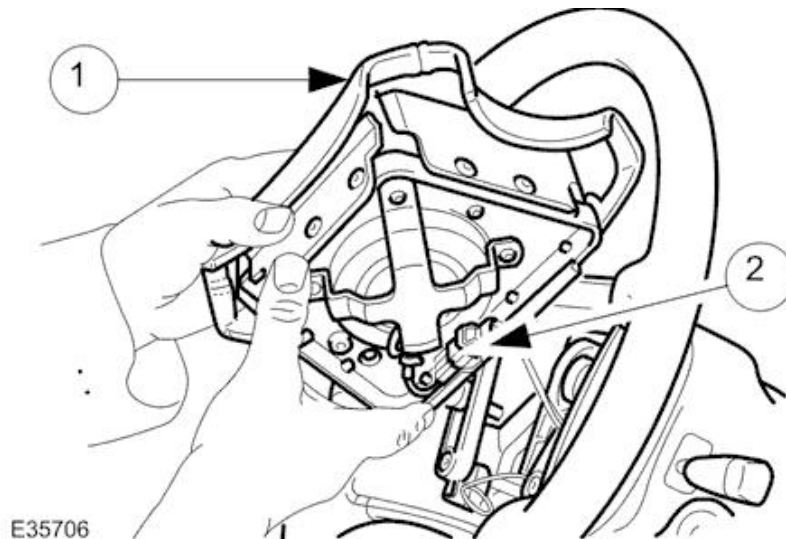
Unhook the air bag electrical plug (E35706) and remove the air bag from the steering wheel.

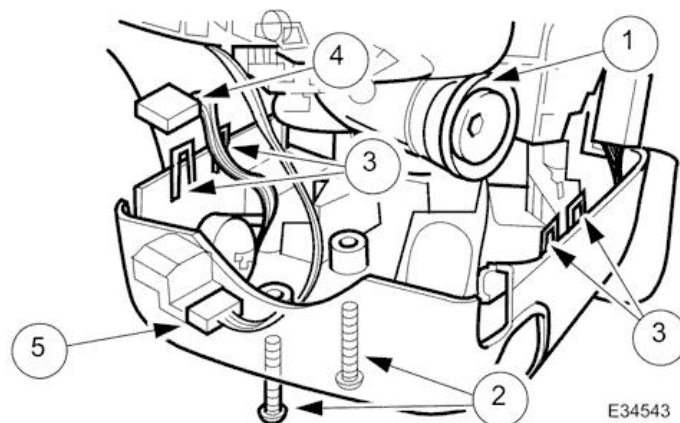
<<76.46.03>> Remove the lower steering column cowl by removing two Phillips head bolts from underneath (E34543).

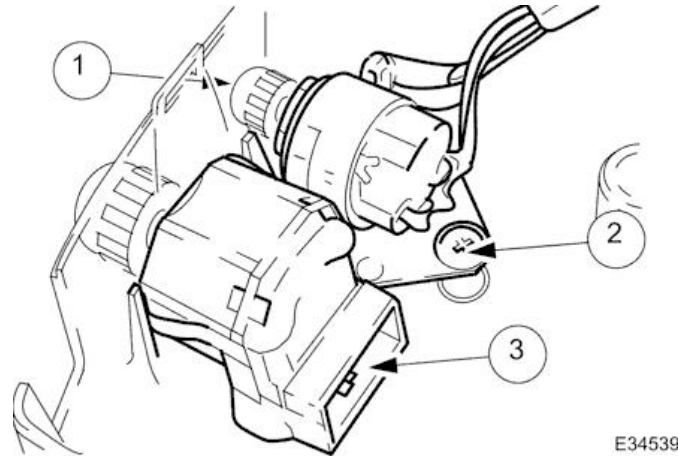
There are four tabs, two on each side, holding the bottom cowl to the top cowl. Gently dislodge these tabs from the top cowl to separate the two halves. The instrument panel dimmer switch and steering column position adjustment switch will come out with the

lower cowl (E34539). Remove the Phillips head screw holding the dimmer switch to the cowl and disconnect its electrical plug to the steering adjustment switch after un-securing its tabs and pushing it through the cowl.

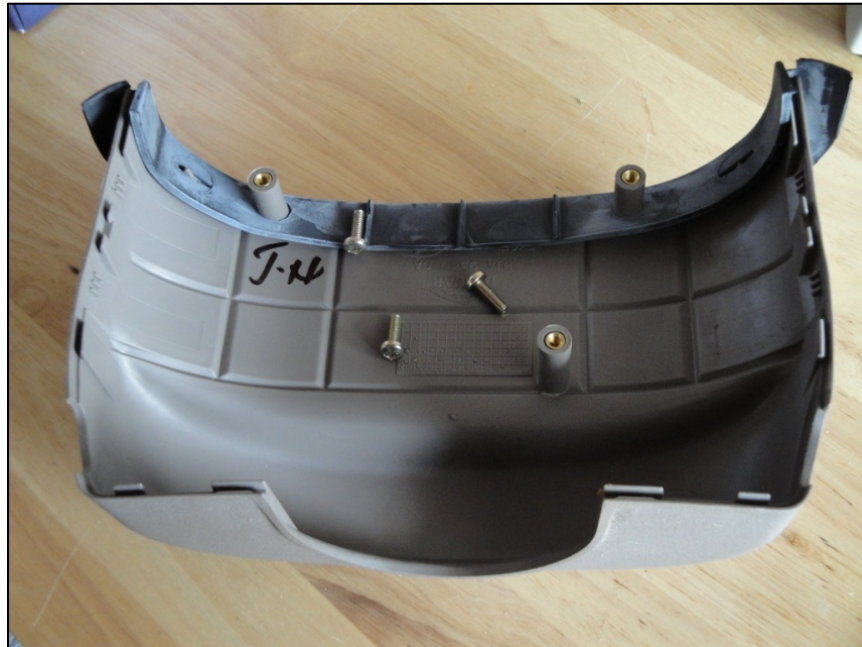
<<76.46.02>> Remove the upper steering column cowl by removing three Phillips head bolts from underneath at the bottom where the lower cowl had been. After the three bolts are removed, just lift it off of the top of the steering column. Note: the JTIS procedure does not mention these three bolts nor is there a diagram of the mounting bolts and upper shroud.

The underside of the upper steering cowl, showing its three mounting bolts

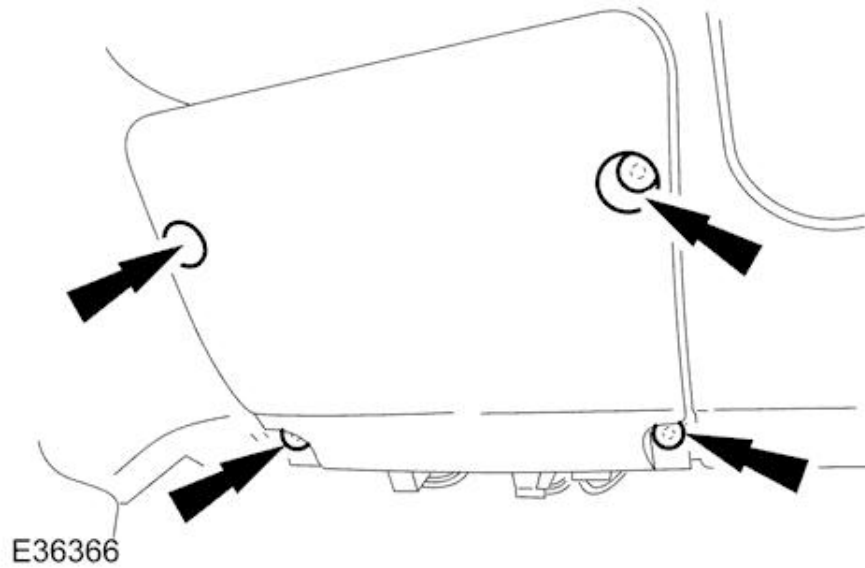
<<76.46.11>> Remove the driver side under scuttle by removing four Phillips head screws (E36366).

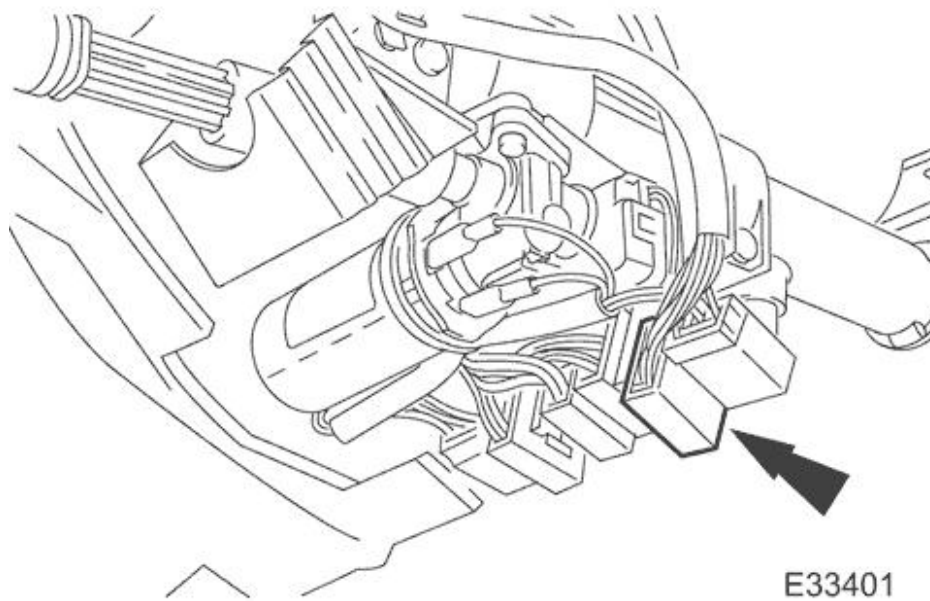
<<86.65.42>> Remove the wiper/washer switch electrical plug (white). The plug must first be released from its mounting bracket in order to disconnect it (E33401).

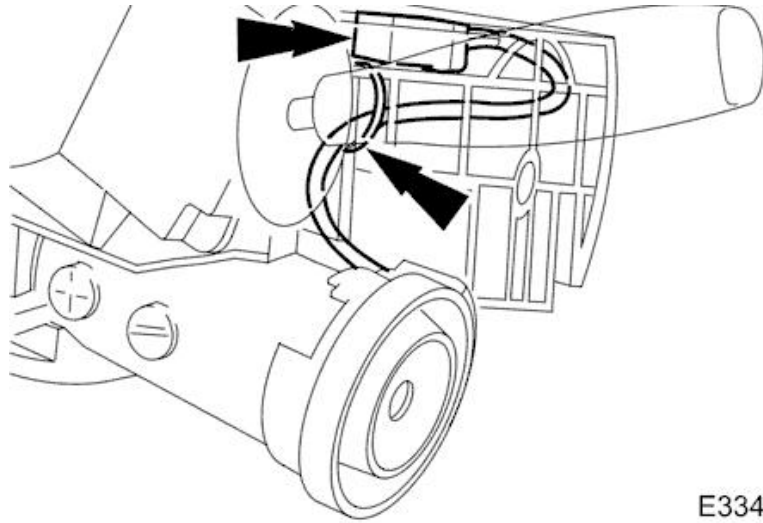
E33403

Cut the tie straps from the key tumbler plug and wiper/washer plug (E33403).

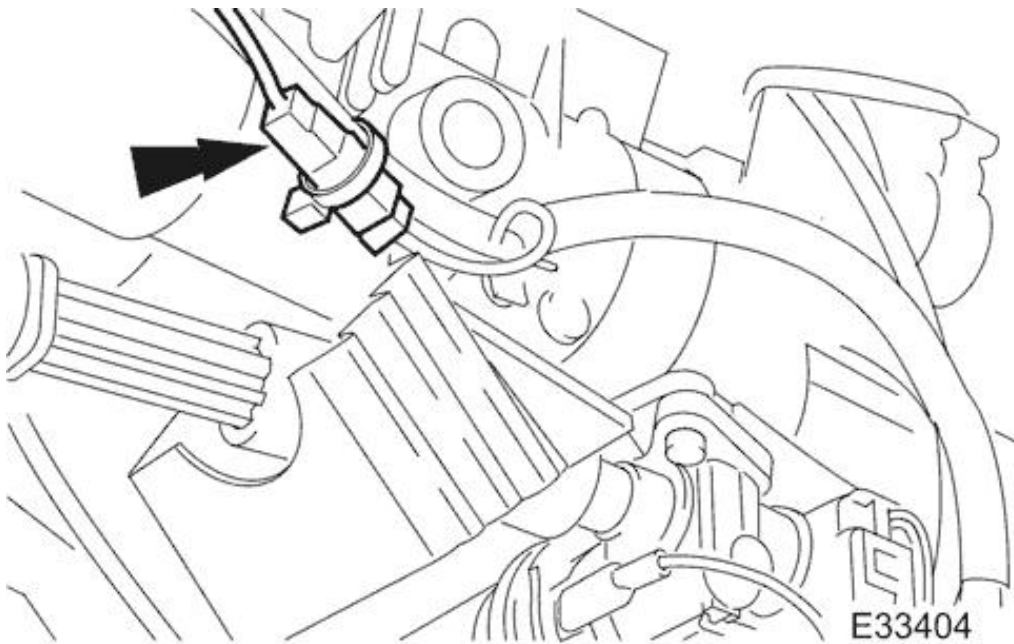
E33404

Disconnect the small blue electrical plug to the key tumbler (E33404).

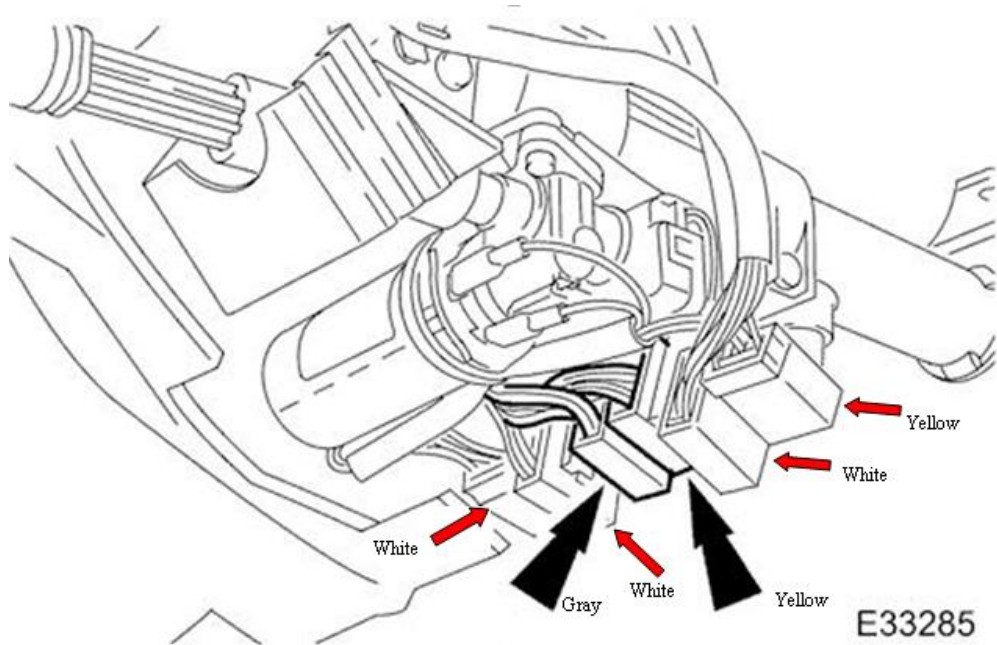
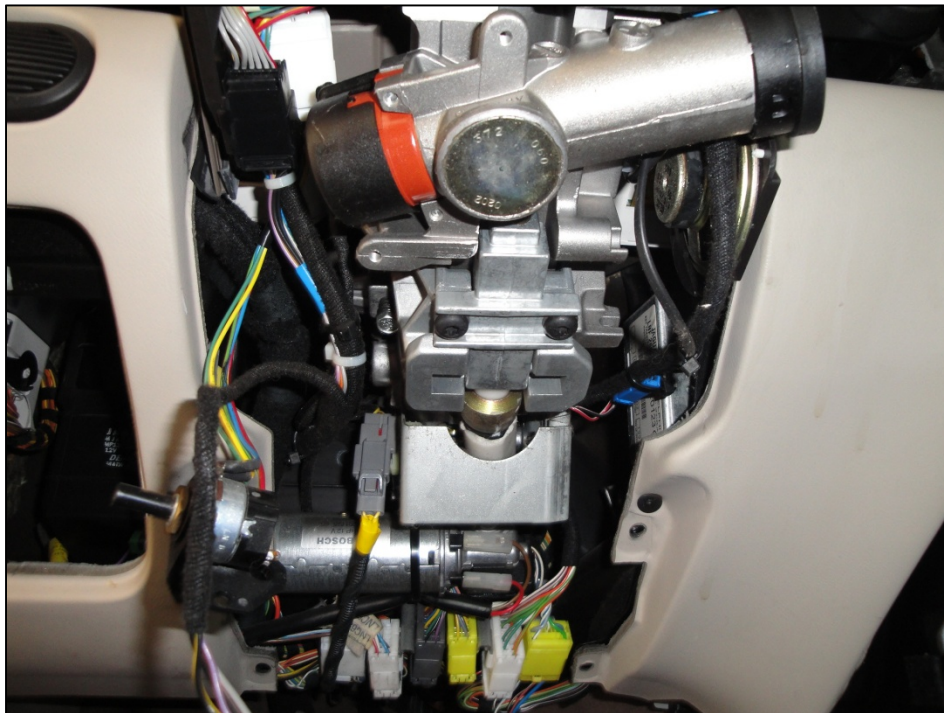
Remove the flasher/lamp/trip meter electrical plugs (black arrows in the diagram below) from their retaining brackets (gray and yellow) and disconnect the plugs (E33285).

Electrical plug colors and locations under steering column.
