AAV rebuild procedure:

This is how I do the rebuild of these units. If that fails I remove them totally, and that is a separate write up, so as to NOT confuse some people, mainly ME.

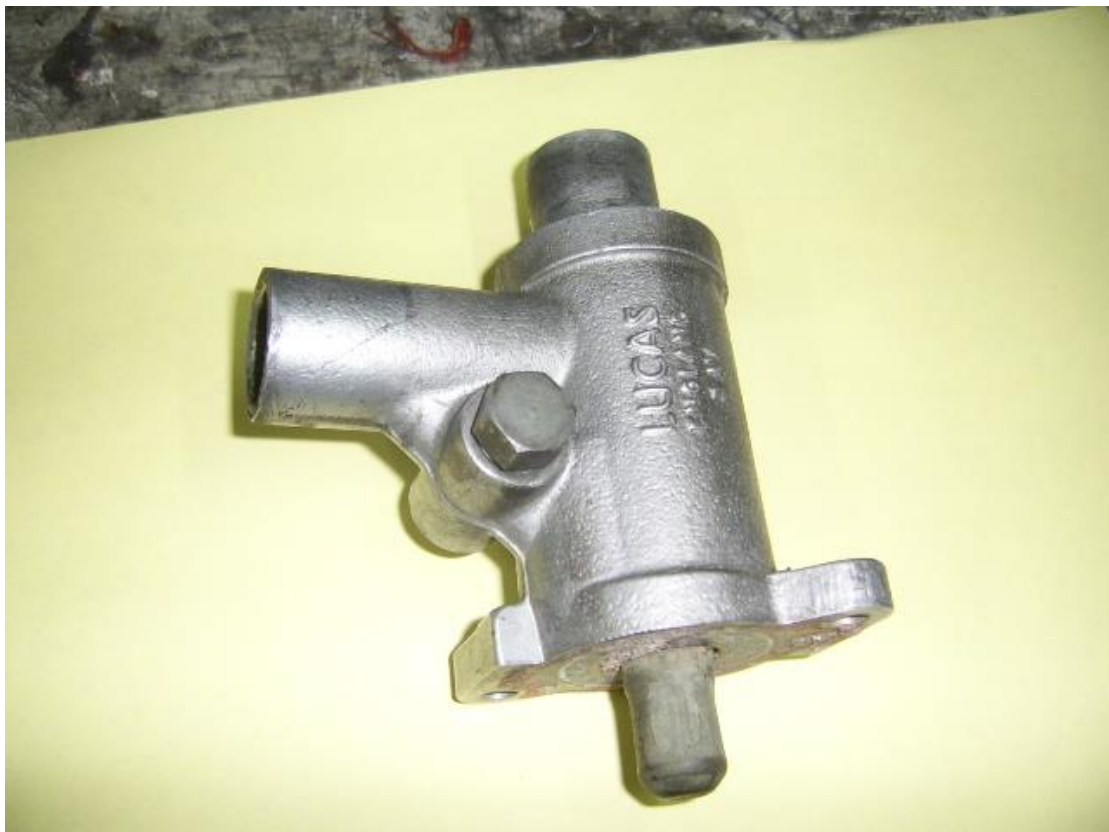
AAV as removed from the engine

Remove the 2 “torx” screws from the mounting face, and wiggle the AAV out of the cylinder head, and the hose that goes to the place you put your thumb. Be careful with that “inlet” hose, as it has a plastic elbow in its length to attach the vent hose from the distributor cap.

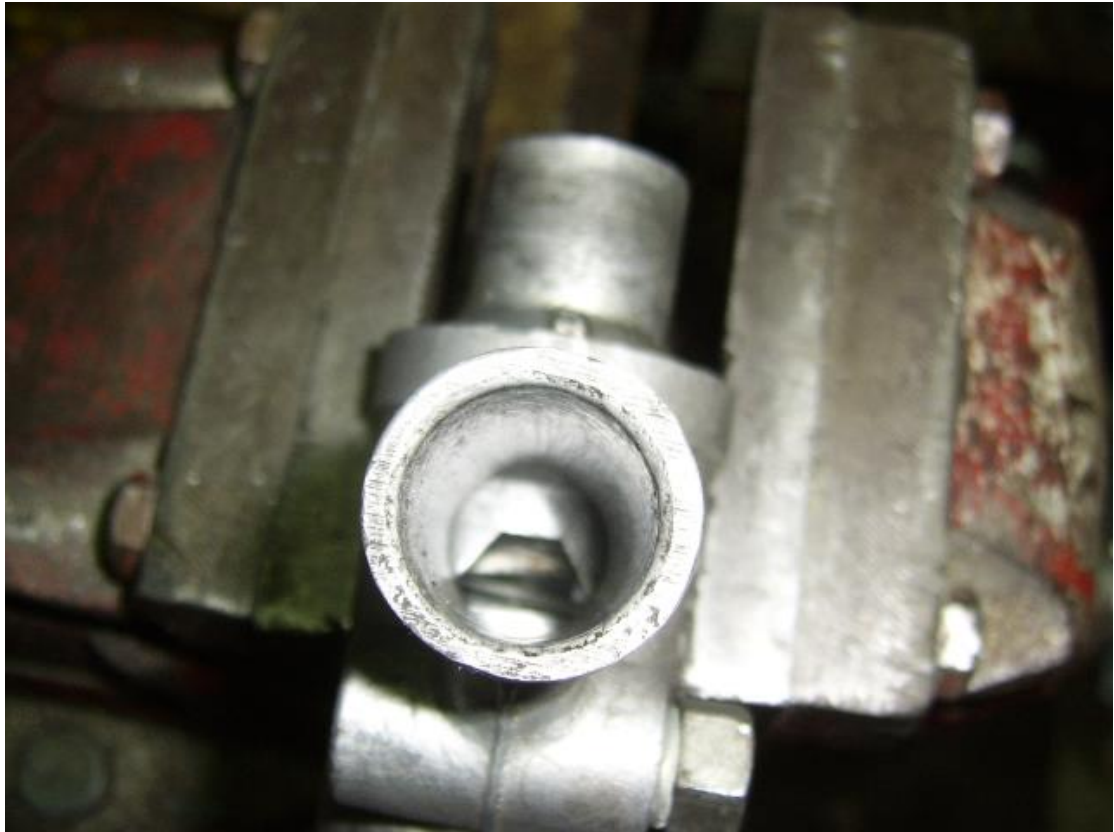
AAV as it is when cold or jammed

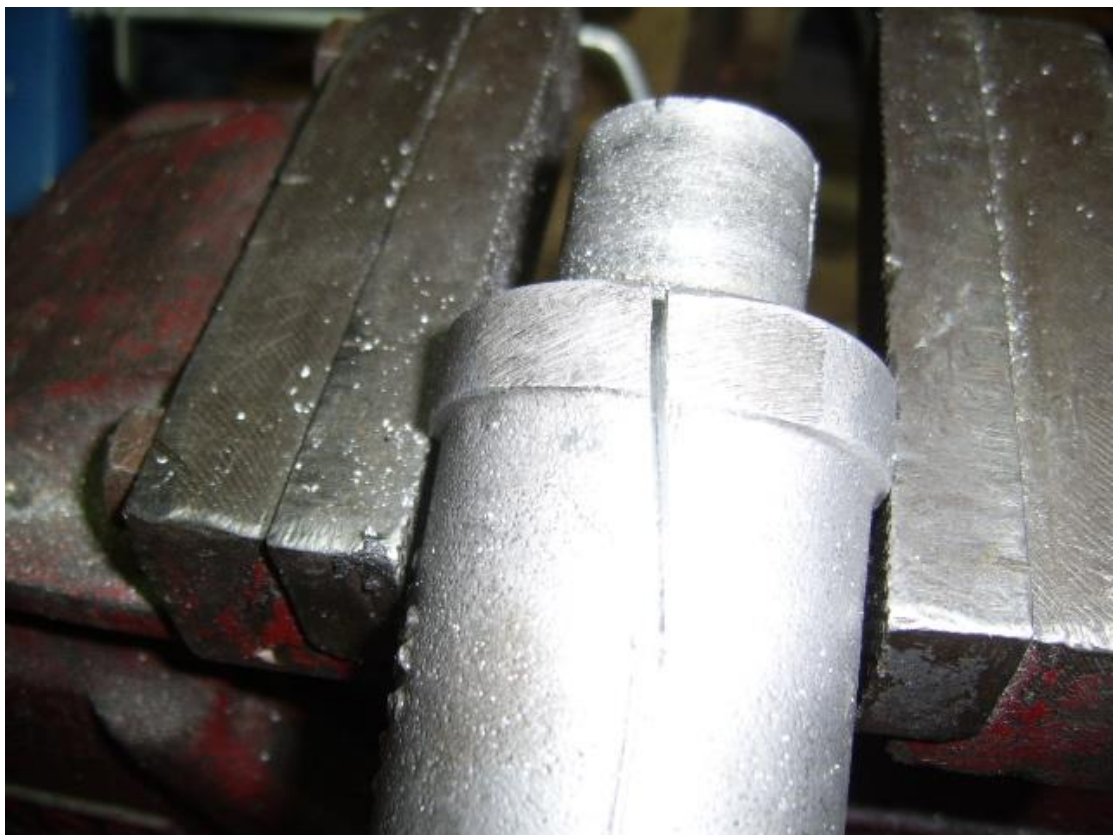
The CUT to release the grip

- 2) Grip the unit in a vice with the inlet spout facing down, and using a hacksaw, or dremel, or similar cutting device, cut a slot in the outer casing length ways, to slice through to upper rim section and a small section of the rest of the body. This slot will be about 1” long THAT IS ALL, TAKE YOUR TIME, until you see the inner portion in the slot. It does NOT take much, and what it does is release the GRIP the outer casing has on the inner section. Now grip that “top hat” section in the vice, and drive the outer casing off the centre section, BE CAREFUL, there is a spring and piston in there, it will NOT spring out, but if you RIP it apart they will fall in the cracks in the floor, and then you are bugged.

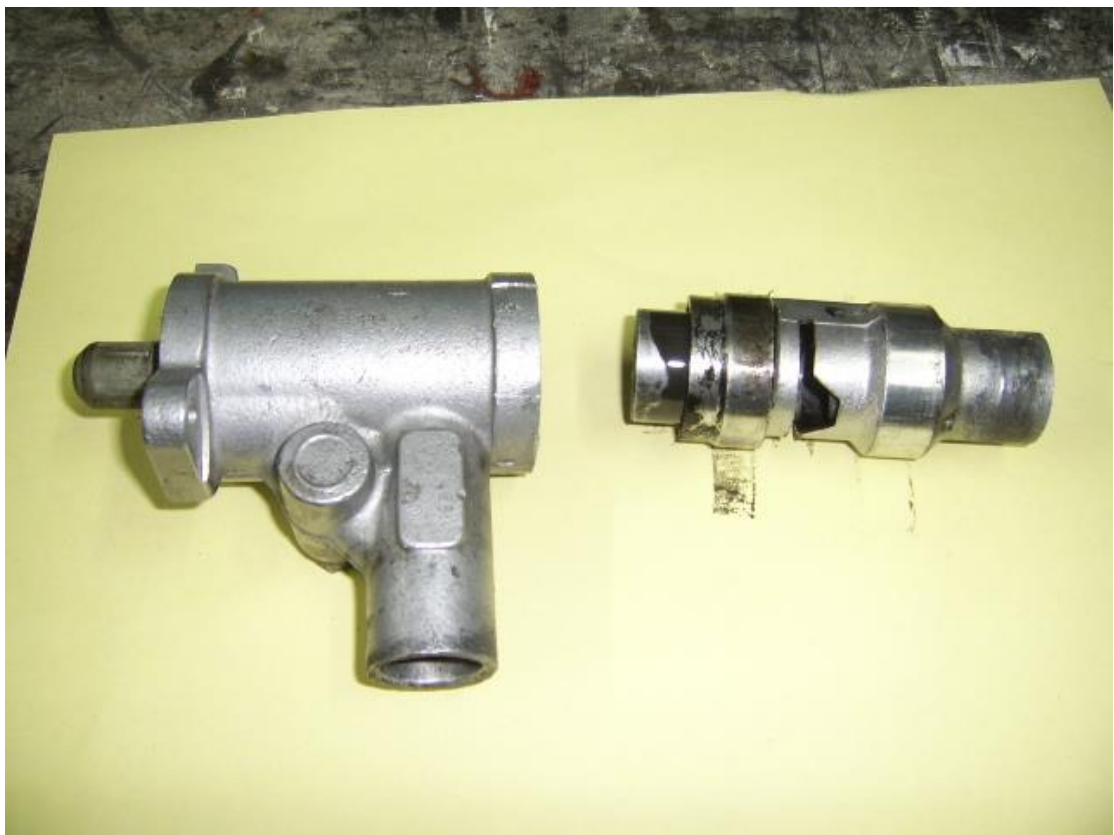
Body on the left and Tophat assembly on the right

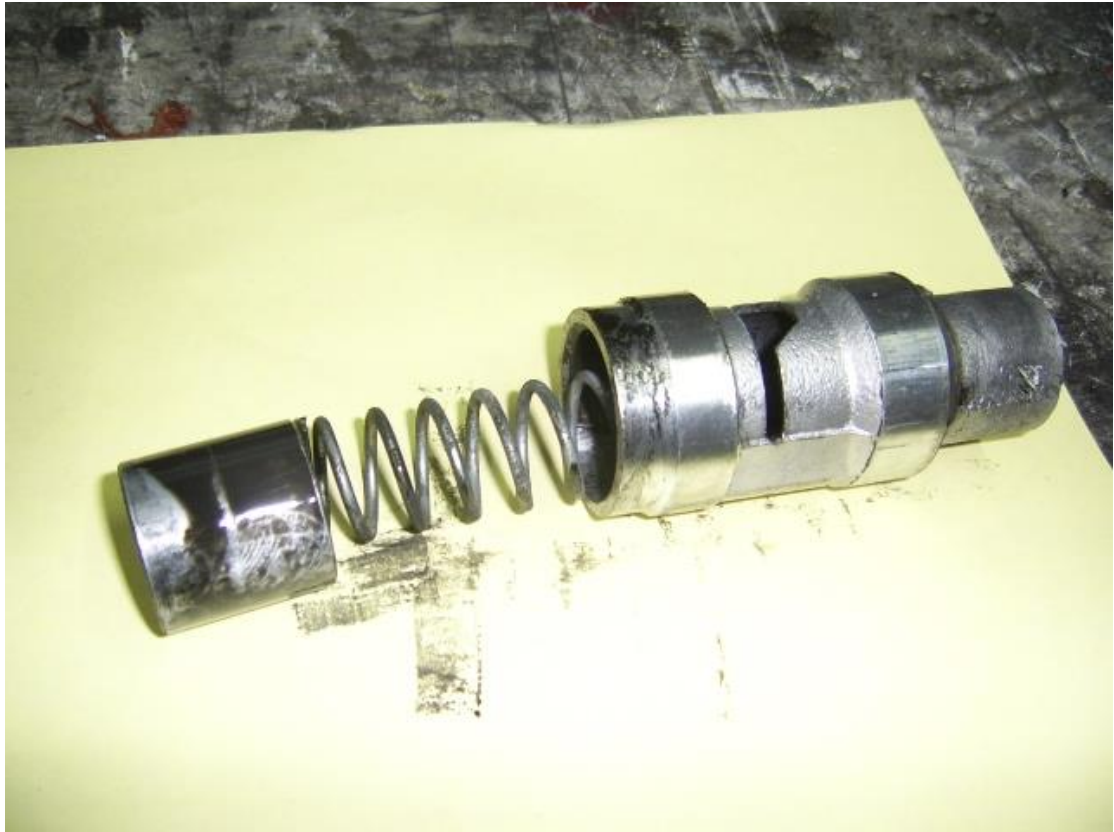
The 3 components of the Tophat

Once you have the desired piston/body slide fit, you are nearly done. Wash all the bits again, and reassemble the 2 main items. I usually place the spring inside the “top hat”, and then the piston (which sits neatly over the spring), and then slide the outer casing over that unit. That way the piston stays in place. Open the vice jaws enough to allow the bulb to sit through the opening and the gasket face to sit flat on the top of the jaw face. Take a rubber mallet, and carefully **TAP** the “top hat” into the outer casing lining up the slot you cut prior to dismantling the unit. I usually drive it down until the “top hat” is below the rim by about 2mm. Look inside the inlet spout, and observe the cut outs, and then heat it up, hot air gun, boiling water, whatever, and observe the 100% closing of those cut outs. If it closes, **DRINK BEER**, you are good at what you do. If it does not close, but is very near, tap that “top hat” a bit further inside the housing, and try again. Now, bear in mind, that the further inside the casing the “top hat” sits the slower the cold idle will be, **NOT** by much, but a tad slower when cold may be a good thing in my opinion, as some engines are at 1500rpm, and I don’t like that.

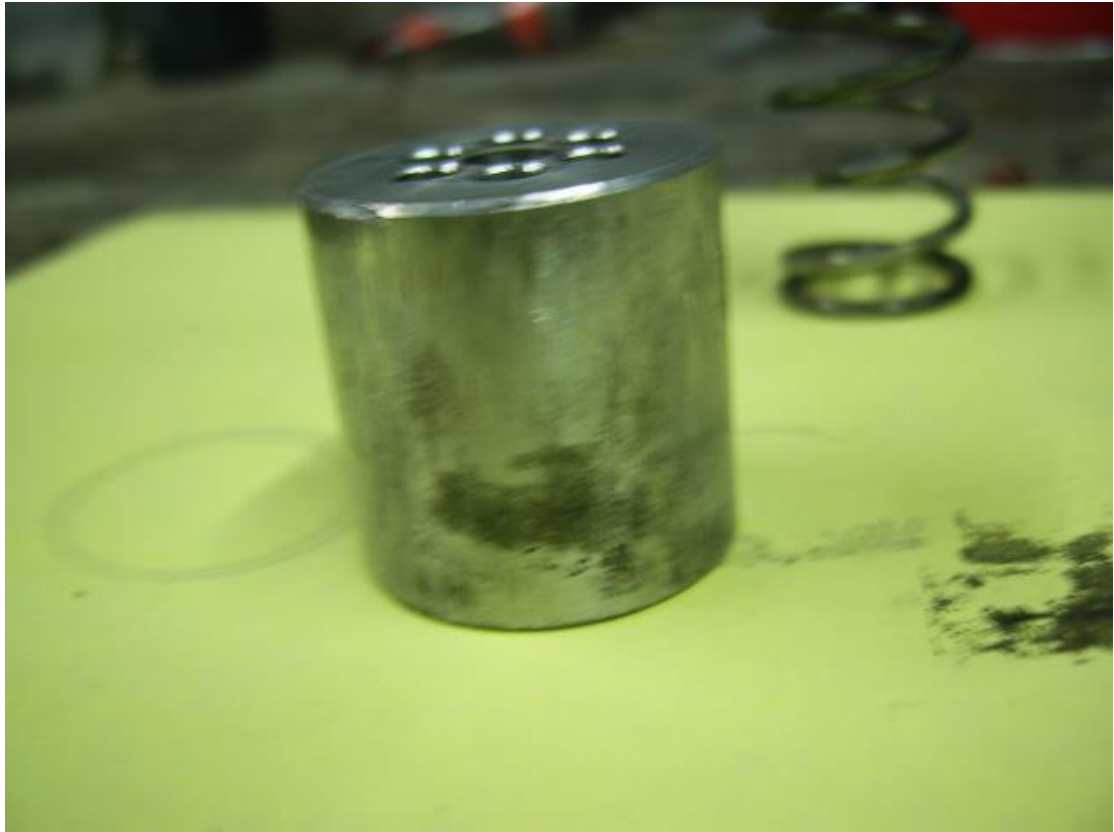
Alloy piston showing scores and carbon build up

If you have an aluminium piston, carefully inspect the outer face for scoring, and clean up as required, either with a fine file and wet and dry

paper. You are looking for a smooth slide in the housing, and this is time consuming, but essential.

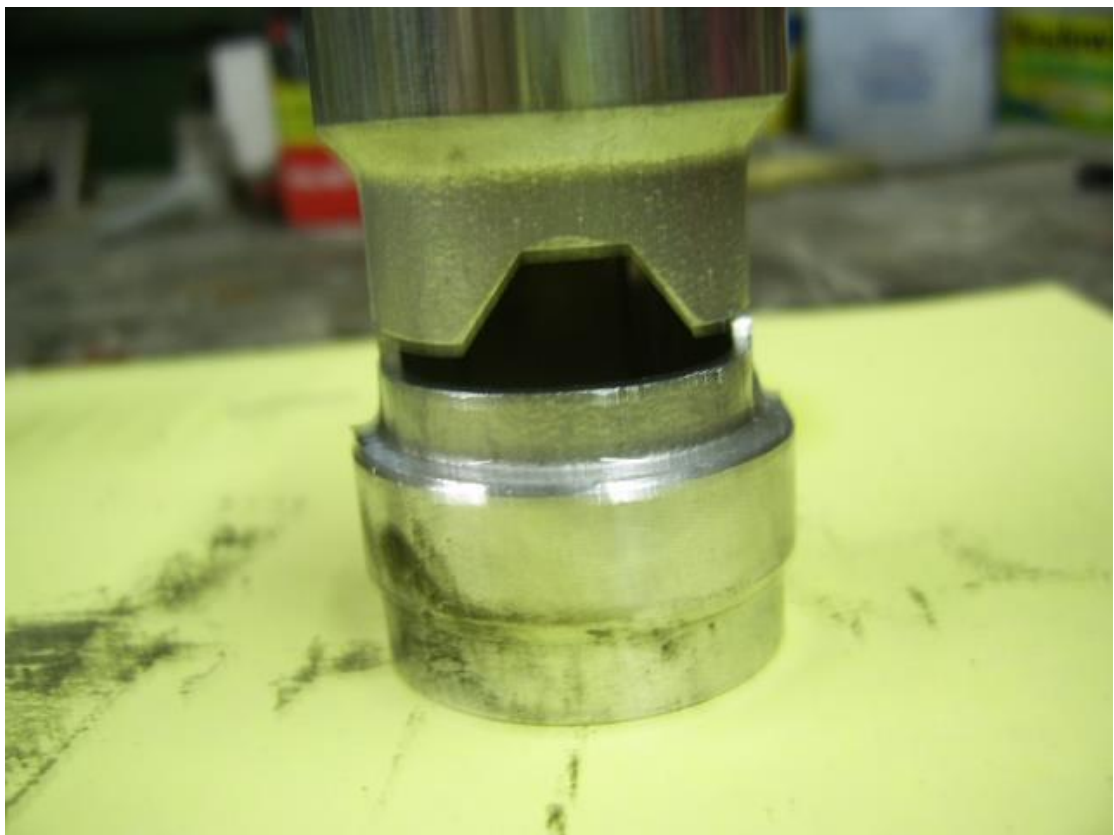
Tophat showing the cut outs that control cold idle.

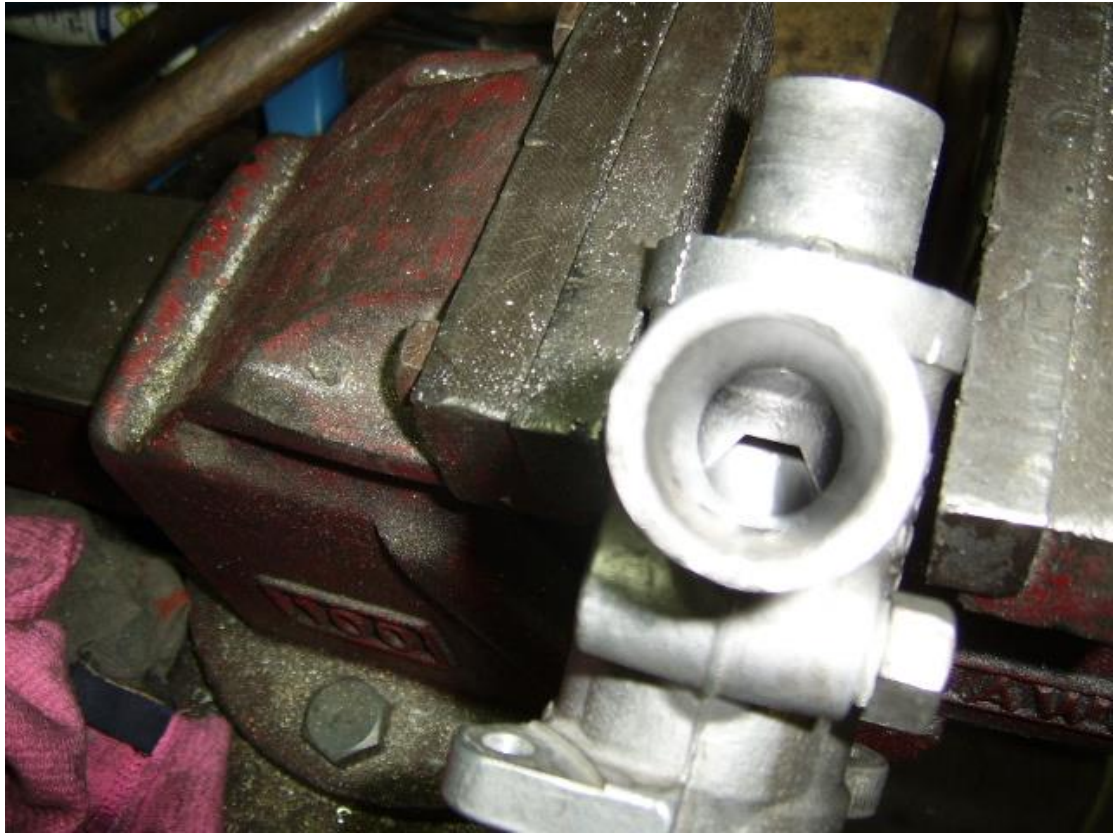
First test after rebuild,
FAIL.

TAKE YOUR TIME HERE, you want a free sliding piston, **NOT** sloppy, as that will give a vac leak, and you need another one of those, **NOT**.

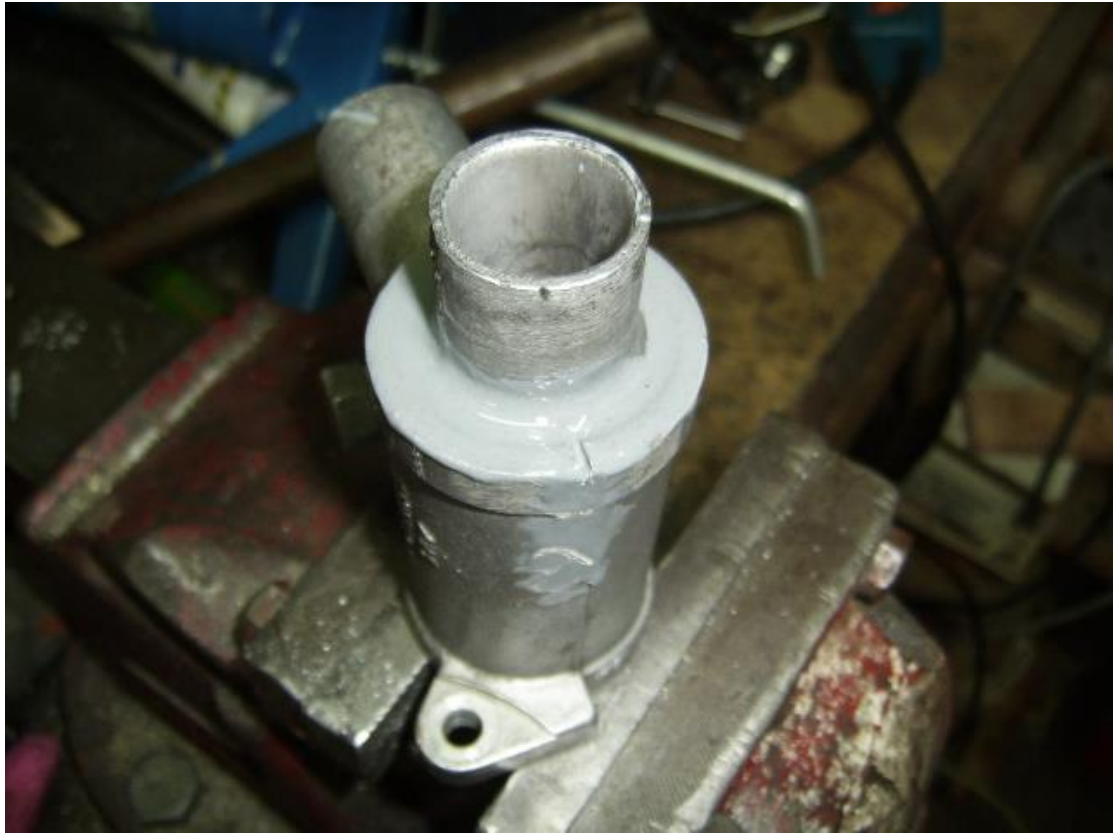
Completed unit with JB weld in place.

Once you are satisfied with your rebuild, take some epoxy filler (I use JB Weld) and fill the slot you cut, and pour some around the top of the rim of the outer casing taking up the 2mm gap somewhat. This stuff takes 24 hours to dry, bad luck, the fast dry stuff will **NOT** work, as it melts at about 100c, remember, haha.
