XJS (1993 Model Year) SECURITY SYSTEM

ADDENDUM to Fitting Instructions

LED and Valet Switch Installation

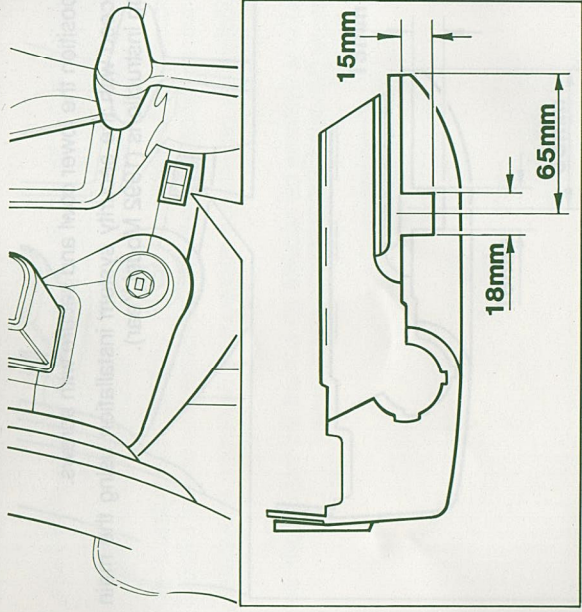
Fig. 1

With the introduction of the driver's airbag module at 1993 MY, the locations of the LED warning light and valet switch have changed.

Mark the position for the valet switch as detailed in Fig 1.

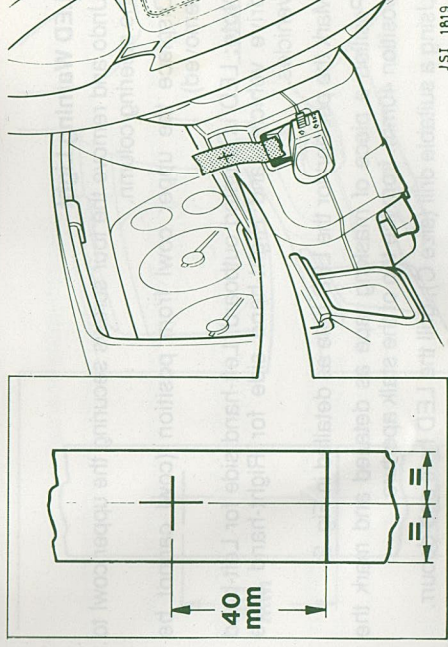
Fig. 2

Valet Switch

Undo and remove the three screws securing the steering column lower cowl.

Remove the cowl.

Cut out the aperture for the switch and deburr.

Note: Switch situated adjacent to ignition lock, inboard.
