Replacing the Auxiliary Air Valve (AAV)

An electrically operated cold start device for the Jaguar V12

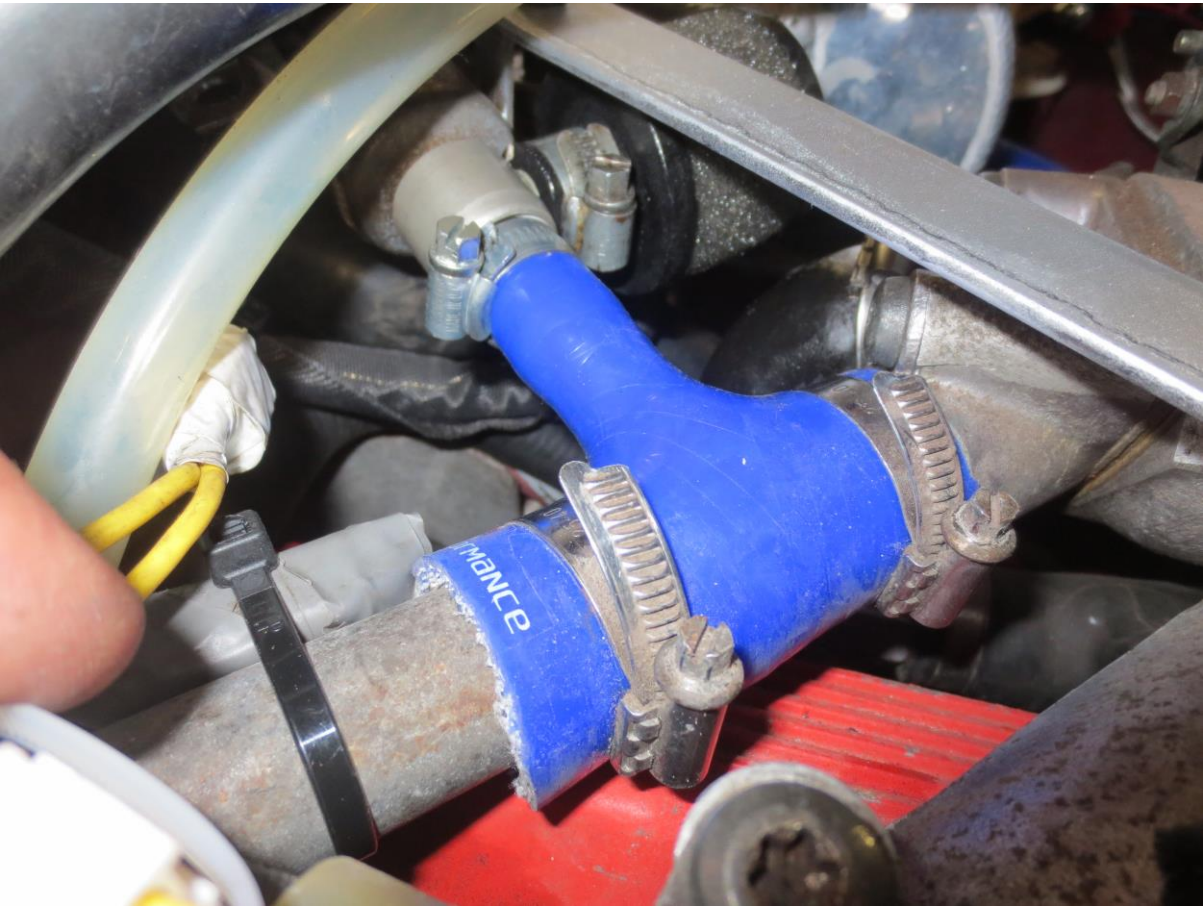
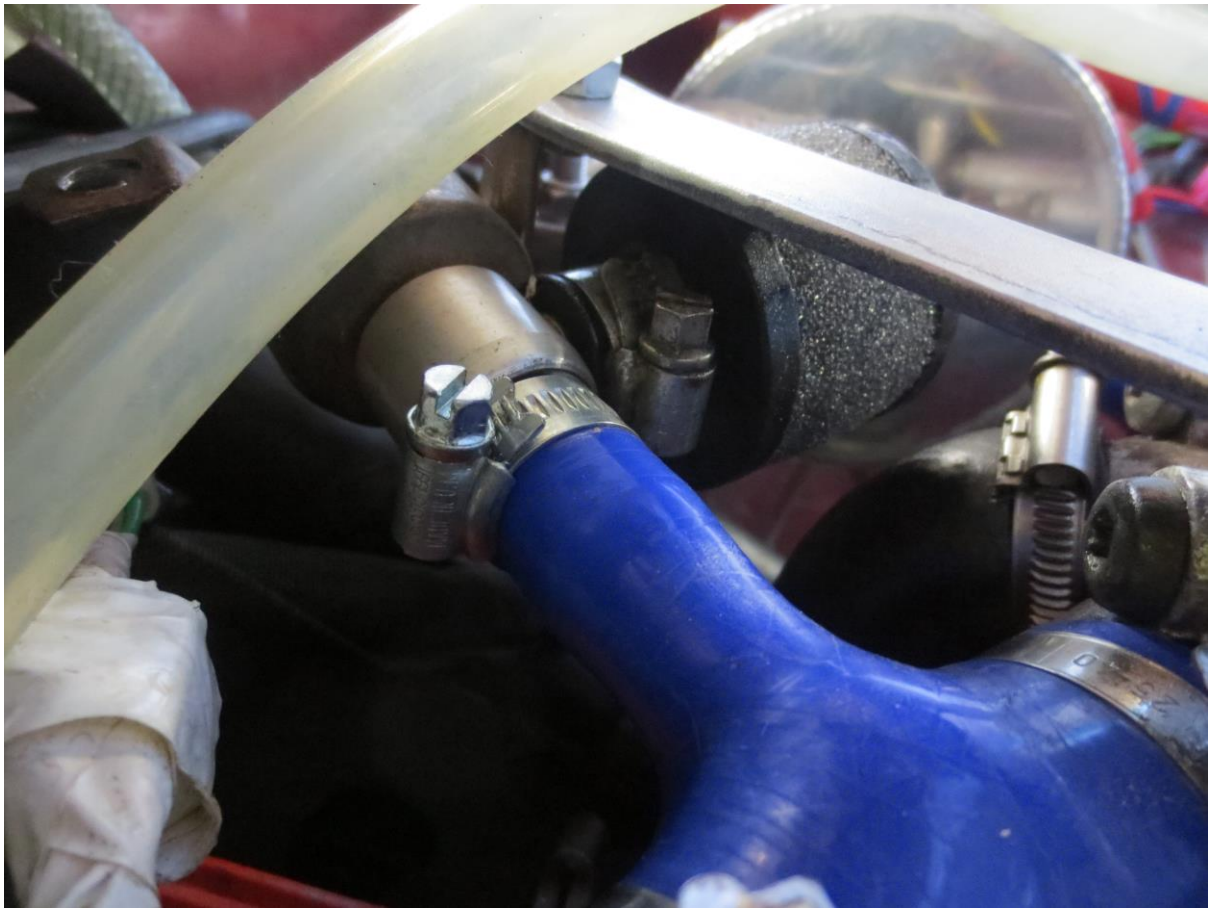
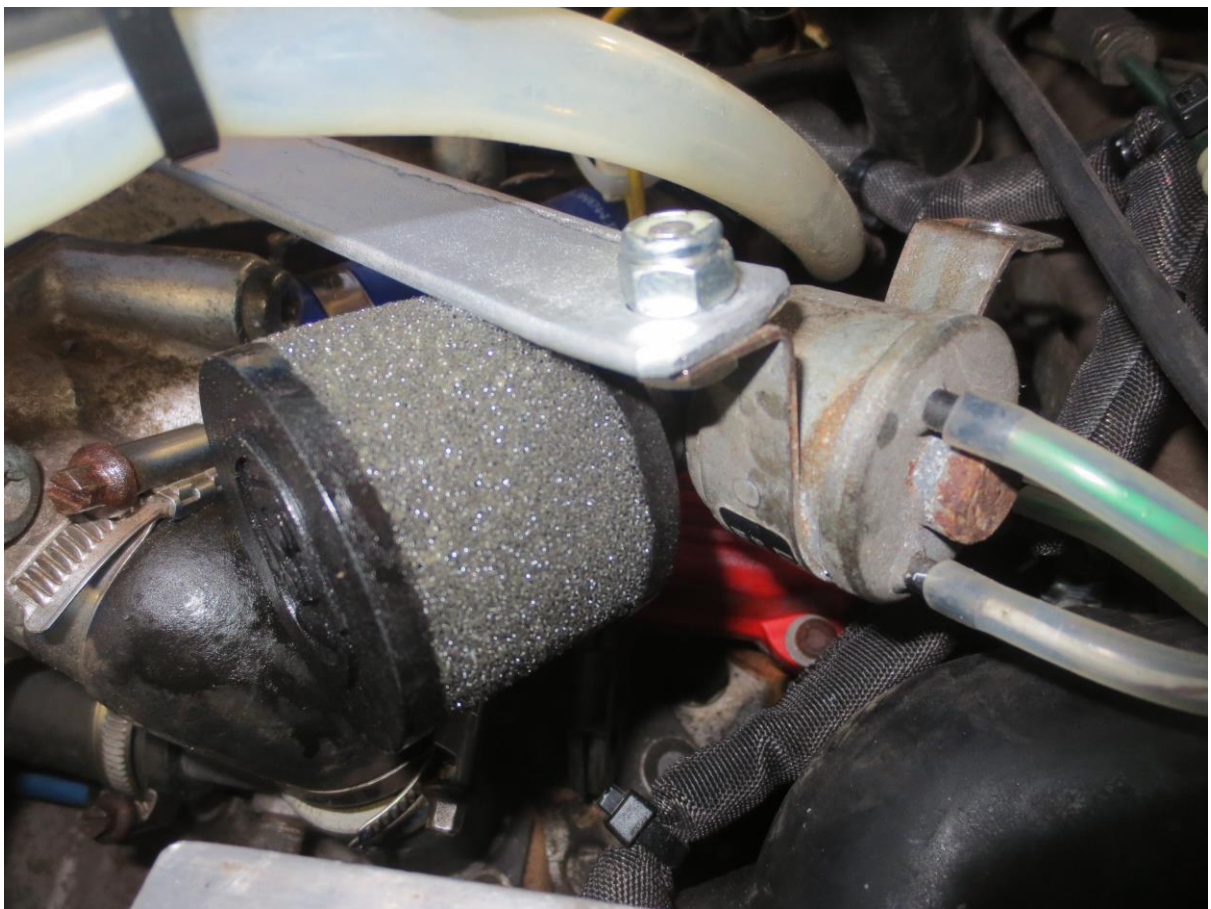
The following photo show how it was installed into the LHS end of the balance pipe, using a Viper Performance unequal T hose with 1 inch across the T and a 13mm diameter leg for the solenoid:

The second possibility would be to connect the solenoid to the large balance pipe that runs across the rear of the engine to balance the manifold pressures. This would also be a viable option, and providing the cross pipe was demounted so a suitable sized spigot could be welded into it, would be a good solution. Or, as in my case, an unequal T hose was found to install in place of one of the 1 inch diameter hose joiners that connect the balance pipe to the manifolds.

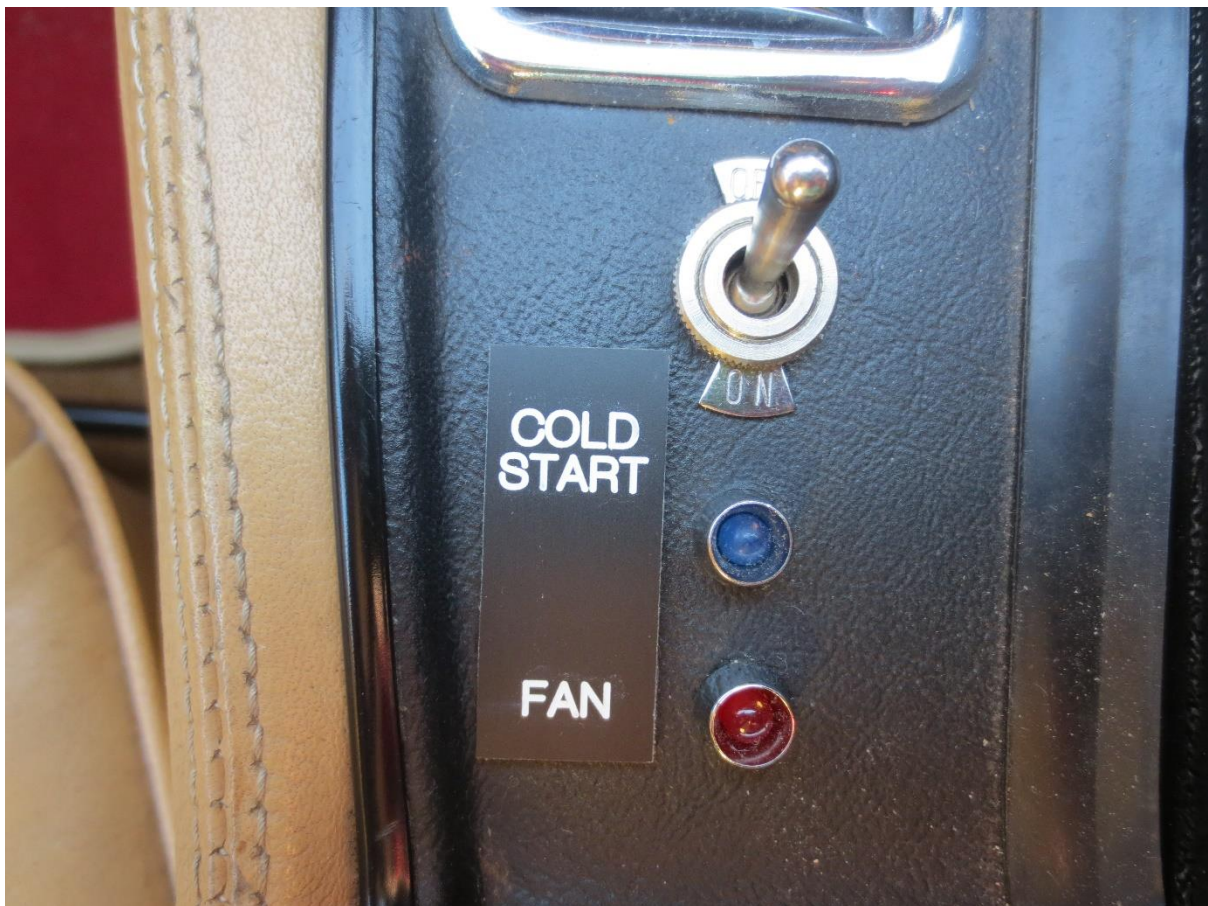
The solenoid is powered by a feed taken from the coil positive terminal, it draws less than an amp and that only when activated, so should not overload the circuit. It has a dedicated inline fuse between the coil terminal and the solenoid. The switching is done to earth from a wire that runs into the cabin through the same routing that the heater unit vacuum tube takes. The cabin switch is installed in the console top just behind the ashtray, together with a dedicated warning light, as shown in the following two photos.

Note that on my car, as the cruise control is removed and I have an electric main fan installed, the cruise control master switch has been repurposed as a switch for the main radiator fan in the event of the thermostatically operated system failing. My car has a "fan running" warning light installed in addition to the cold start warning light and switch.
