## Replacing the Auxiliary Air Valve (AAV)

## An electrically operated cold start device for the Jaguar V12

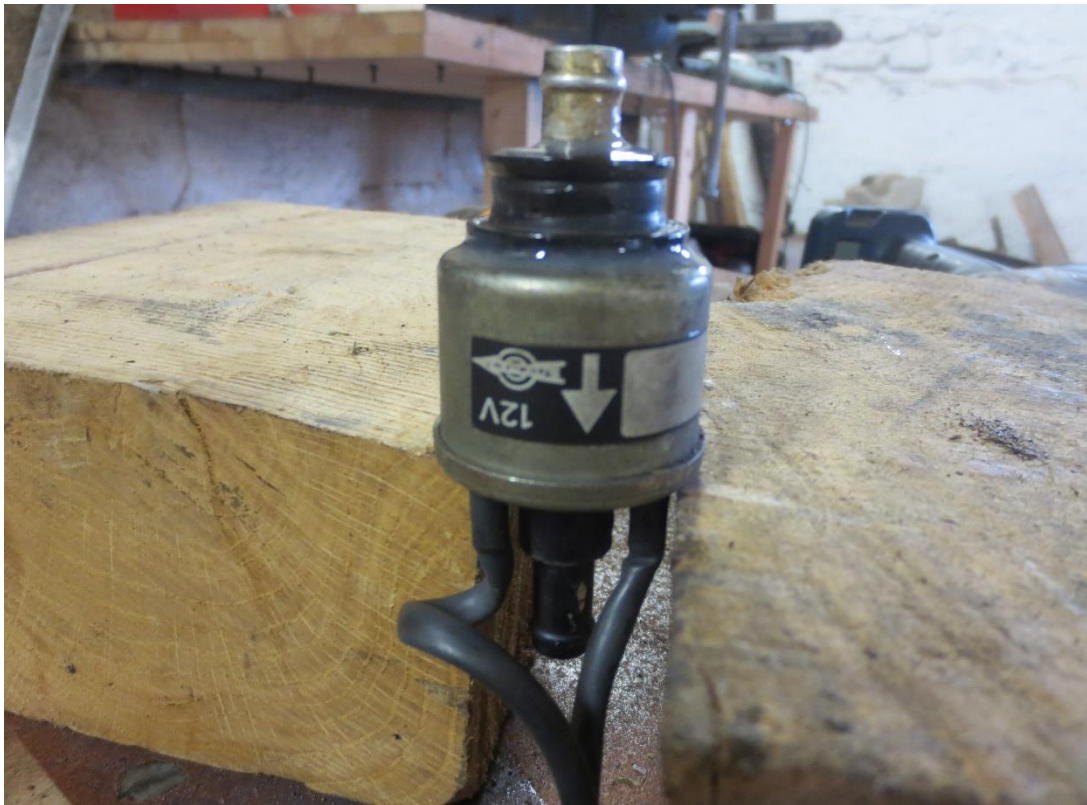
The ideal mechanism for this function is an electrically operated solenoid that can be switched on and off from the cabin. The problem was finding a suitable one that gave enough airflow. As standard, many V12 XJSs are fitted with a solenoid that is automatically activated when the air conditioning compressor runs. This is an extra air device to ensure that in traffic, or at a standstill for some other reason, the load produced by the compressor running does not stall the engine if it is ticking over. The OEM solenoid works well for this anti-stall function, but my experiments showed that it does not flow enough air to reliably run a stone cold engine from startup. The bore of the solenoid's air pipe is just too narrow. A photo of this item is shown below:

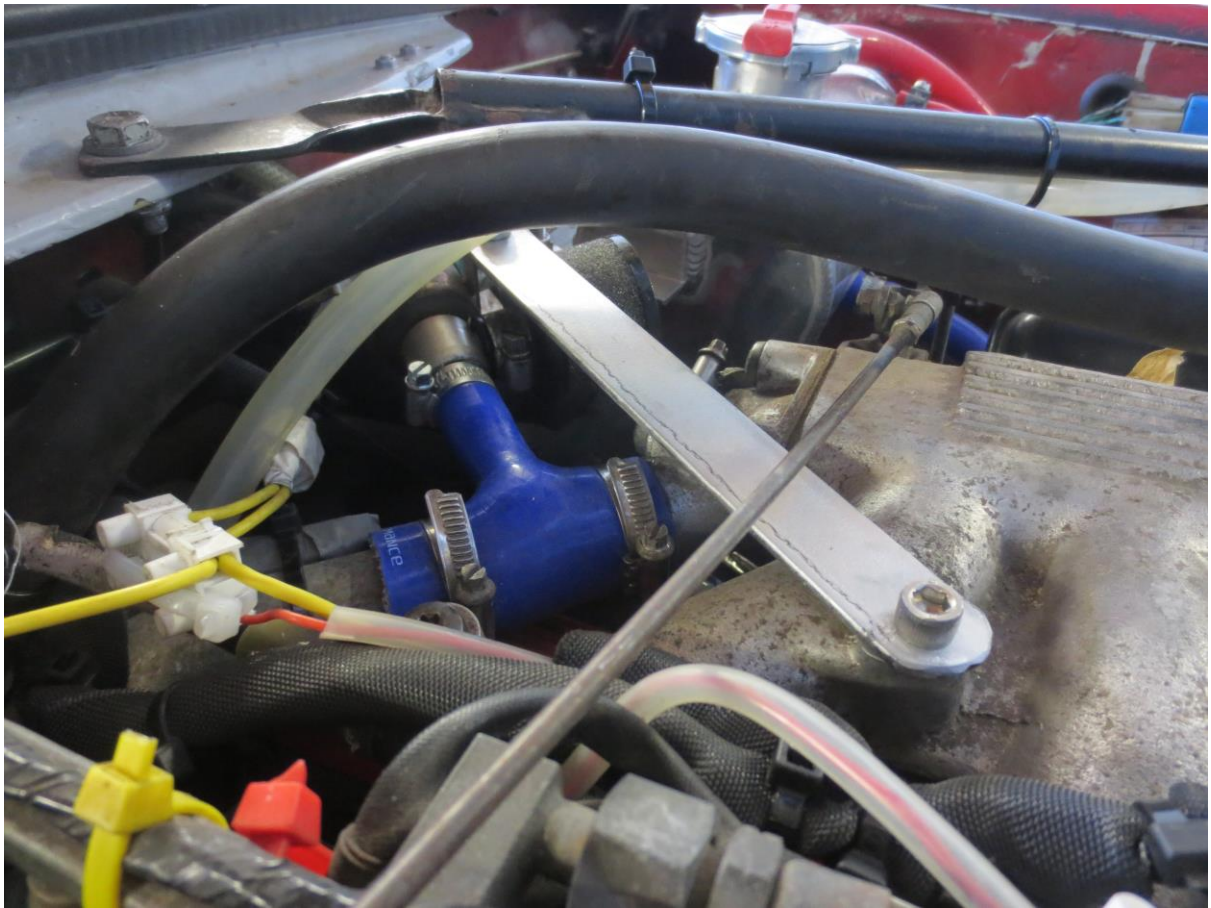
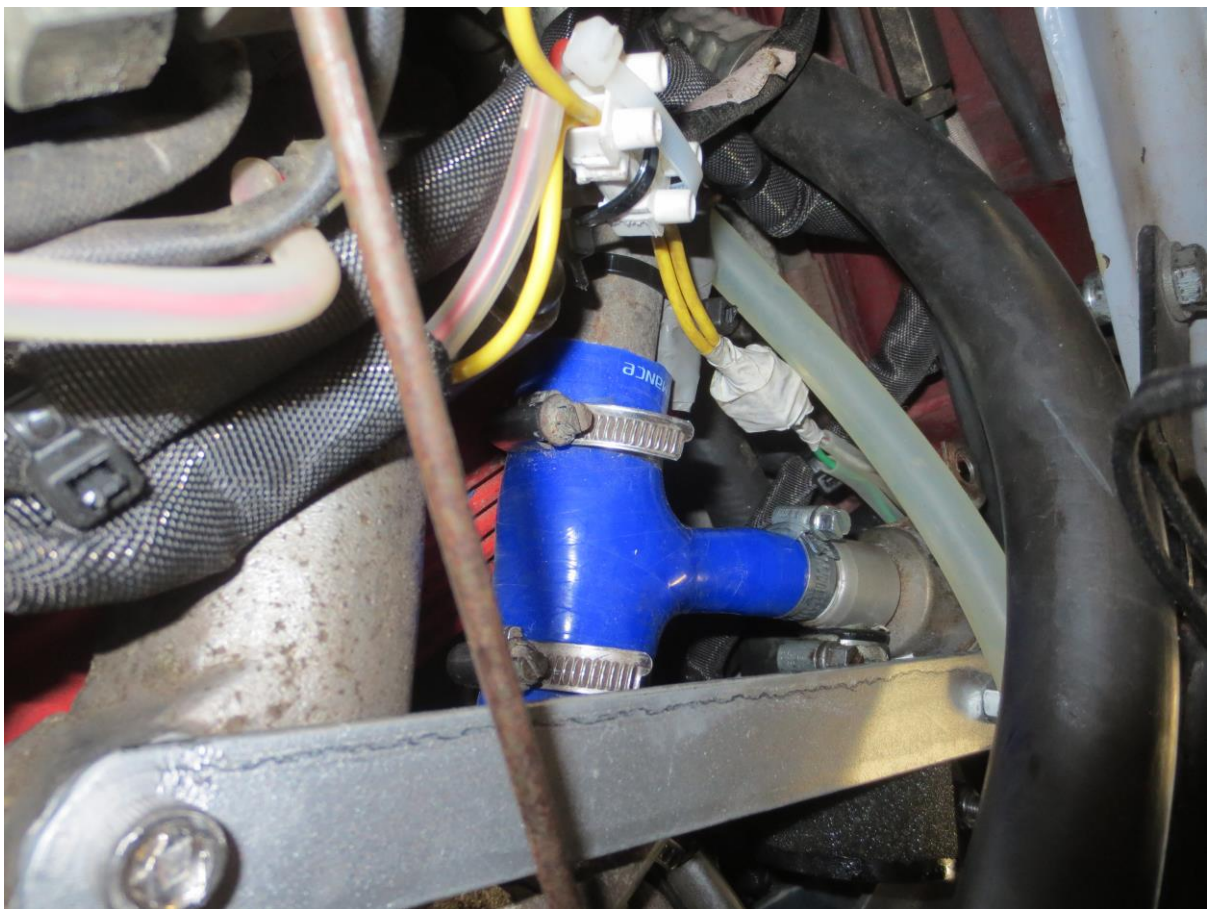
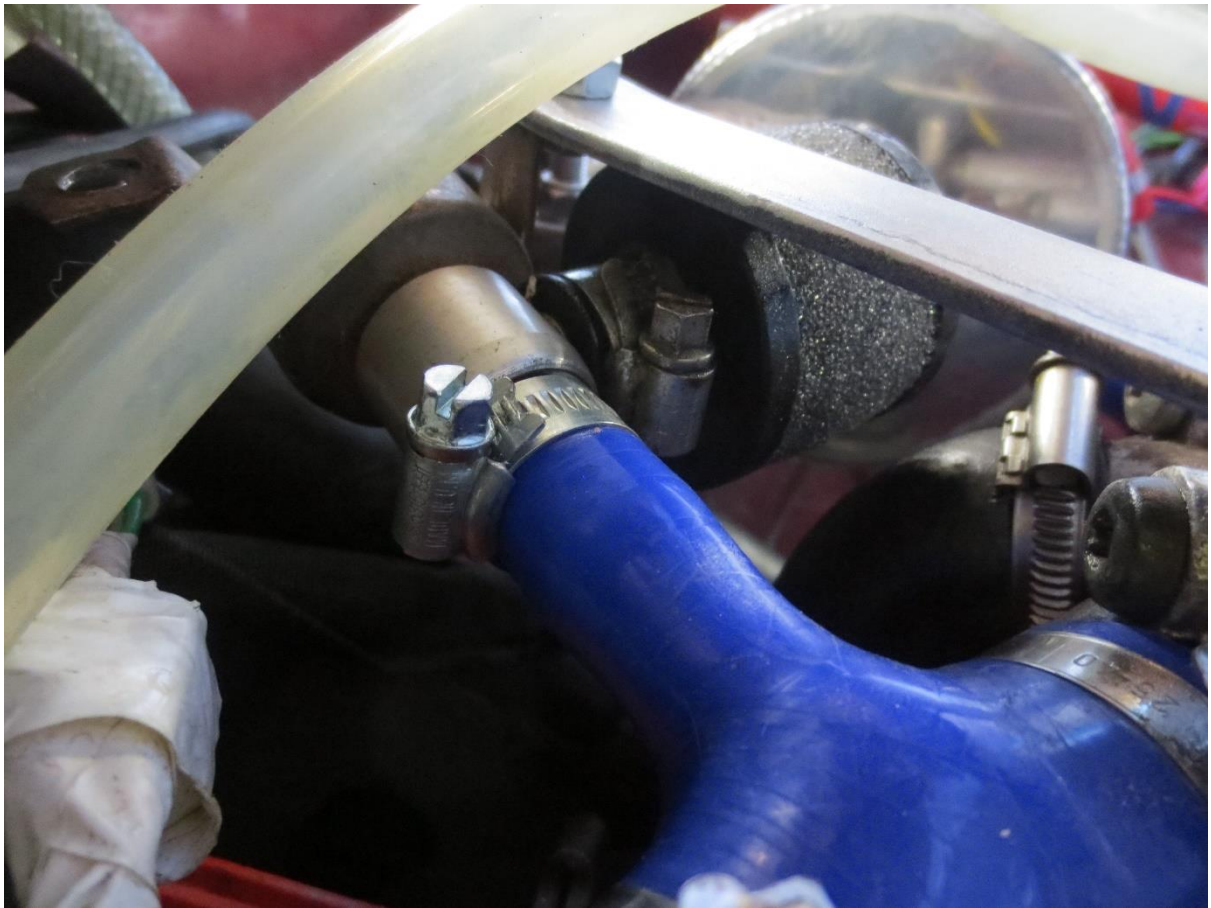
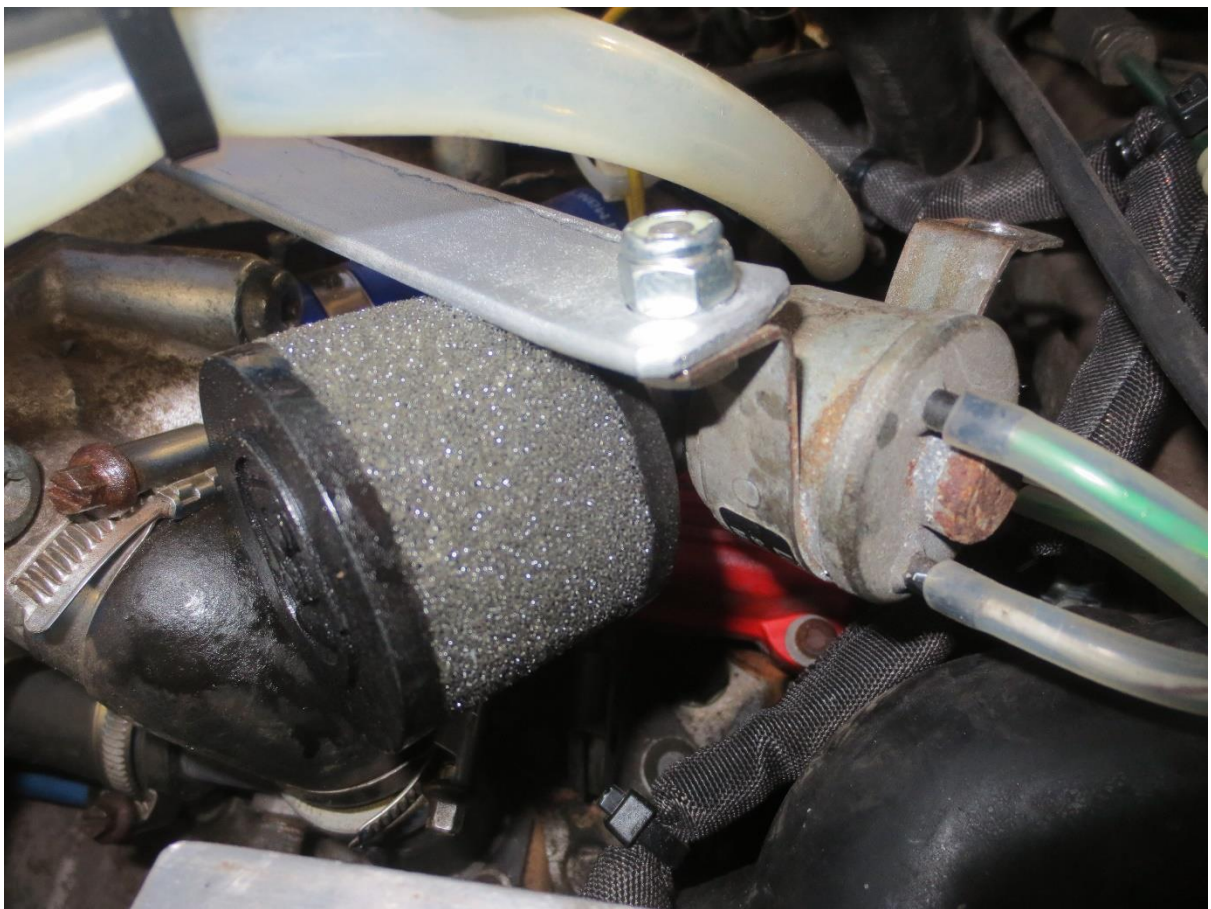
The following photo show how it was installed into the LHS end of the balance pipe, using a Viper Performance unequal T hose with 1 inch across the T and a 13mm diameter leg for the solenoid:

The second possibility would be to connect the solenoid to the large balance pipe that runs across the rear of the engine to balance the manifold pressures. This is the option I chose. In my case, an unequal T hose was found to install in place of one of the 1 inch diameter hose joiners that connect the balance pipe to the manifolds.

4. A new solenoid can still be purchased, but it is expensive; however second hand ones are easily available in the UK and quite cheap.
5. The feed pipes from the solenoid to the manifolds need to have an ID of 13mm minimum to provide enough flow and connect to the solenoid easily. I have used thick walled silicone tubing with reinforcing fibres that will easily withstand the engine bay heat and not collapse under manifold vacuum when the cold start system is switched off.

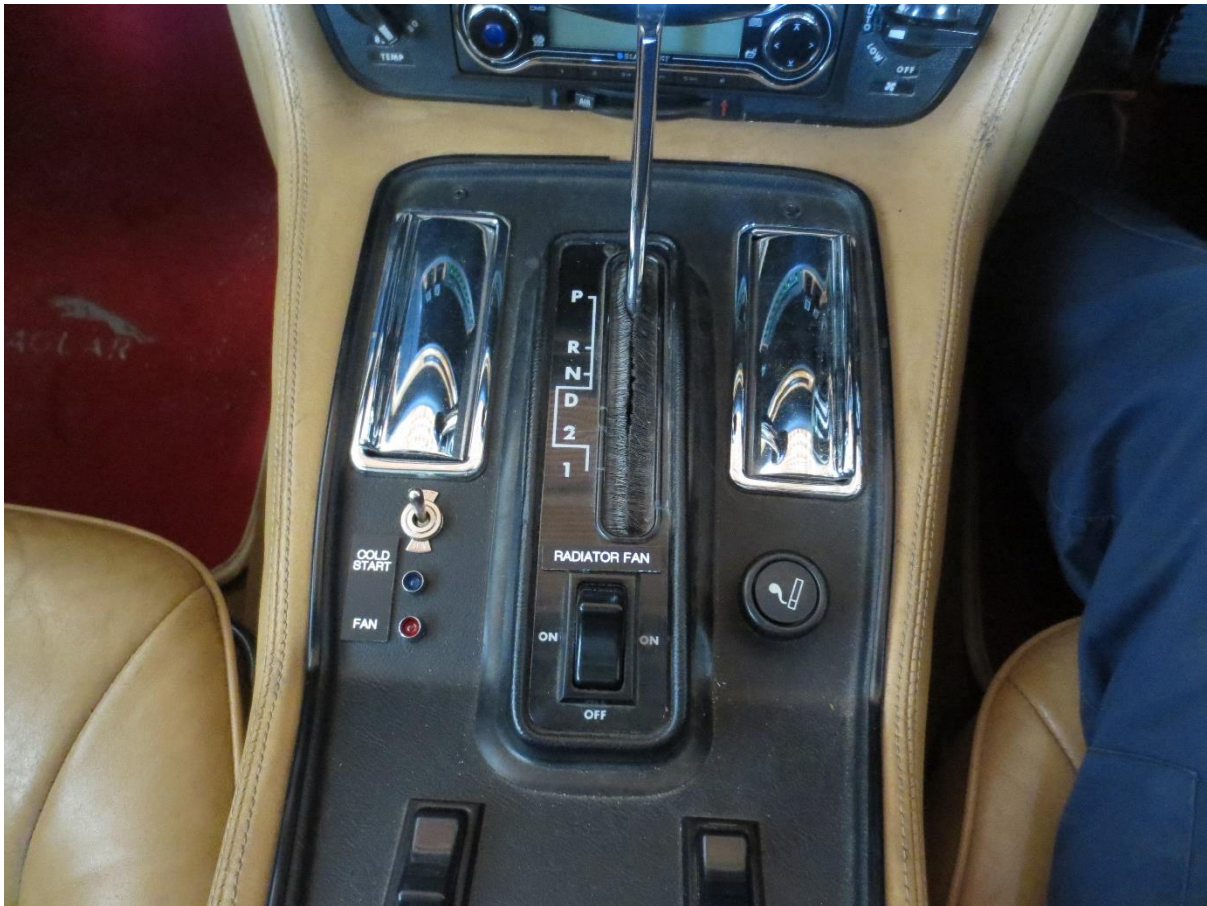
The solenoid is powered by a feed taken from the coil positive terminal, it draws less than an amp and that only when activated, so should not overload the circuit. It has a dedicated inline fuse between the coil terminal and the solenoid. The switching is done to earth from a wire that runs into the cabin through the same routing that the heater unit vacuum tube takes. The cabin switch is installed in the console top just behind the ashtray, together with a dedicated warning light, as shown in the following two photos.

Note that on my car, as the cruise control is removed and I have an electric main fan installed, the cruise control master switch has been repurposed as a switch for the main radiator fan in the event of the thermostatically operated system failing. My car has a "fan running" warning light installed in addition to the cold start warning light and switch.
