Jaguar rear outer pivot arm greasing. Inboard brake style.

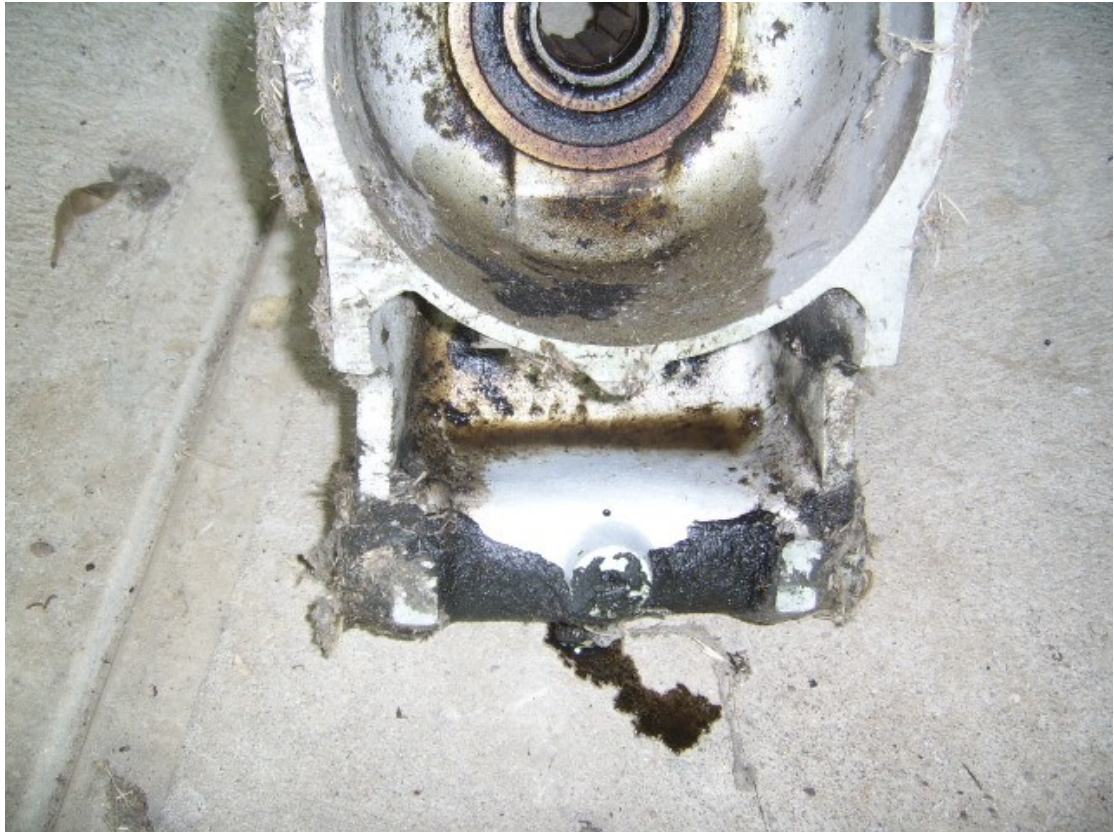
Figure 1 General view of that SMALL hole

This is due to a small "bleed hole" in the face of that casting, about 90deg to the nipple inlet. So as you grease the area, thinking you are doing a great job, the grease is actually going out of this hole and up inside the tube that forms the lower wishbone. The resulting outcome is that NO grease has actually got into the bearings, which are at either end of that casting, water gets in, it has to, the only seals as such for those bearings a felt rings (if they are still intact, I doubt it), the bearings fail, the car gets all wobbly and knocky from the rear, and you got lots of work in front of you to replace them.

I simply drilled that bleed hole slightly larger, to suit whatever you choose to plug it, using wheel bearing grease on the drill bit, it is stickier than normal grease, and collects the drilling swarf perfectly. Then I inserted a suitable self tapping screw, VERY short in length, in that hole. You could go all fancy and tap a thread and put a suitable 4mm bolt in there, your car your choice, but it is NOT visible unless the rear hub is partly removed.

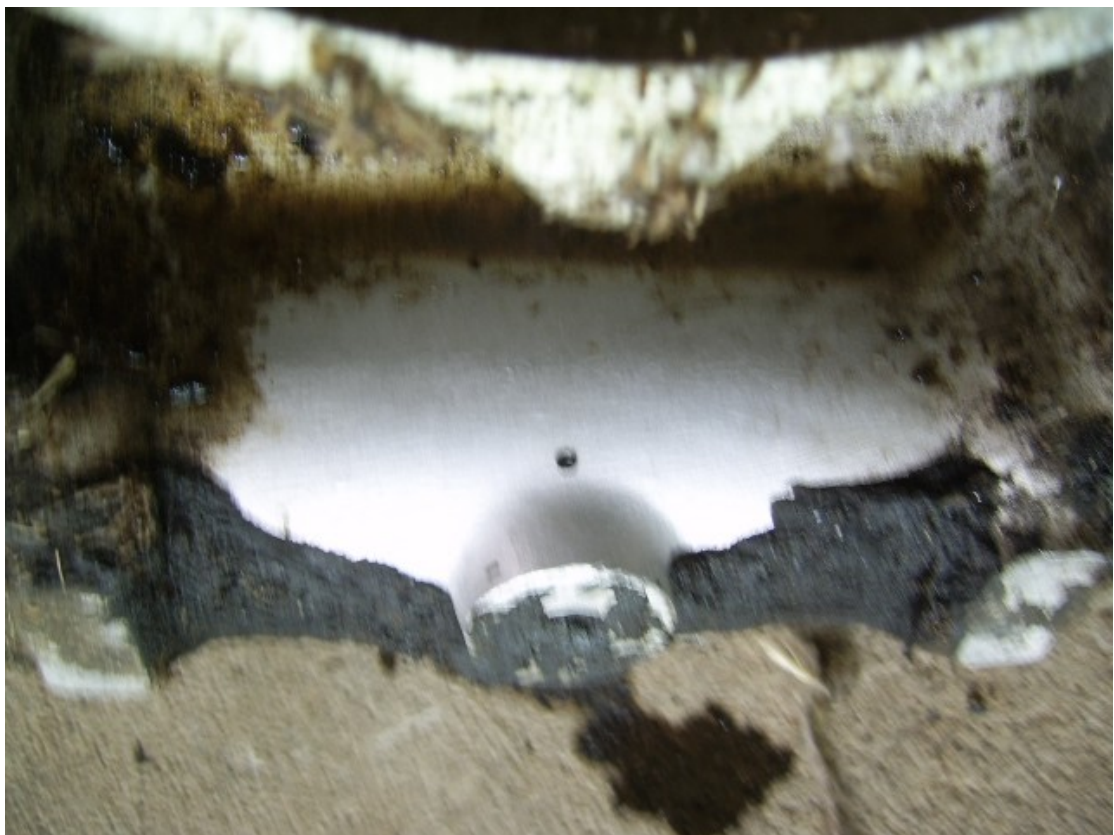
Figure 2 Close up of said hole

This is an old hub under the bench, it clearly shows the hole I am discussing.

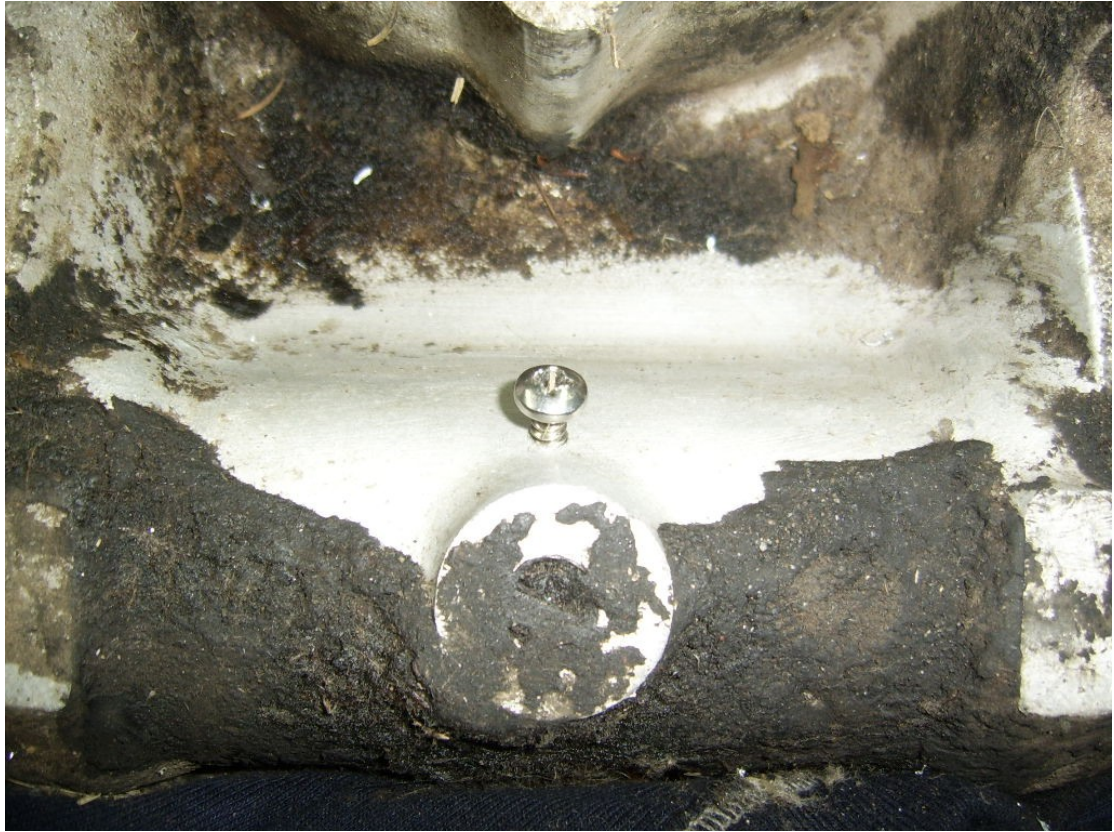
This the screw as a sample of what is needed. This is a tad too long, but for the sake of this article it serves the purpose.
