NOISY ALTERNATOR BELT:

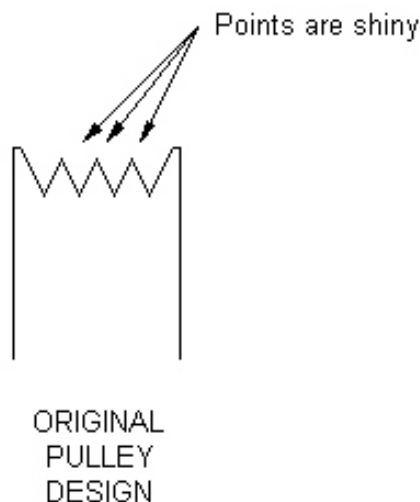
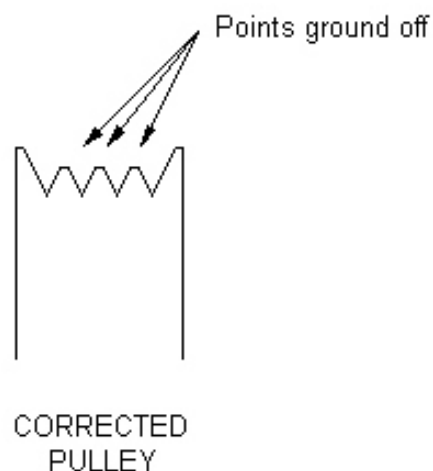
The multi-groove belts, unfortunately, cannot wear anywhere near that much before they begin to slip. In fact, after the pulley itself has a little wear on it, they cannot wear at all before they begin to slip -- the brand new belt will slip almost immediately. This is because the belt will contact the pulley on top of the ridges between the grooves and ride on these edges rather than wedging down into the grooves. Sitting up on these smooth edges, it can

It is easy to confirm this is what's happening: look at the alternator pulley with a flashlight. If the top edges of those ridges are bright and shiny, you've found the problem. Usually, the inside surfaces of the V's are much duller, sometimes even rusty, indicating the belt isn't even touching them. The fix is easy, too, except that it requires getting that pulley out -- which isn't easy. With the pulley removed from the alternator, mount it on something that will spin it (a lathe, or find a way to chuck it up in a drill if you don't have a lathe) and grind the edges of those ridges down.

Don't worry about grinding off too much. Yes, you are reducing the contact area of the wedge area, but the fact is that once the belt is actually wedging rather than skimming around the ridges, contact area isn't a problem -- the multi-groove belt will easily handle all the load of the alternator and then some without complaint. Just make sure to grind the ridges down enough that they won't be a problem any more, even with a worn belt.
