Rebuilding the XJS independent rear axle

Many owners, like me, are quite happy to replace front axle bearings and adjust them, but find the rear hubs and UJs in the driveshafts something of a mystery, and their replacement, rebuild and setup quite daunting. In my case, circumstances forced me to take some brave pills and get stuck in. Although my car is a 1985 V12 XJS coupe, this procedure will be the same for any model of Jaguar that has the inboard-braked independent rear axle.

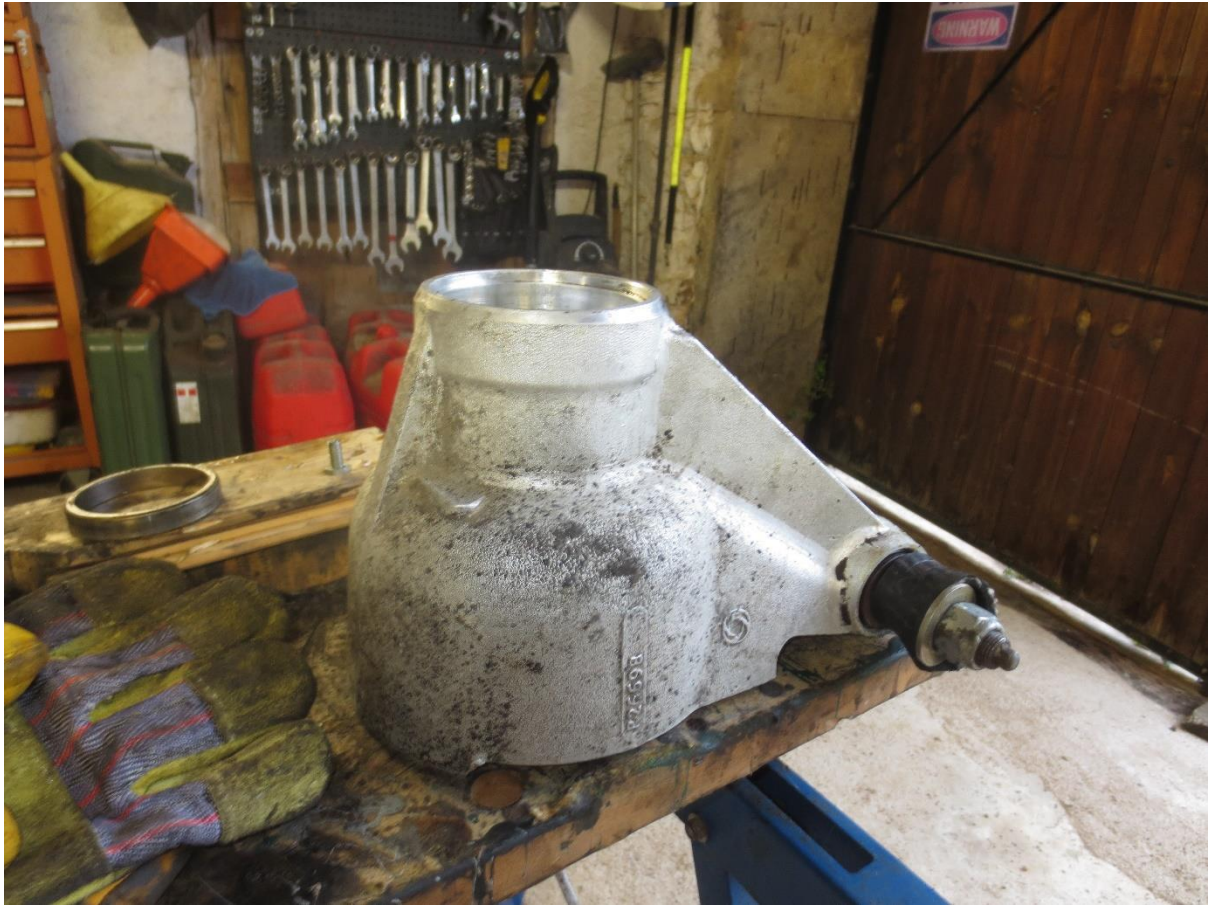
Photo 1: Hub carrier

Hub carrier: this is the large aluminium casting that surrounds the outer end of the driveshaft.

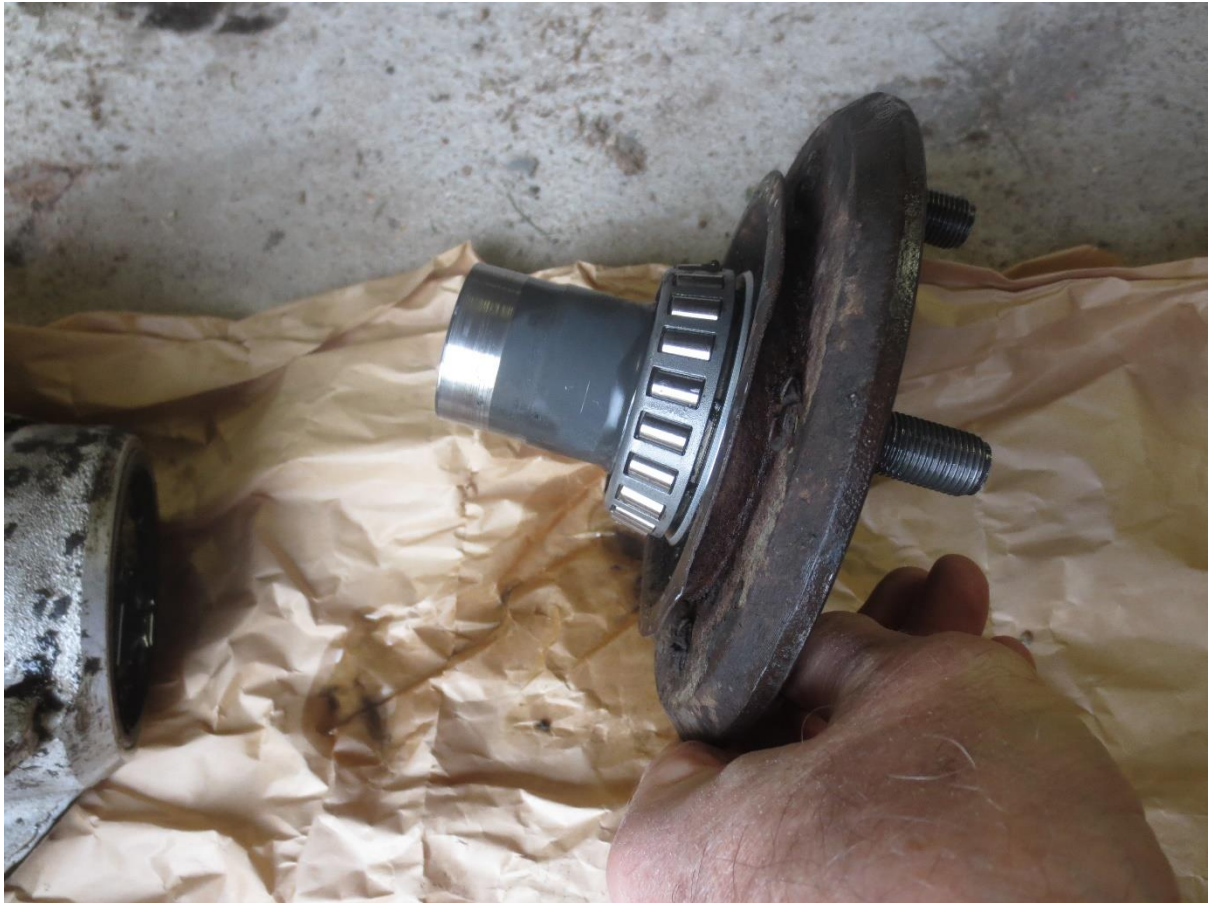
Photo 2: hub with outer bearing's inner race still in place. The inside of the hub tube is machined with female splines

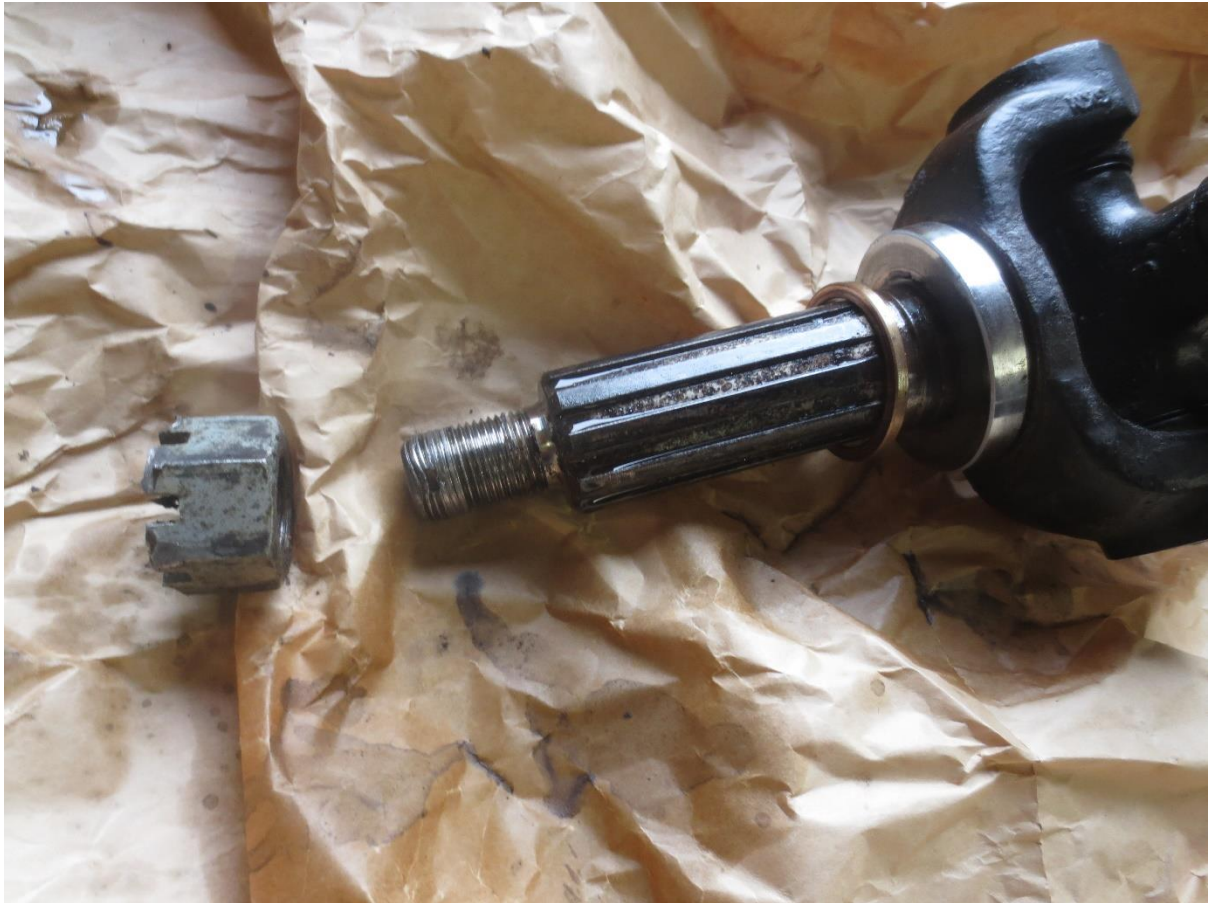
Photo 3: the male splined end of the driveshaft that fits into the female splines of the hub, and thus transmits drive to the hub and road wheels. Note the two spacers on it against the UJ yoke. These are important and must be carefully retained.

The problem is that the nut on the end of the driveshaft (see photo24) HAS to be seriously tight at 120 ft/lbs! This clamping force cannot be taken through the bearings, it has to be transmitted through the hub tube to the machined flat on the yoke-end of the splined driveshaft. Photo 10 shows the bare part in close up, and photo 3 shows it with the two spacers in place. The first silver

coloured spacer is also the track for the inner bearing oil seal, and all assemblies have this fitted. The purpose of the second smaller phosphor bronze spacer shown in photo 3, is to fill up the remaining space between the end of the hub tube and the silver spacer. This second spacer therefore comes in many thicknesses, because the exact gap to be filled may vary by a few thou. Obviously the required thickness in any individual case must be measured.

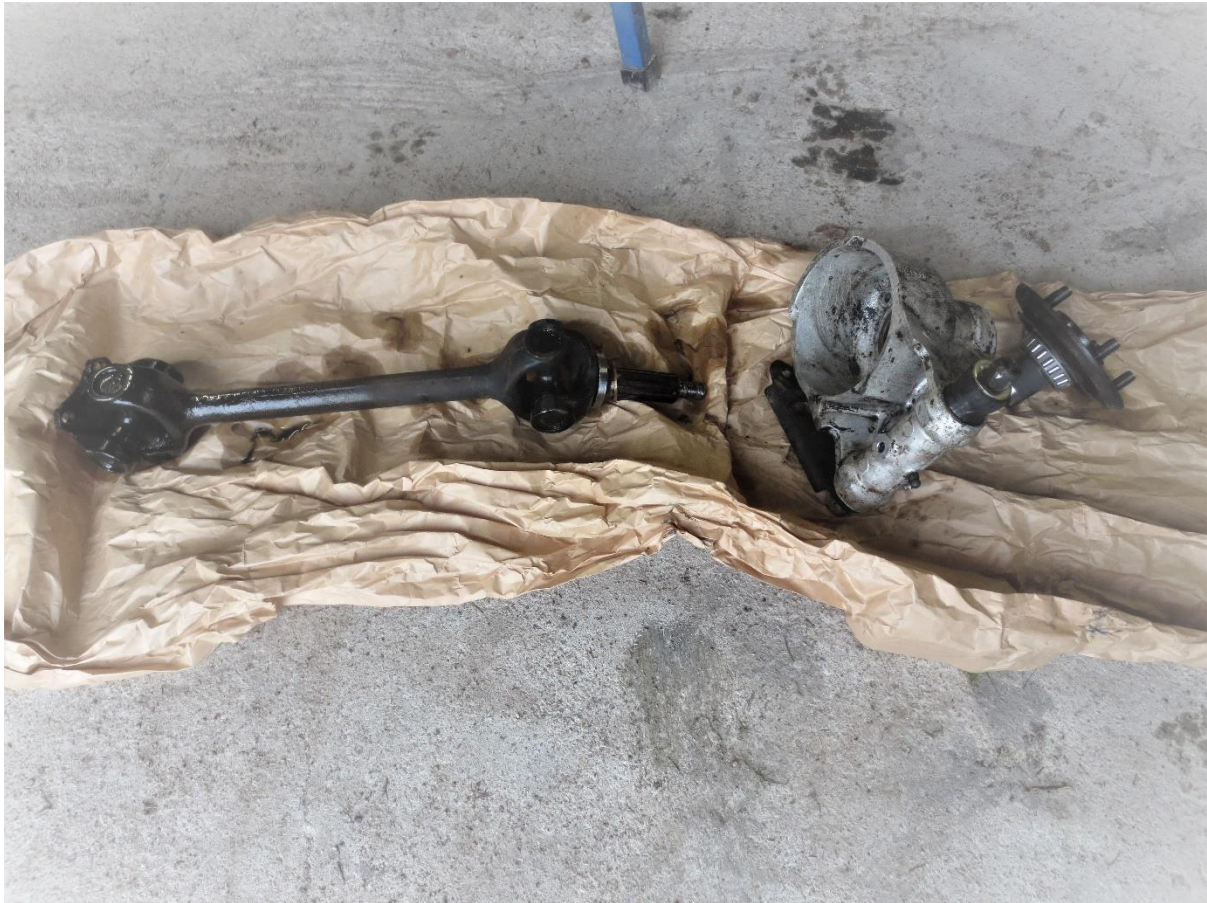
Photo 4: the entire assembly laid out in order.

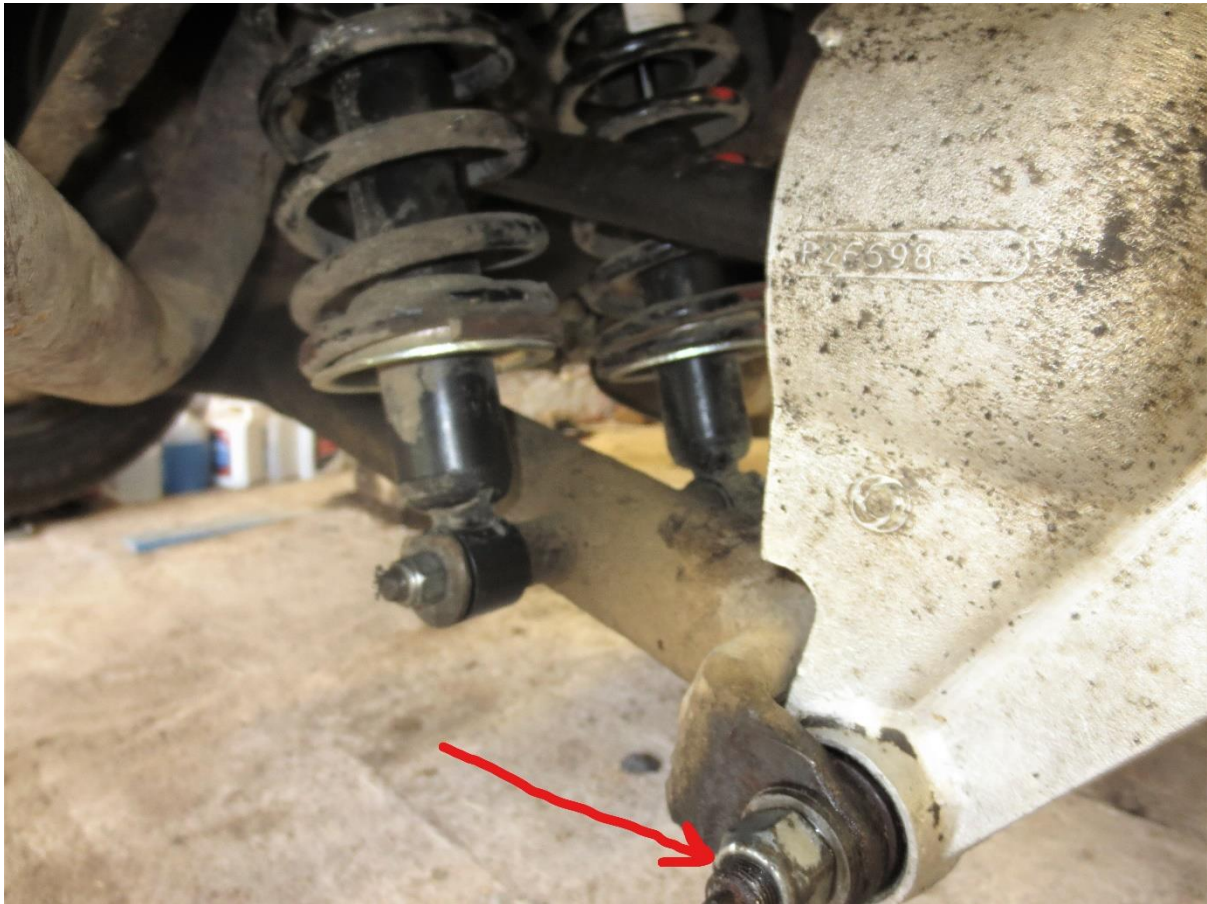
At this point the sole connection remaining between the driveshaft/hub assembly and the rest of the car is the hub carrier fulcrum, see photo 5.

In photo 5 the red arrow marks the hub carrier lower fulcrum pin. At this point in the process, it is the final attachment point of the assembly to the car. It must be unbolted and CAREFULLY driven out with the hub assembly supported on a table or bench so it cannot drop. *Very important:* as soon as the hub assembly is free of the suspension arm, refit the pin into the hub. Use a short length of rubber hose on one end to keep everything in place. If you look again at Photo 1 you can see the fulcrum pin replaced in the hub carrier with a length of old coolant hose to take up any slack. There are bearings and spacers inside the fulcrum and these will drop out of place if the pin is not replaced.

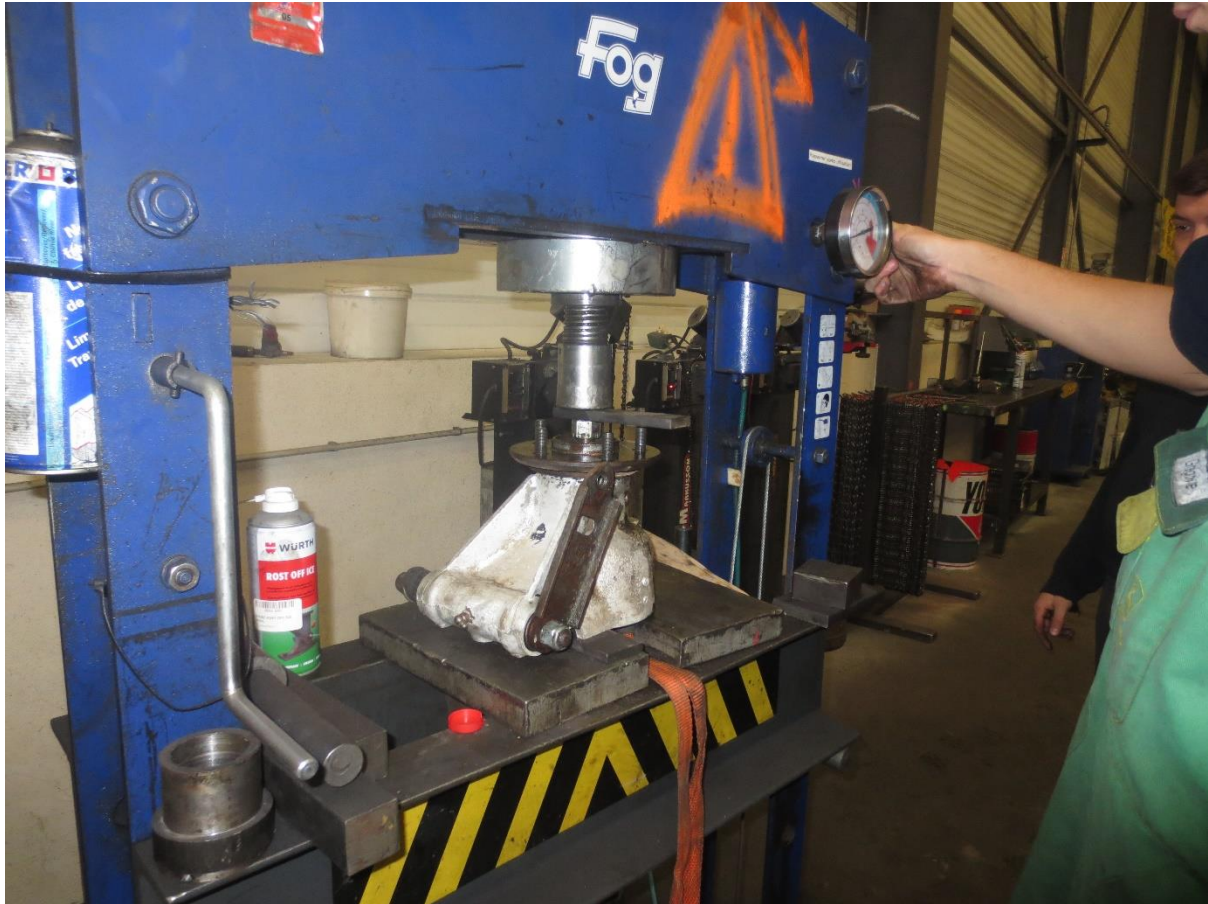
most of its life in the UK. Therefore the driveshaft was well rusted/gunked into the hub. I tried a puller, it broke. I tried a bigger one, it did nothing. So I went down to the local heavy vehicle repair place and asked the cousin of my son's best friend to help. Photo 6 shows the procedure:

Photo 6: 40 tonne hammer-action hydraulic press. The driveshaft retaining nut is on the threads to protect them, it required all 40 tonnes to shift the splined shaft from the hub, and it gave at about 4mm a thump. The driveshaft is hanging down below the press table. Both sides needed the same treatment.

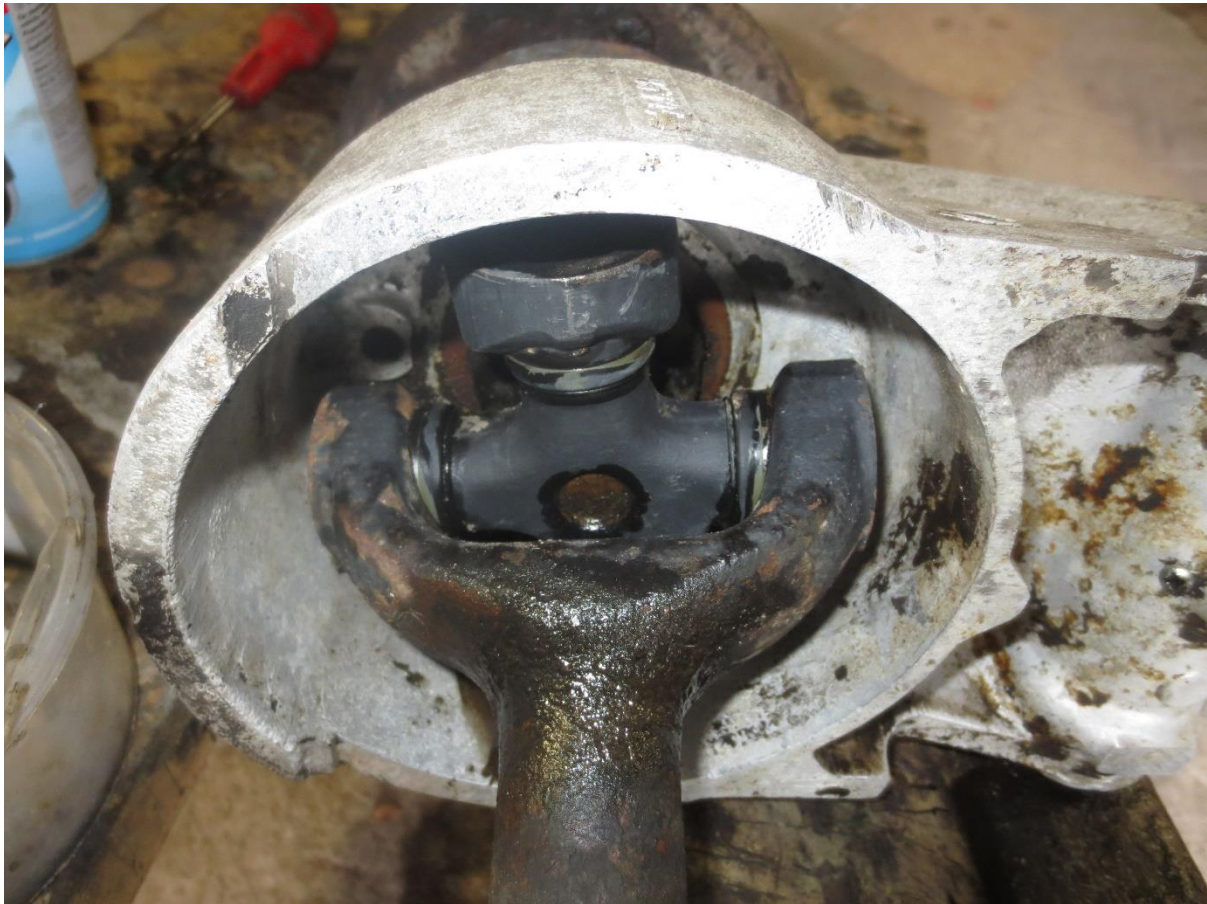
Photo 8: close up of the old UJ in the hub carrier showing the arms in each yoke. Also illustrating why the driveshaft has to be removed from the hub to change it.

The task of replacing the UJs is easy to understand in principle, but quite hard in practice. Each UJ has four arms, two go into each yoke, one yoke on each end of the driveshaft. As shown in photo 8.

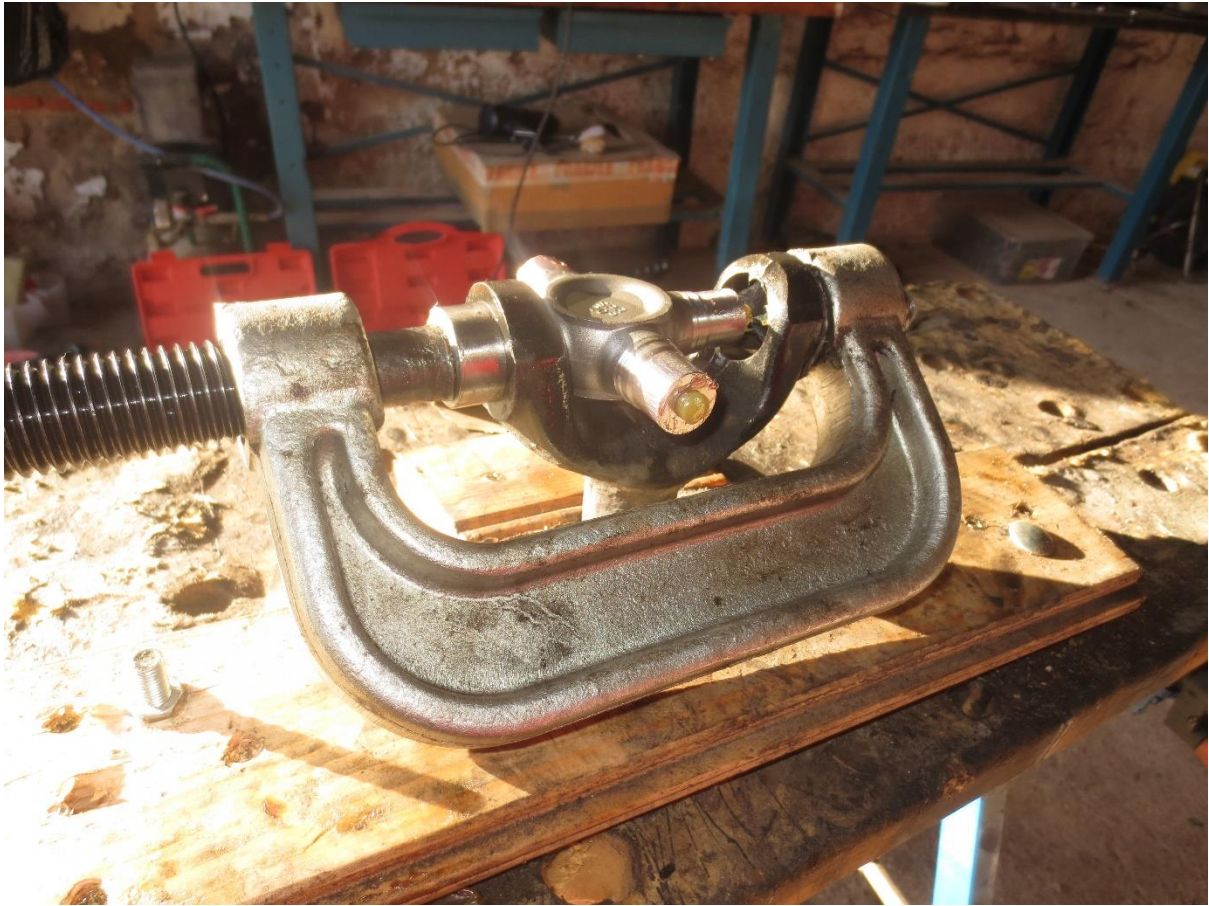
Photo 9: the arms of the new UJ are clearly shown, and also one of the caps being pushed into the yoke and over the UJ arm. There are needle roller bearings inside the cap (grease them to hold them in place while the cap is pushed into the yoke). The tool being used is cheap to buy from Amazon or motor parts places.

The UJ arms fit loosely into the holes in the yoke, and are held tightly in place by caps pushed into the yoke and over the arms. The cap in turn is held into the yoke by a circlip that fits into a groove in the yoke. The following photos show the detail:

Although rather out of sequence, now that the way UJs fit is clear, a few words about removing the old ones. First the circlips have to be removed, then, the tool shown in photo 9 is used to push one cap inwards, which pushes the opposite cap out of the yoke. Once poking out enough, a large pair of grips is needed to prise it right out, or, good tip this, grip the cap in a vice and use the leverage of the driveshaft to wriggle it out. Repeat this four times until the caps are all off and the UJ is free. If trouble is encountered, the UJ can always be cut with a small angle grinder just below the cap between it and the centre.

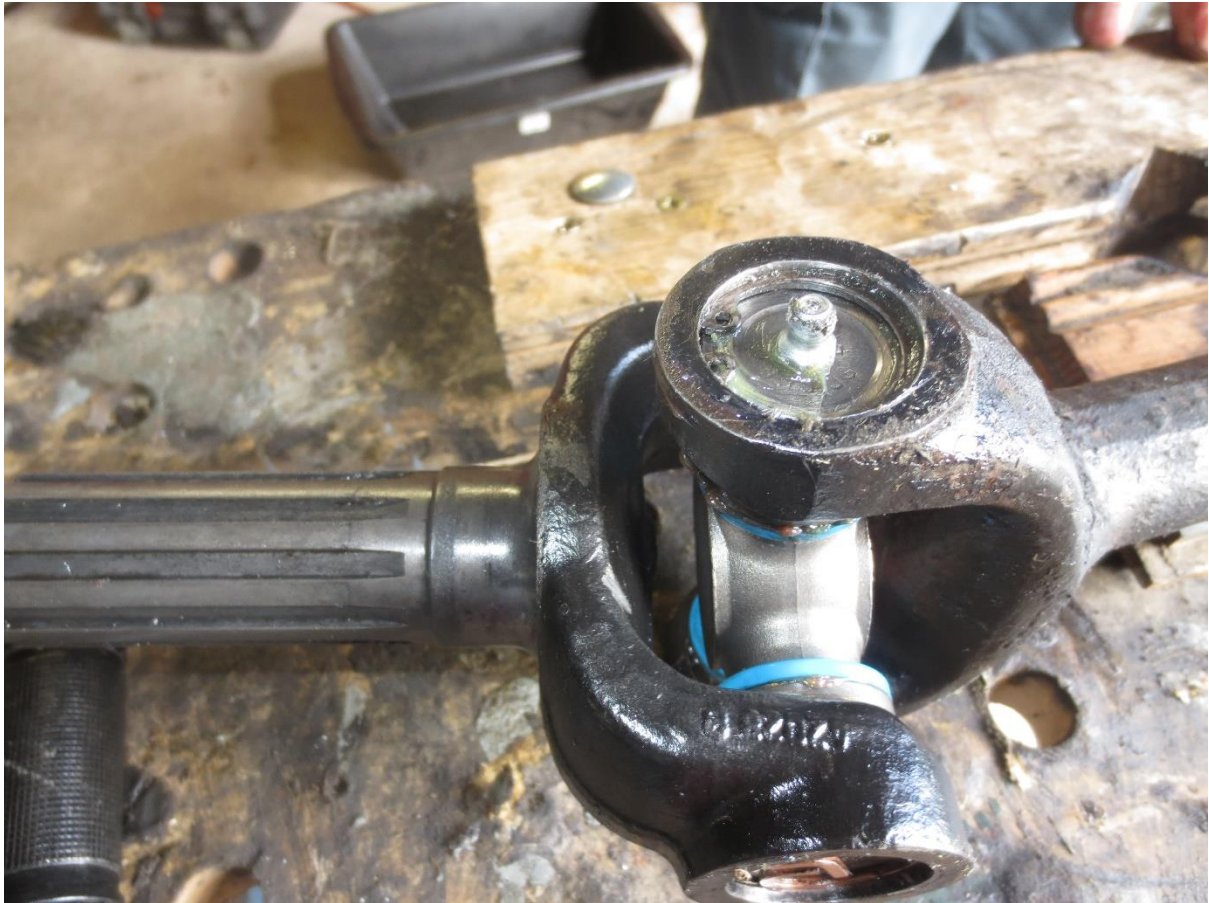
Photo 10 shows the finished new UJ in place with the grease nipple screwed into it. The circlip holding the cap into the yoke is also clear to see.

Photo 10: the new UJ fitted into the driveshaft yokes.

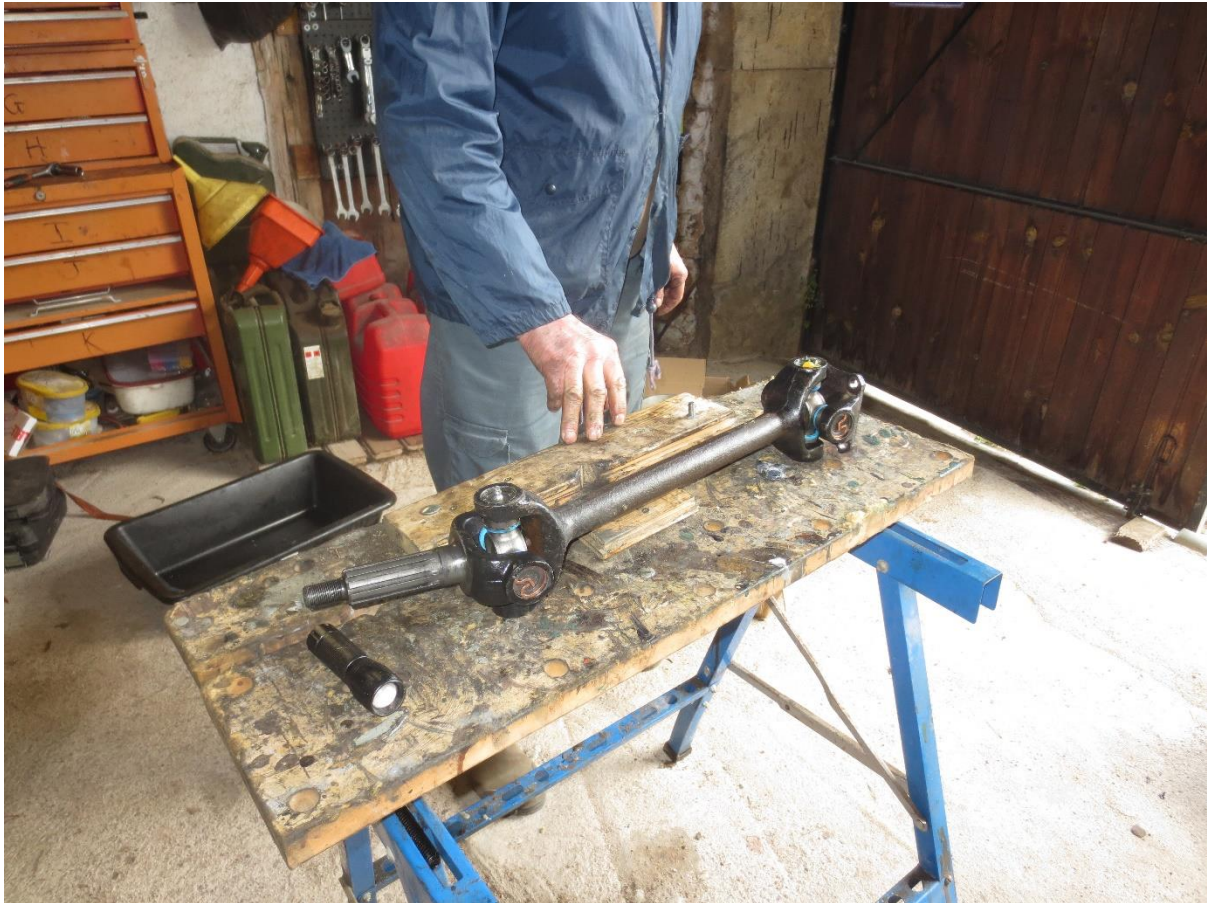
Photo 12: the clean driveshaft with derusted splines and shiny new UJs, ready to be refitted to the hub.

At this point the driveshaft has its new UJs installed and is ready to be replaced in the hub, see photo 12

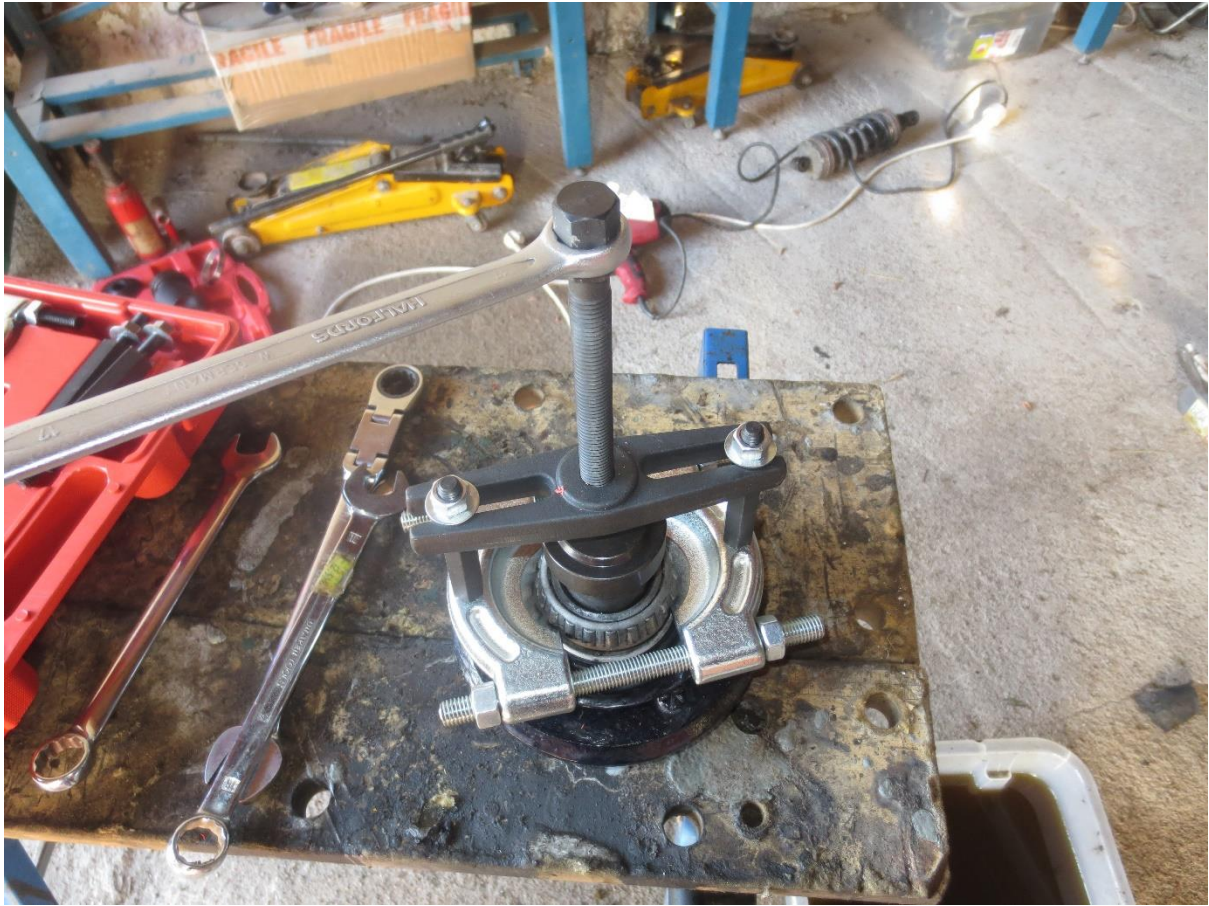
Photo 13: the bearing puller kit pulling the old outer hub bearing inner race from the hub.

As mentioned above, if the driveshafts came out of the hub assembly easily, and the hub bearings are all good, the driveshaft and original spacers can just be refitted to the hub and all is ready to go. In my case however, the hub bearings had to be replaced as they were damaged in the effort to remove the driveshafts. The removal of the hub inner bearing, inner race, is described above, the hub outer bearing inner race (shown in photo 2) needs to be pulled off using part of the bearing puller kit. Photo 13 shows this being done:

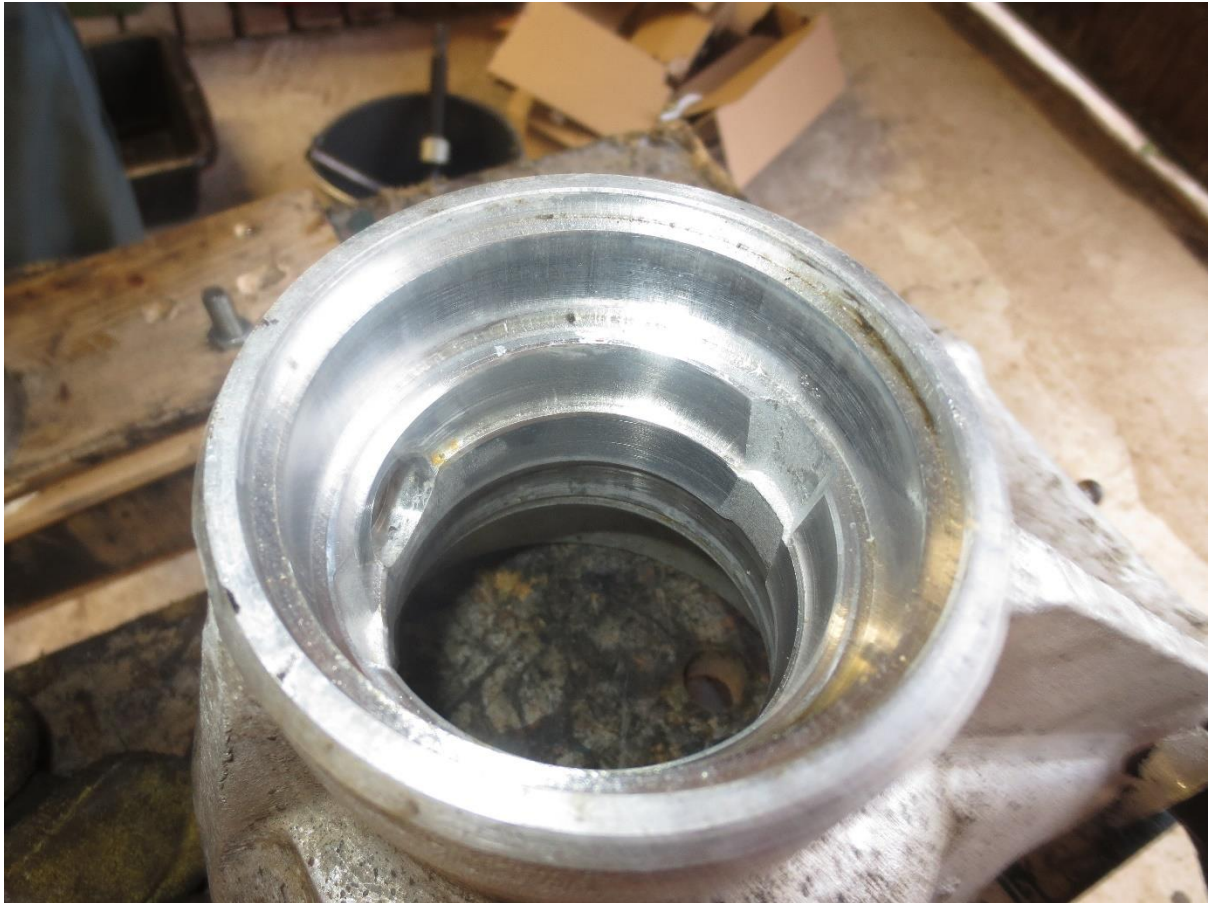
Photo 14: the empty hub carrier showing the indents that allow the outer races fitted to it to be driven out.

The hub carrier is now empty of the hub but must have the old outer races driven from it, prior to installing the new bearings. This is quite easy to do with a hammer and a brass drift, as there are indents in the carrier for this purpose, see photo 14.

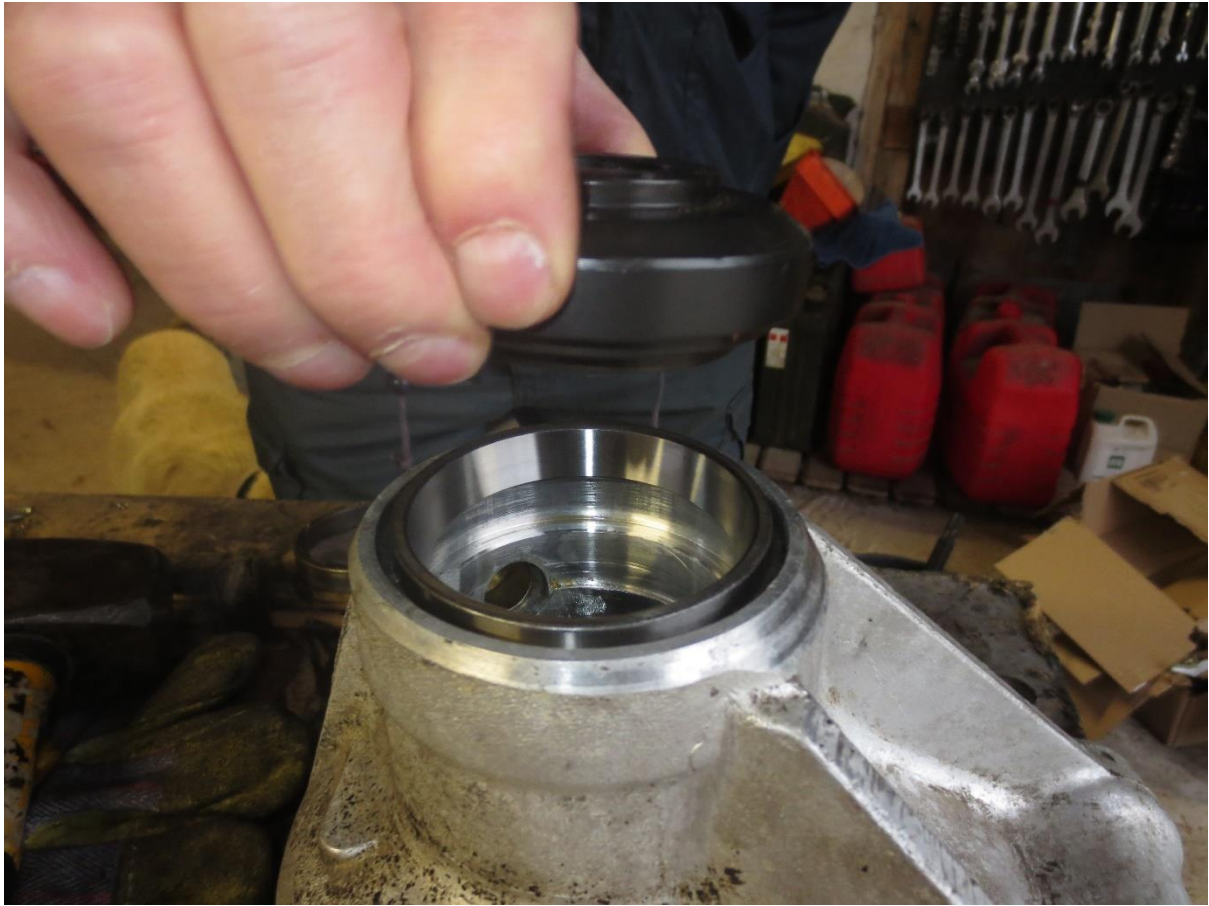
Photo 15: the new outer bearing race being driven into the carrier.

The new bearings' outer races are driven carefully into the clean empty hub carrier, using suitable tools from the bearing puller kit. Photo 15 shows the outer bearing outer race being driven into the carrier:

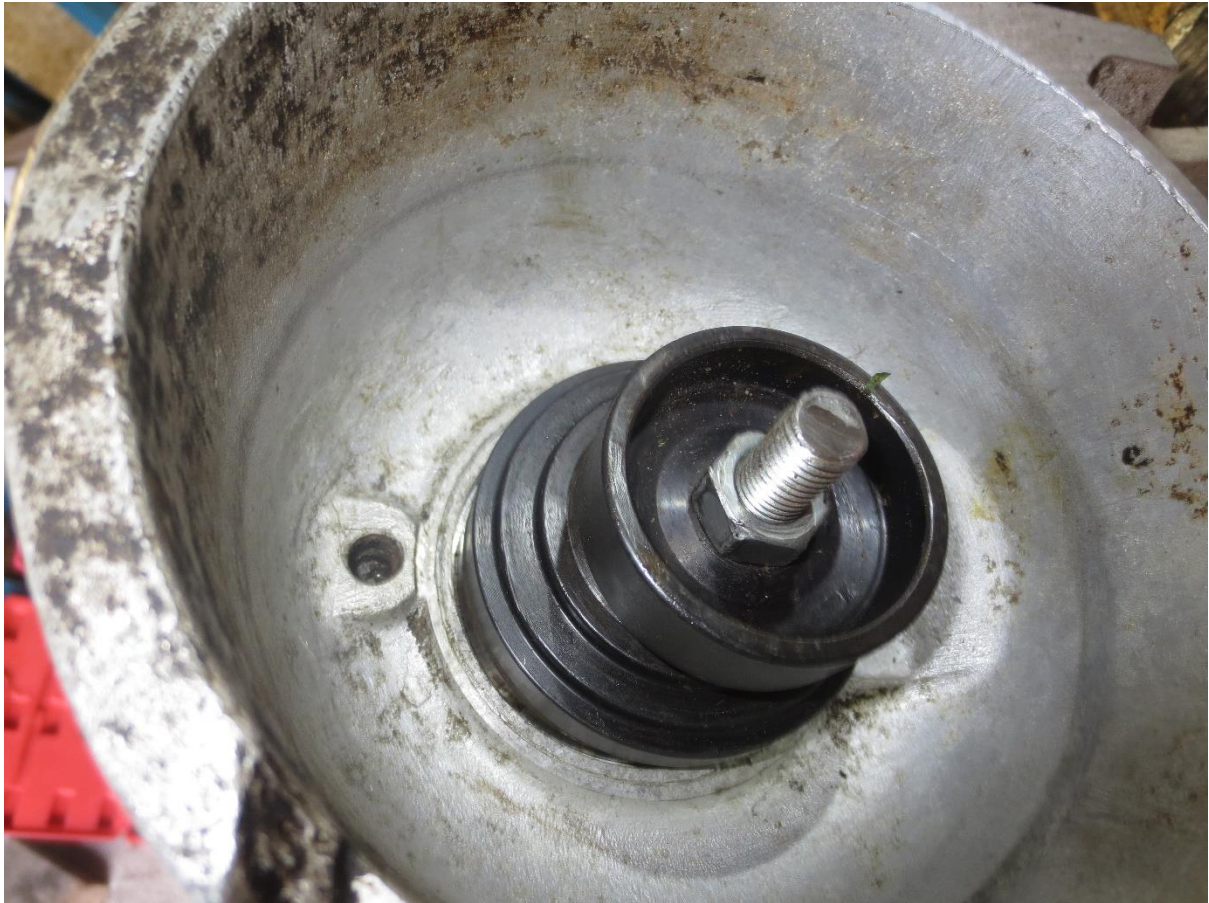
Photo 16: The inner bearing's outer race is being installed into the carrier using a suitable diameter driver, some spacers and a threaded rod to push it into place. Out of shot the other end of the threaded rod goes through a bit of square steel tube across the carrier, so the clamping force can be applied. After race has been wound in, use a brass drift and just tap it down round its circumference to ensure it is 100% seated. Photo 17 shows the carrier with both outer races installed, all ready for the next stage of assembly.

The inner bearing race has to be wound into the carrier using threaded rod and suitable sized bearing pusher pieces, as a hammer cannot be used, see photo 16.

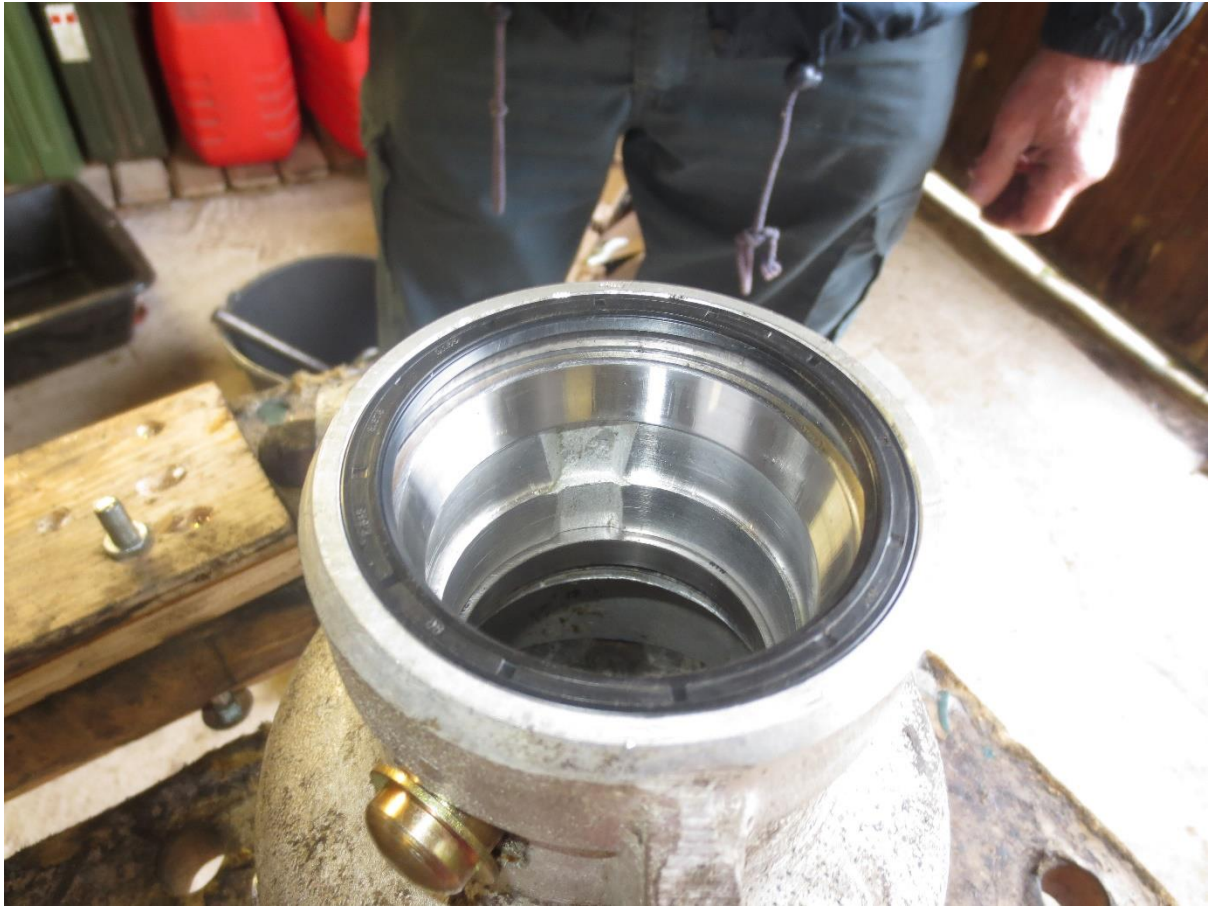
Photo 17: the new bearings' outer races in place in the clean carrier. Note the outer bearing's oil seal has to be installed at this point, as shown in the photo. Now the hub has to be fitted to the carrier. First the new outer bearing, inner race is driven onto the hub, see photo 18.

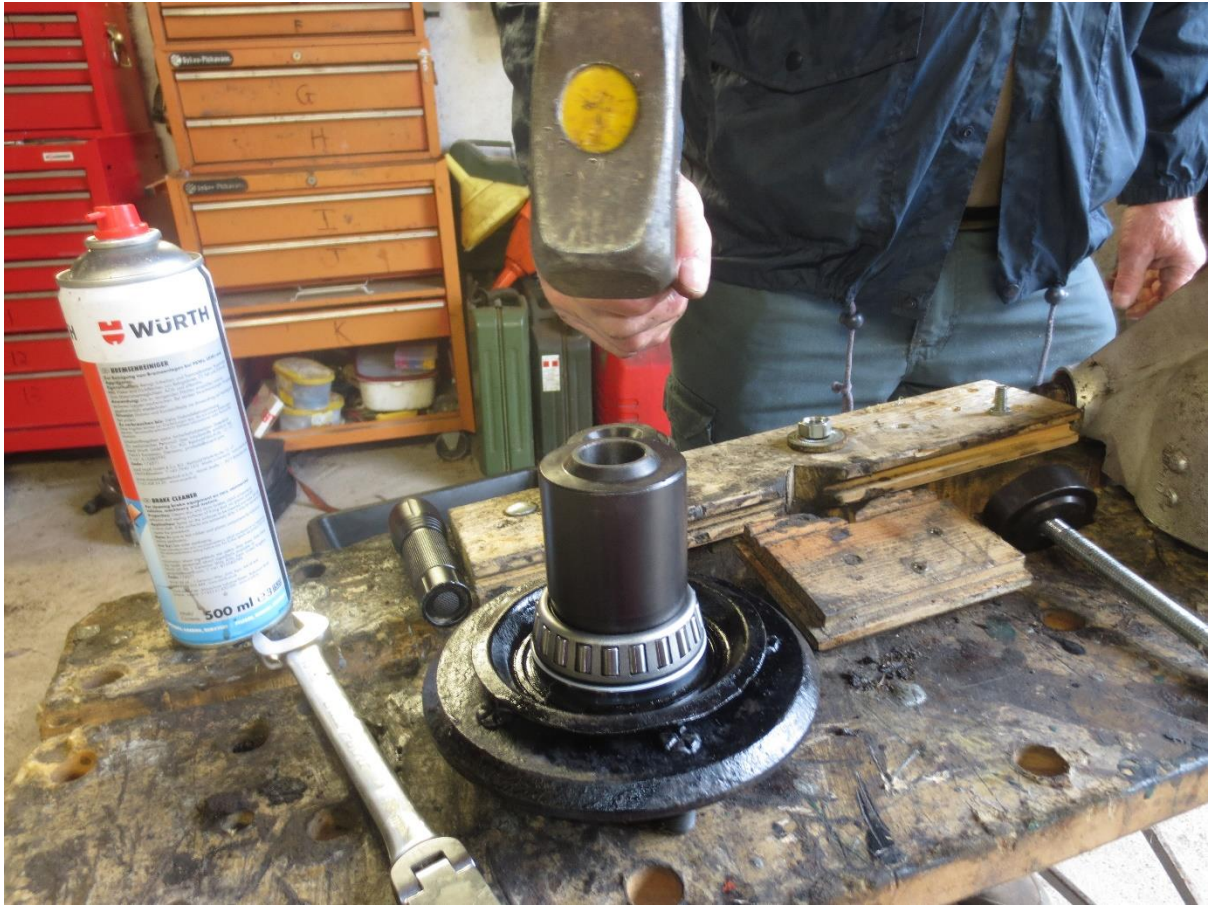
Photo 18: driving the new outer bearing inner race onto the hub. Next the hub is fitted into the hub carrier and the inner bearing's inner race placed in position. The inner race cannot be fitted to the hub tube by hand pressure, it too has to be wound in place. Photos 19 and 20 show the stages required:

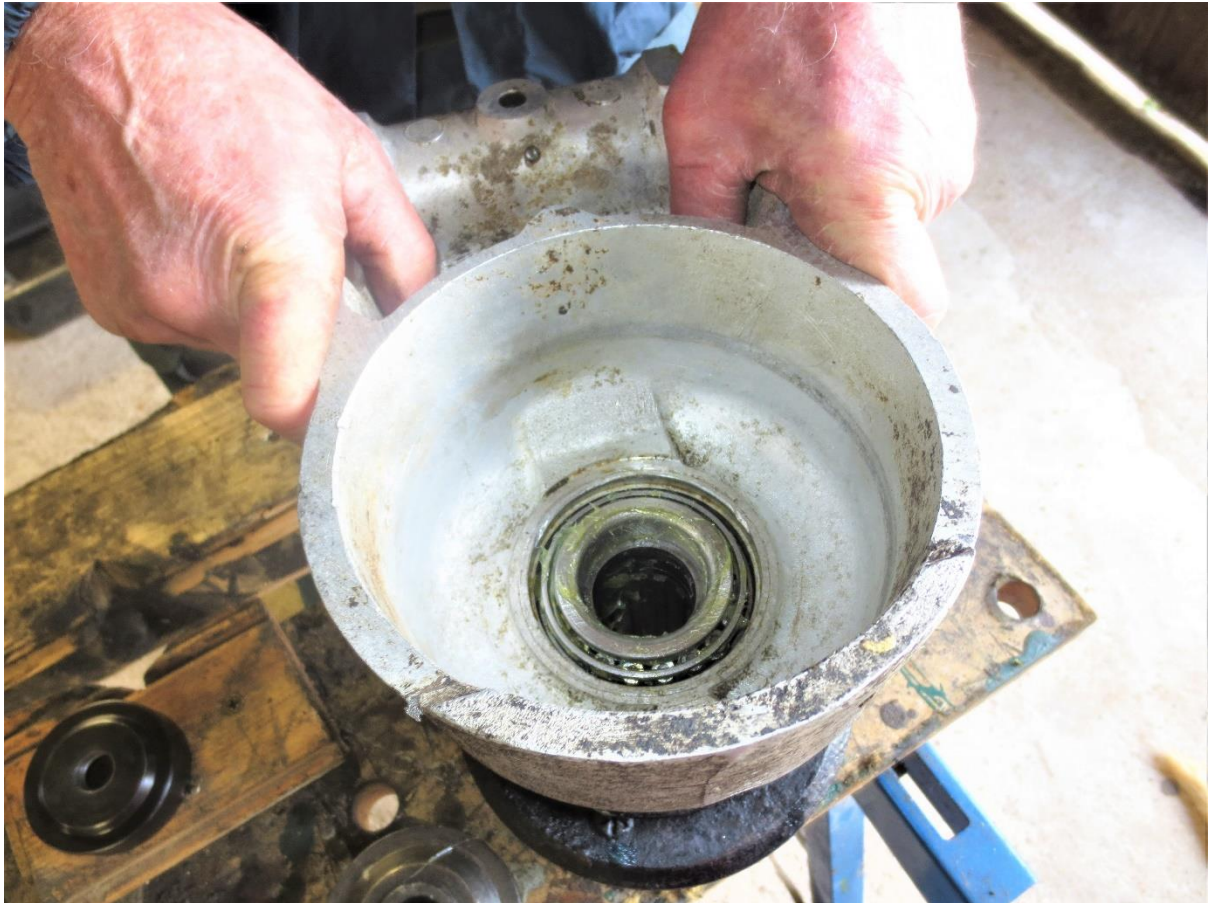
Photo 19: the inner hub bearing inner race placed in position, it is against, but not yet fitted over, the hub tube, which can just be seen inside.

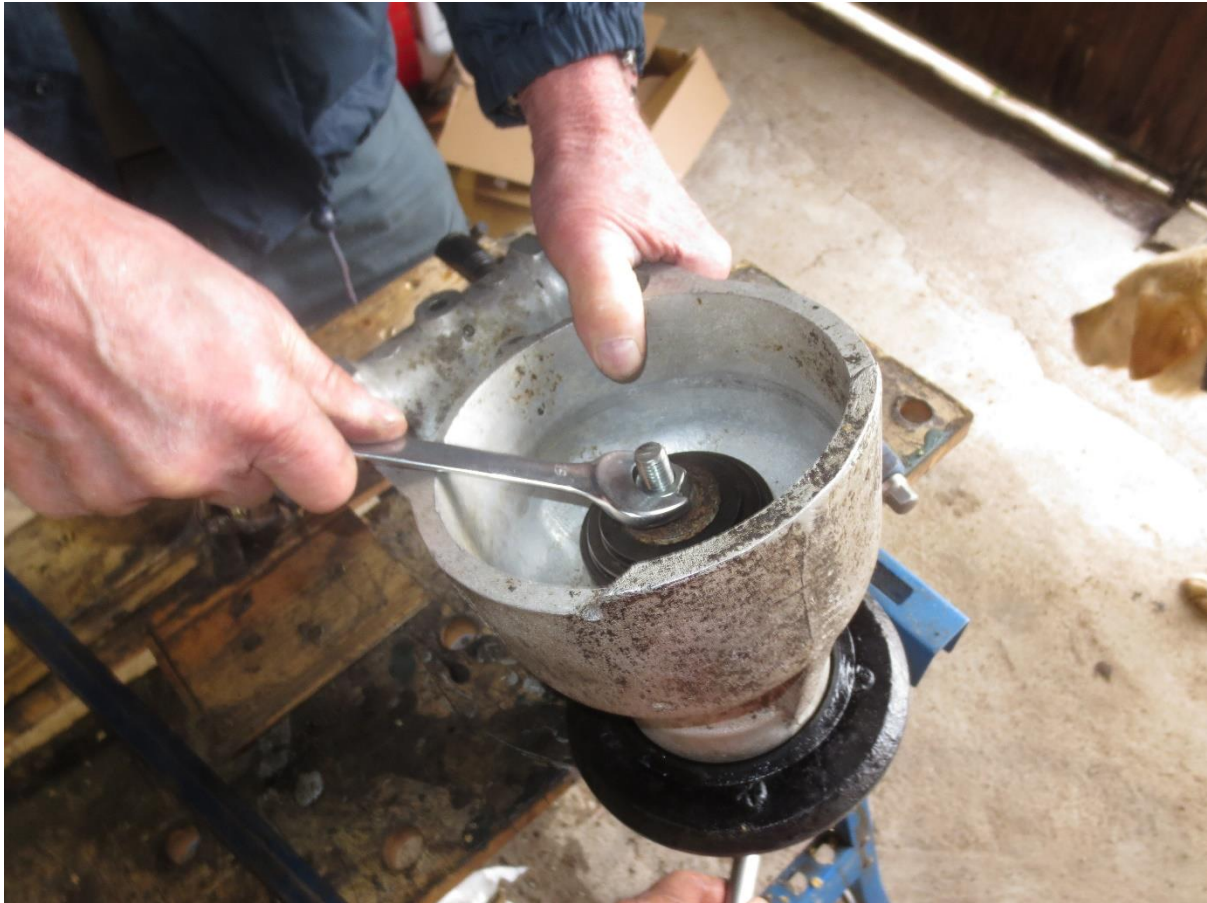
Photo 20: winding the inner bearing race over the hub tube.

Photo 20 shows the inner race being wound down over the hub tube. Again threaded rod and suitably sized drivers are needed.
