Rebuilding the XJS independent rear axle

Many owners, like me, are quite happy to replace front axle bearings and adjust them, but find the rear hubs and UJs in the driveshafts something of a mystery, and their replacement, rebuild and setup quite daunting. In my case, circumstances forced me to take some brave pills and get stuck in. Although my car is a 1985 V12 XJS coupe, this procedure will be the same for any model of Jaguar that has the inboard-braked independent rear axle.

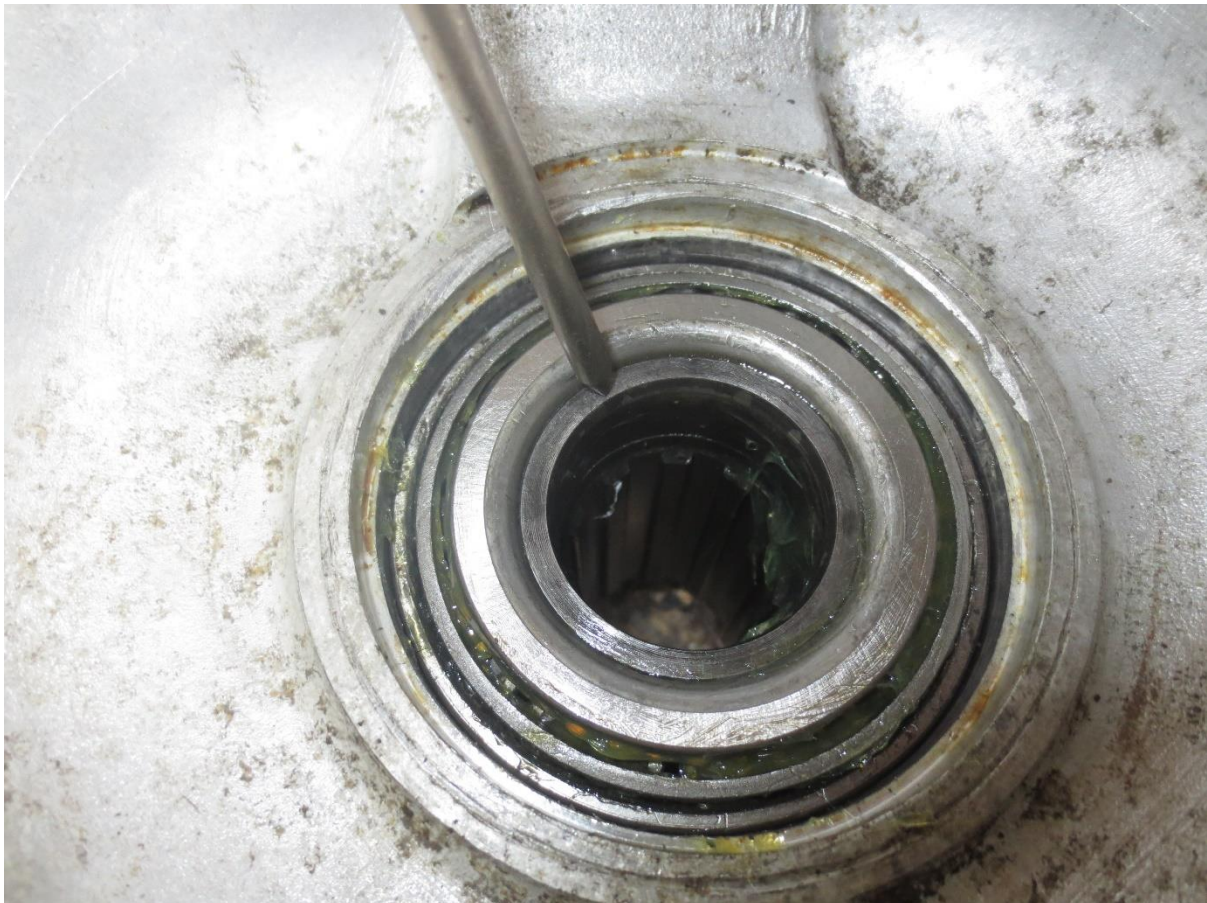
Photo 21: the pointer is on the hub tube which is below the level of the bearing race. Therefore, if the driveshaft was to be fitted with only the large silver spacer/oil seal track in place, when the outer castellated nut was done up to its specified torque, the large silver spacer would crush the inner bearing race into its outer, and the entire thing would be jammed tight and unable to rotate.

Now look at the following photo 21: the hub tube on which the pointer is placed is below the level of the bearing inner race:

Obviously, a second, small diameter spacer is required to fill the gap between the hub tube and the bearing, so when the outer nut is done up, the bearings are not crushed as the hub tube carries the torque through the spacers to the driveshaft machined flat, just below the yoke. The question is, how big a spacer? In photo 22 the pointer is on the bearing race.

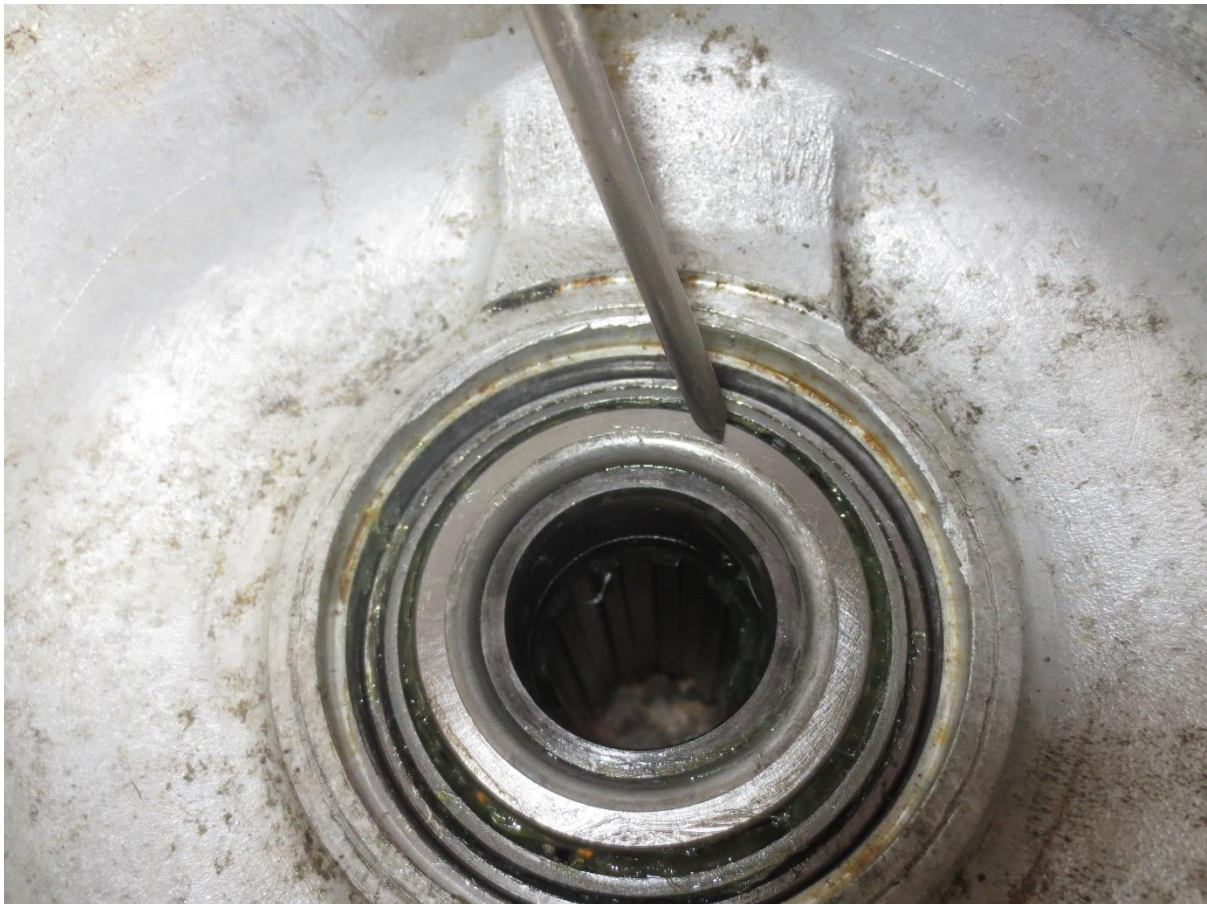
Photo 22: In this photo the pointer is on the bearing race, it is the difference between the height of the pointer in photos 21 and 22 that needs to be carefully measured and a spacer selected of this precise thickness plus 0.001 to 0.003 thou to give the endfloat Jaguar specifies.

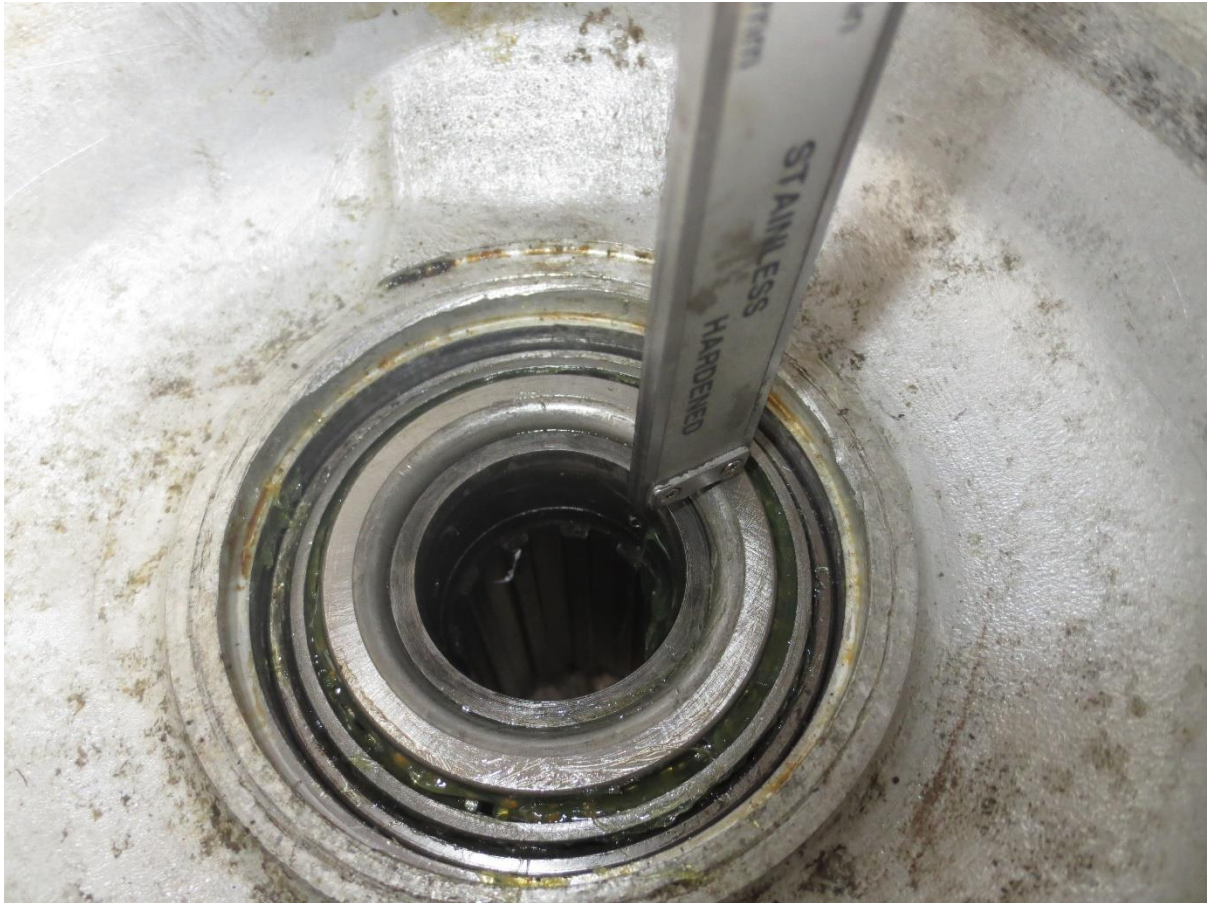
Photo 23: ensuring the bearing is properly seated, and taking three measurements at points around the circumference, the gap between the bearing and the hub tube is easily and accurately measured. In my case it came to 136 thou, so I needed a spacer of thickness 138 thou to be in the middle of the specified range. This would then give a bearing endfloat of 2 thou.

The easiest and most accurate way to measure this distance is by using an electronic micrometre as shown in photo 23.

These spacers in all the many required thicknesses were originally made of phosphor bronze and are still available from Jaguar Heritage Parts. Sadly, and in my view foolishly, Jaguar require customers to buy a minimum of 5 of any one size at a time, and they are not cheap! SNG Barratt sell steel ones singly. In my case I lucked into a huge motherlode of genuine factory ones, in almost all sizes, on Ebay for a very small outlay.

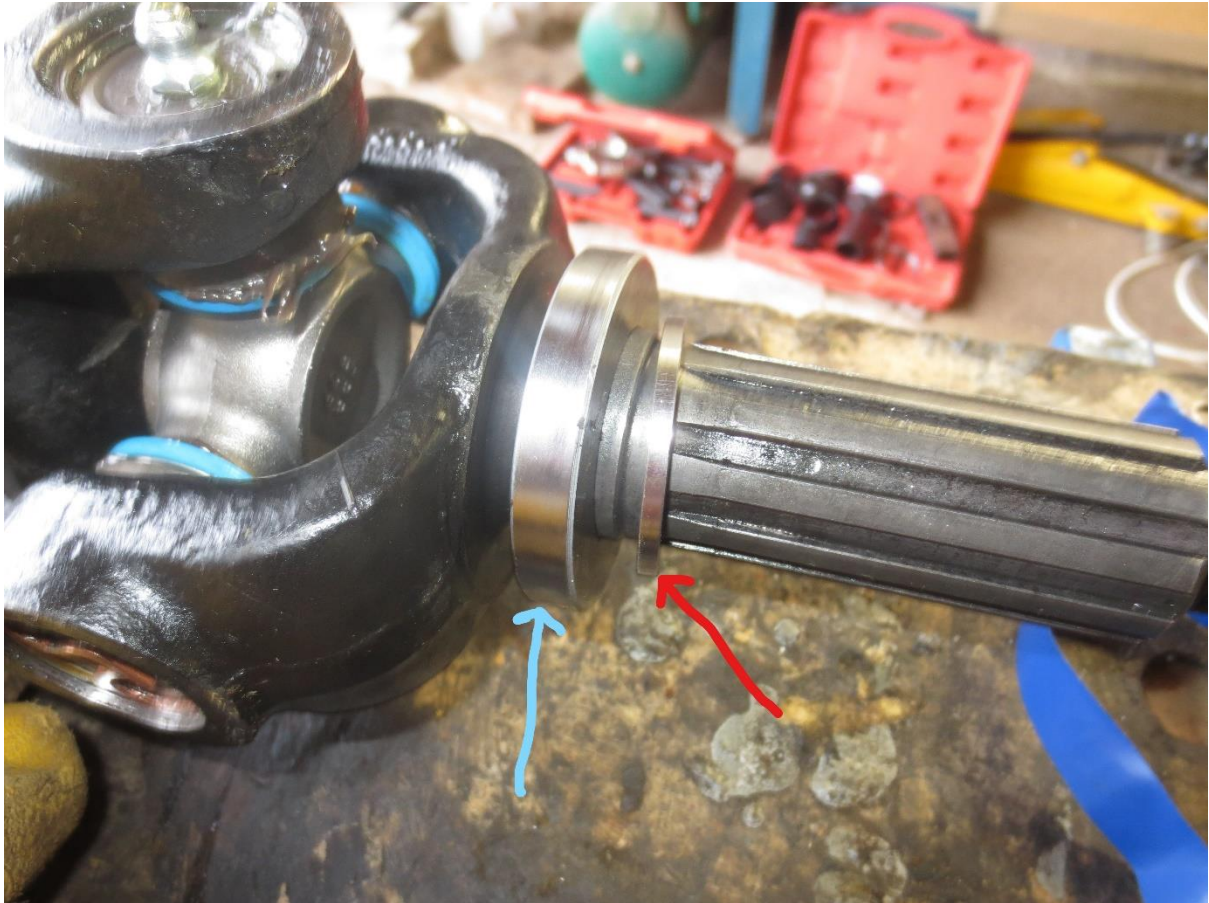
Photo 24: the blue arrow shows the speciality steel oil seal track, the red arrow shows the phosphor bronze spacer of the correct thickness. These two items MUST be in place before the driveshaft (suitably coated in nickelslip in my case) is slid into the female splines of the hub. If the hub bearings have not been changed, just re-use the original spacer and track.

The remaining assembly is very straightforward. First install the oil seal into the carrier on top of the inner bearing. Now look carefully at photo 24.

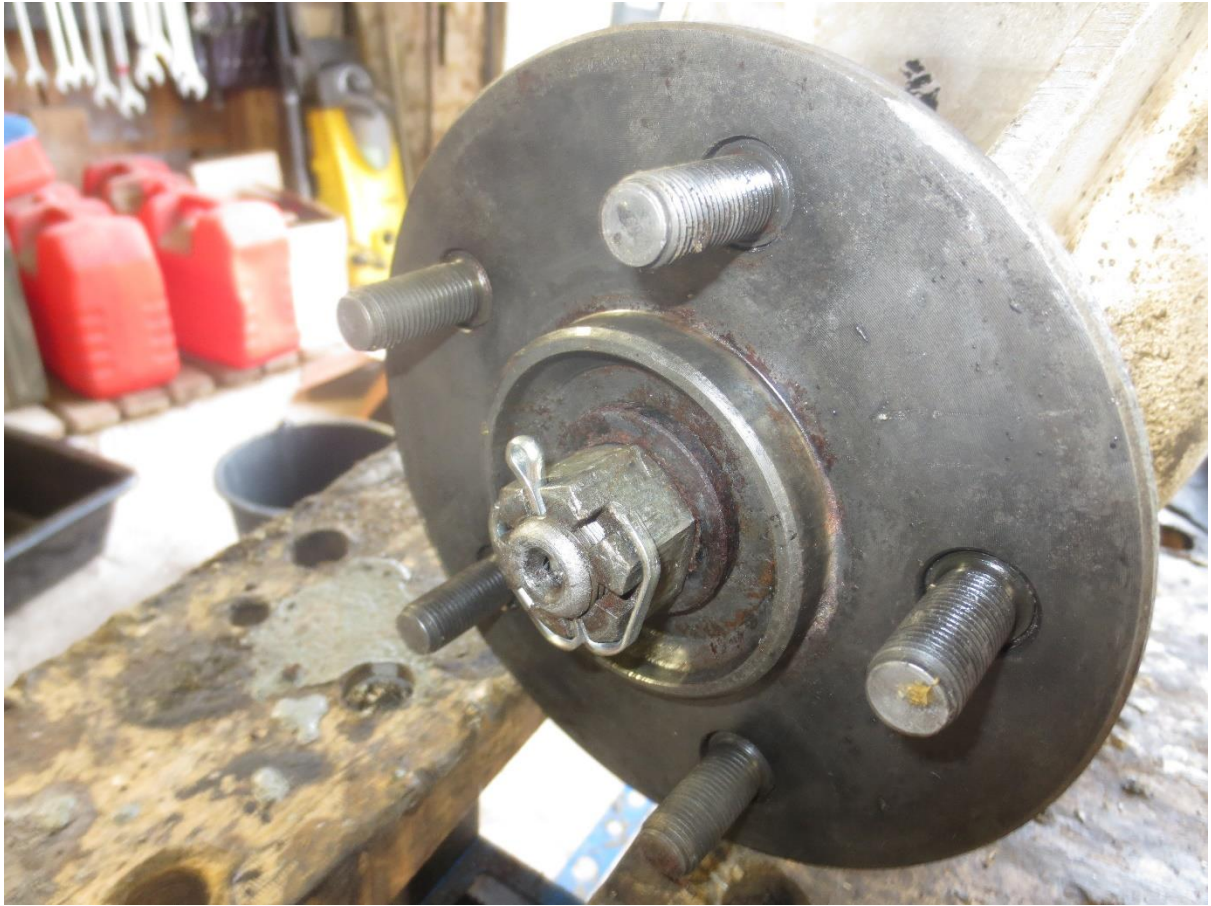
Photo 24: outer thick washer, nut and split pin fitted.

Now, finally, fit the thick washer to the end of the driveshaft poking through the centre of the hub by the wheel studs, and do up the outer hub nut to the specified torque of 120 ft/lbs and fit the split pin. Job done (apart from refitting it all to the car, that is!).
