2007 - Jaguar XKR

Fixing An Air Conditioning Condensation Leak Into Passenger Foot Well

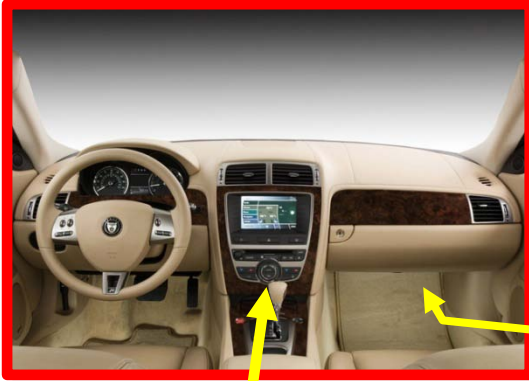
Water leaks from the Fan Motor that is located under the glove compartment

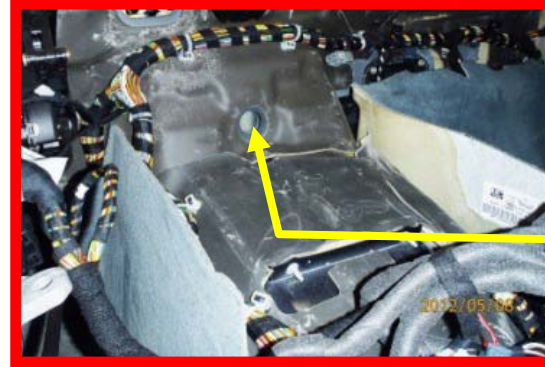
Drain Hole Through Firewall exits just above transmission housing

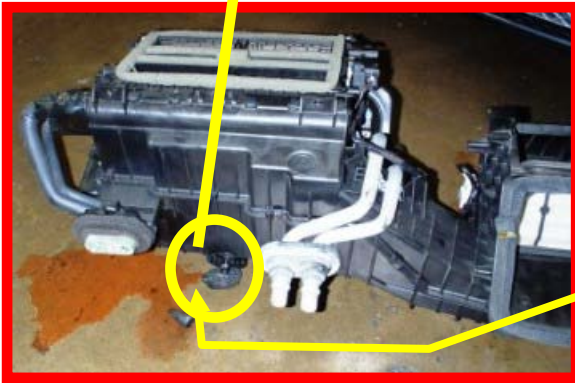
AC Unit - Drain (Duck Bill Hose) under the evaporator area which passes through the engine firewall just above the center of the transmission.

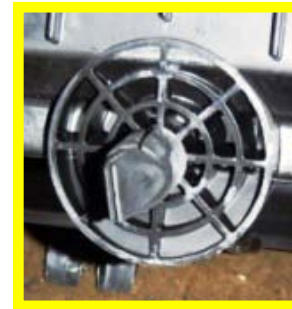
Duck bill Hose showing through the sealing material that seals between the AC Drain hole and the vehicle firewall.

Duck bill Hose with the sealing material removed. (Duck Bill Design to prevent insects coming into the car?)

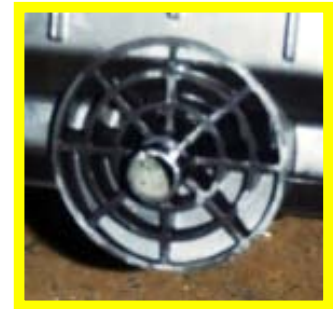
Drain Hole from Evaporator with the Duck Bill Hose and Sealing removed..

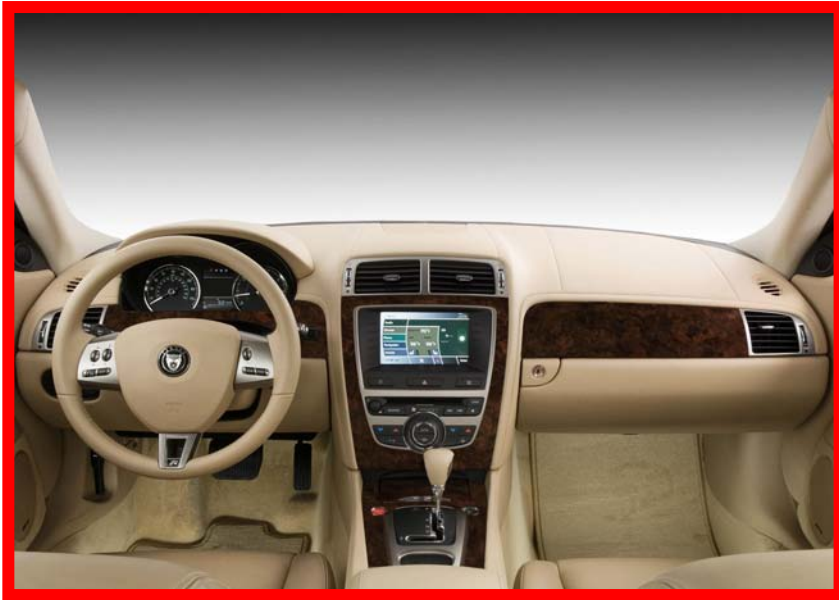
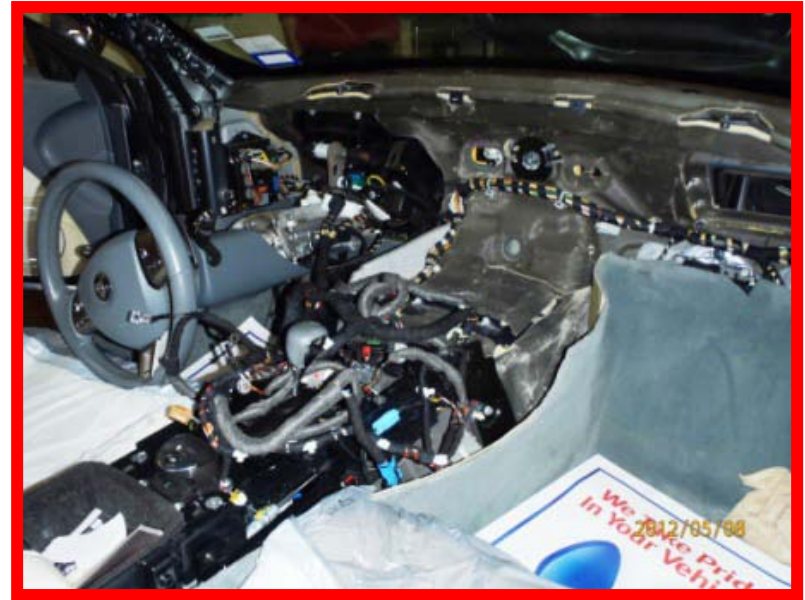
The car goes from a wonderful, luxurious presentation on the left to the truly heart stopping “oh my lord” on the right in order to replace the \$2 Duck Bill Hose that drains condensation water from the air conditioning unit.

- Do the straight replacement of the Duck Bill Hose – Seems rational but if the design is known to be flawed, perhaps it is worth doing something else?
- Cutting the Duck Bill seems to have worked for some, it does not require dash removal but the hose is very short and could result in water not exiting the vehicle.
- The Advice I got and went with was to replace the Duck Bill hose with a Fuel grade hose of the same diameter – it is heat resistant and should not block.

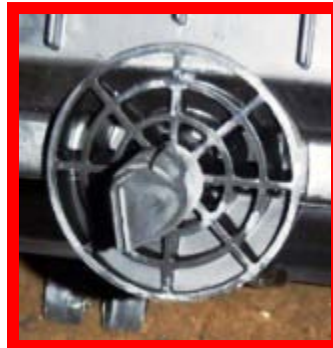
The fix was unsuccessful, probably because the water under the evaporator is almost in a “tank” environment when it is not draining so the amount of water that “sloshes” to the motor housing area is too much, too quick for the drain to handle.

An initial fix attempt was to put a drain on the low point of the motor housing – this is where excess water leaks to.
