## Vacuum Leaks and Injector rebuild on 07 x150 base:

I finally resolved the rest of the vacuum leaks (“VL’s”), some of which were documented in another thread. This is meant to be a summary of repairs for those searching for this continuing problem on early year X150s. Of course, mine is base, but most of this applies to any 4.2.

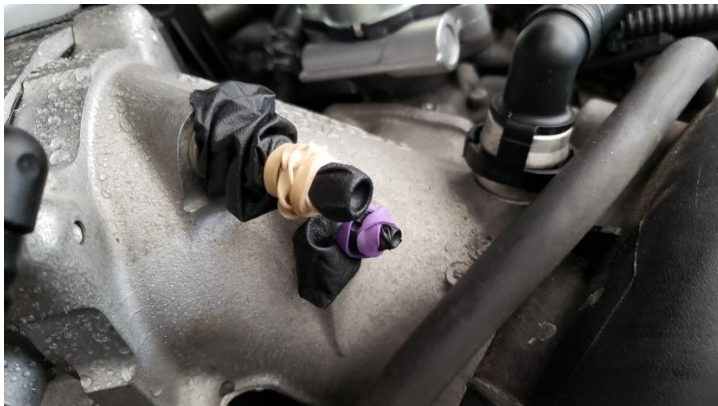
Vacuum Leak Isolation:

Live testing isolated vacuum systems. Covered, engine running. Set baseline, plugged in each, recorded changes

Upper left is evap system. No leaks.

Next, to right, is vacuum to AIR system. Vacuum line rotted, replaced. Caused about 5% of LTFT failure.

- Blocked off the vacuum ports on the TB, one to the AIR system switch, the other to the Purge Valve and on to the fuel vapor system. Pic below. Tested each with then engine running. The AIR vacuum line, a weird thin hose set that crumbled at a touch, dropped the LTFT from 18% down to 13% when I blocked it off. So, replaced the line. Note -- there are at least two types of this vacuum line. Get the one that has four port connectors on it. The other vacuum port to the purge valve tested fine.

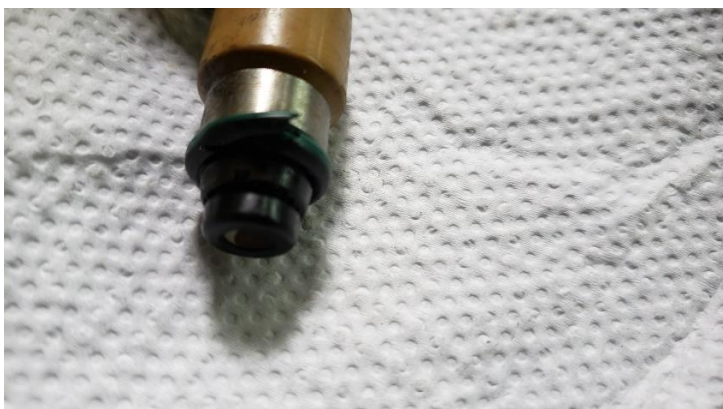
Injector Damage:

- There's a pic of the injector below. Looks like the last tech didn't use a very thin wipe of silicone grease when installing the injector and tore the lower oring. (Note: there is a debate on silicone grease vs. O2 sensors. Some use a dab of oil if they are concerned. But use some lube.) Previous owner spent big bucks at his Jag dealer chasing the P0174 caused by this oring. It was missed by his Jag techs, but they did take the opportunity to replace his fuel pump, fuel filter and two injectors.

Damaged lower oring from poor installation. Major cause of Vacuum Leak. Caused the rest of the LTFT error coding.

- As good smoke pressure increased, I got a blast of it out of the middle injector on Bank 2. So, I bought an injector rebuild kit, not expensive. Make sure the lower injector oring is Vitron, though both the upper and lower can be. Used the service manual to pull the fuel rail and replaced all the injector orings and intake filters. About 2 hours. Did all of them, since I had to pull the fuel rail anyway for the one.

- OK, injectors. The rebuild is simple. First, do one at a time from removal from rail to reinsertion. Two orings, the base cap and the internal filter. Spray out and backflush with throttle body cleaner or carb cleaner. Rebuild vids are out there. Note I could not ultrasonically clean or test the injectors due to circumstances, but I will sched that for another day. Worked fine when installed. If you can remove them for a couple of days, have them fully cleaned before you rebuild them. Here in South Florida, basic testing, cleaning and rebuild are about \$25 for each injector. The internal filters were rotted away in many of the injectors, so be prepared to replace them. I suspect most injector replacements could be solved with a rebuild.

- I cleaned out the injector sockets with paper towels soaked in carb cleaner. Plenty of crud in the sockets. Quick thin wipe of silicone grease on the various orings, then reinsert in fuel rail. Injector mount clip in place. When complete, insert fuel rails in injector sockets. With clean sockets and greased rings, everything should slide easily in place. Torque the rail, since that and the injector clips are all that's holding everything in. Very easy.
