© D. Jensen 2006	<b>REPLACEMENT OF V8 SECONDARY TIMING CHAIN TENSIONERS</b>	V. 1.0 June 2006
Distribution: <a href="http://www.jag-lovers.com">www.jag-lovers.com</a>

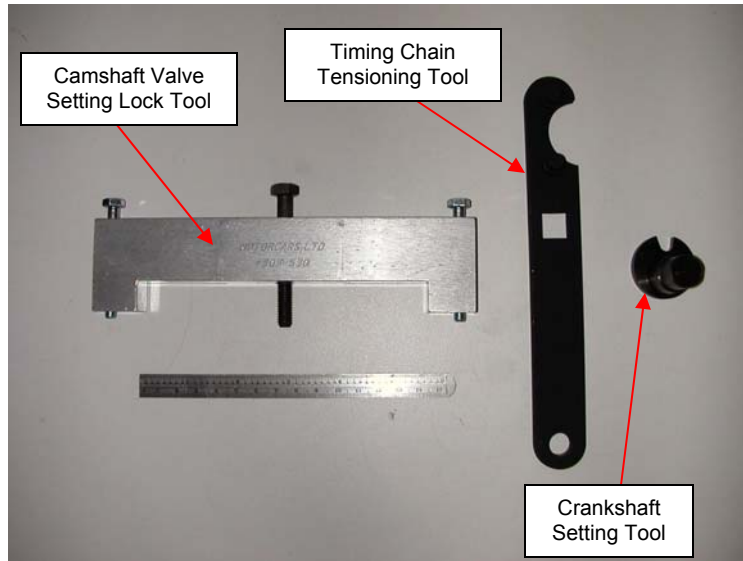
Fig. 1 Special tools

The most important tool, in my judgment, is the Camshaft Valve Setting Lock Tool (\$125; see Fig. 1) (the 6-in. ruler is there to show scale only). I was not convinced that a homemade tool that I could make would preclude the cams from rotating as the sprockets were retorqued following tensioner replacement. I believe this is important since the V8 camshafts and sprockets are not splined as they are on earlier Jag engines. The Jag tool really locks the cams in place, with no uncertainty as to their alignment. Note that I did not buy two locking tools since I was replacing the tensioners one side at a time and thus did not need to lock both sides simultaneously.

I also bought the Timing Chain Tensioning Tool (\$75) and the Crankshaft Setting Tool (\$50). While I was pretty certain I could fabricate a tool like the tensioning tool as others have done, in the end I decided for \$75 to just save myself one or more trips to Home Depot and the time to fiddle with getting it right. Note the square opening in the handle for a 1/2-in. breaker bar used to provide counterforce during freeing and retorquing of the sprocket-to-camshaft bolt.

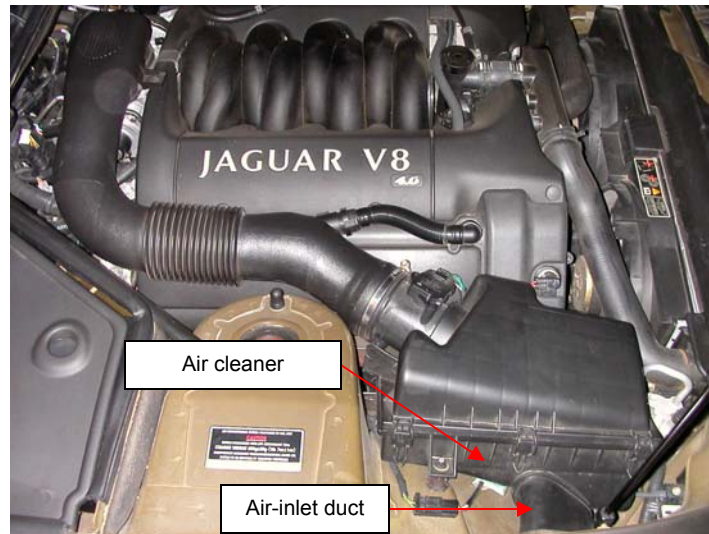
Fig. 3 Right-side view of engine bay with air filter and intake tube in place

Figure 3 shows the right-hand side of the engine compartment before the start of disassembly. The arrangement of the air filter and duct seems very similar to that of the X308 XJ8 and was removed easily in accord with the instructions. I found that a long screwdriver was helpful in disconnecting the two inboard clips helping hold the air-cleaner cover in place. As may be apparent from Figs. 3 and 4, it was also necessary to remove the air-cleaner housing in its entirety to provide access when working on this side of the engine. A helpful hint is that the air-inlet duct can be loosened from and pushed into the air-cleaner housing by squeezing two tabs on the duct. This simplifies removal of the housing.
