TECHNICAL BULLETIN

JAGUAR SERVICE	Recall T493 - 1995 MY/Recall R493 - 1996 MY – AJ16 EGR System – Replace PROMs and EGR Valve	17-12 Amended 08/02
	MODEL 1995-96 MY XJS 4.0L VIN 194775-226645	DATE 11/01

ISSUE:

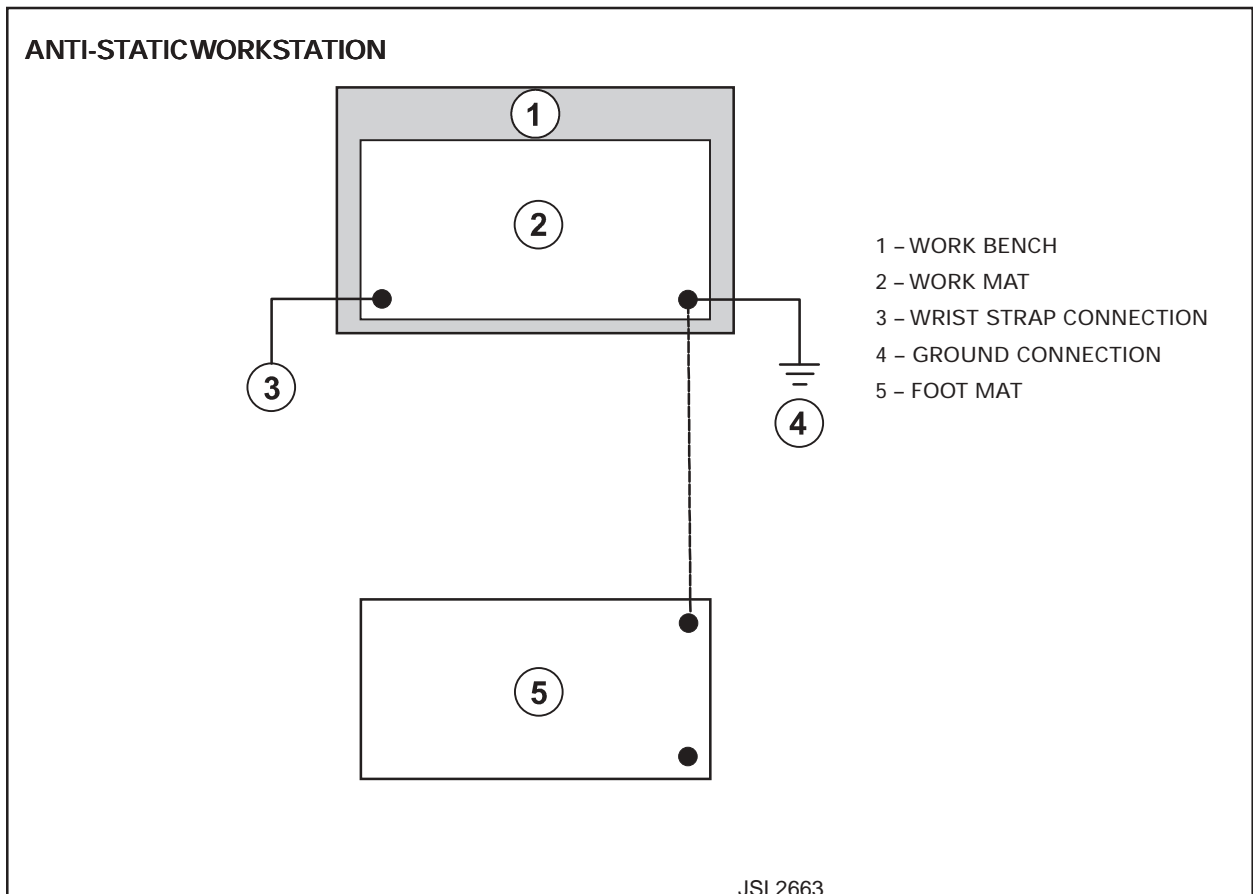
ILLUSTRATION 1

⚠ Caution: Perform the following operations at an antistatic workstation (previously supplied) while wearing a grounding wrist-strap (Illustration 1). Additional work mats can be sourced locally, such as Radio Shack cat. no. 910-3780.
