Repairing an XJS instrument cluster

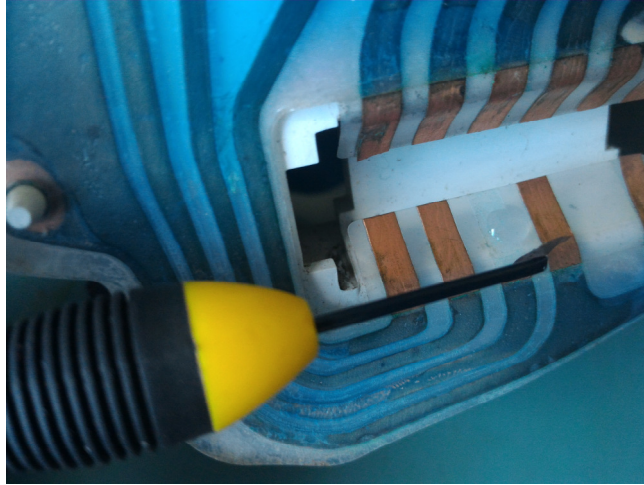
A problem I came across was a broken trace on the top RH (looking from the front) Globe. I repaired this using a bit of solder wick. This is a repair I did 5 years ago and it's still going strong. You could also solder a couple of bits of wire, as long as it touches the globe carrier it should work. Any damaged traces can be repaired with wire as long as it is insulated.

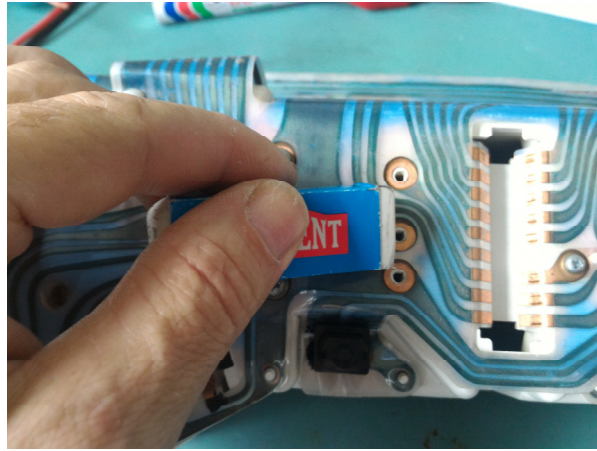
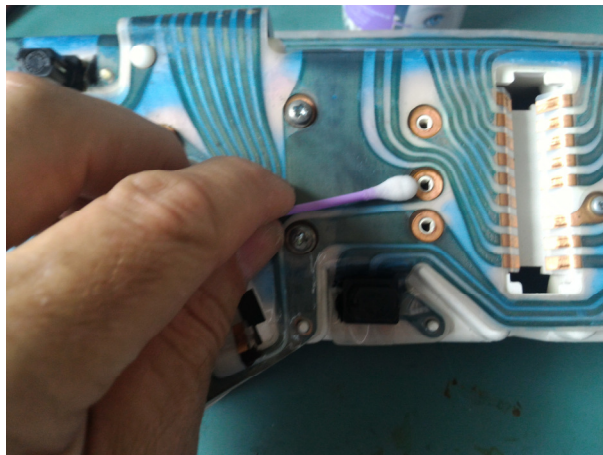
All of the gauges are held in by screws which touch the trace and copper PCB of the gauge. The photo below is the oil pressure gauge with the screw removed you can see the light and a couple of marks where the screw touches the gauge PCB, not a good design IMHO.

Remove all of the screws (you can do this one at a time) and clean the trace with a pencil eraser if they are very dirty, then run over them with Isopropyl Alcohol on a cotton bud. If they look clean then you can skip the eraser and just clean with IPA and cotton bud.
