MODEL
2007 XK

NUMBER
XK100-001

TECHNICAL BULLETIN

New PDI Instructions to Activate Passive System

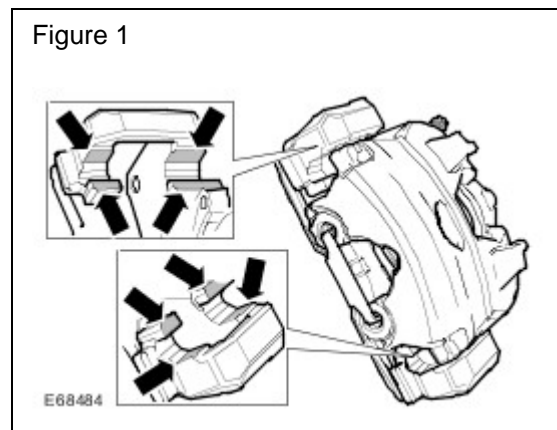
Cause: Front brake caliper to brake pad anchor interface.

1. Refer to Global Technical Reference (GTR) Workshop Manual section 206-03, operation 70.40.02 and remove front brake pads.
2. Clean the brake pad anchor surfaces of the caliper carrier. (Arrowed in Figure 1)
3. Grease the brake pad anchor surfaces of the caliper carrier. (Arrowed in Figure 1)
4. Refer to GTR section 206-03, operation 70.40.02 and install front brake pads.
5. Repeat steps 1-4 on the opposite side front brake caliper carrier.

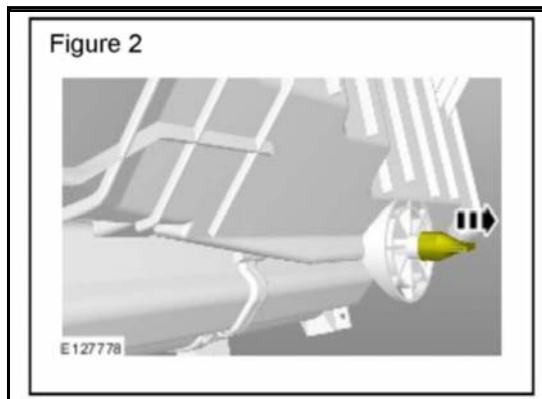
Care should be taken to ensure no further damage is caused to the vehicle interior. When removing a Heating Ventilation Air Conditioning (HVAC) unit which has shown signs of leaking from the blower motor, approximately one (1) liter of water will remain in the unit which will drain out when the seal to the bu khead is broken.

3. Remove and discard the drain tube from the rear of the heater unit. (Figure 2)
