MODEL
2007 XK

TECHNICAL BULLETIN

New PDI Instructions to Activate Passive System

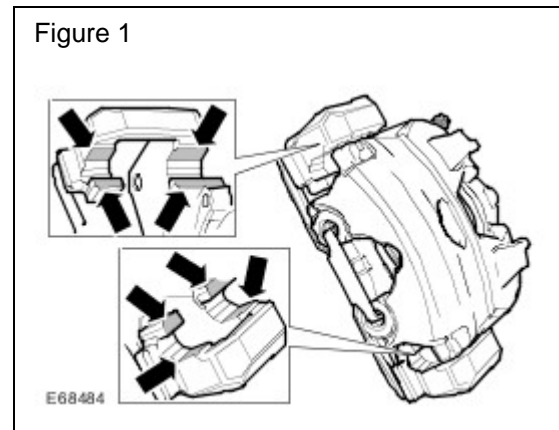
Cause: Front brake caliper to brake pad anchor interface.

1. Refer to Global Technical Reference (GTR) Workshop Manual section 206-03, operation 70.40.02 and remove front brake pads.
2. Clean the brake pad anchor surfaces of the caliper carrier. (Arrowed in Figure 1)
3. Grease the brake pad anchor surfaces of the caliper carrier. (Arrowed in Figure 1)
4. Refer to GTR section 206-03, operation 70.40.02 and install front brake pads.
5. Repeat steps 1-4 on the opposite side front brake caliper carrier.

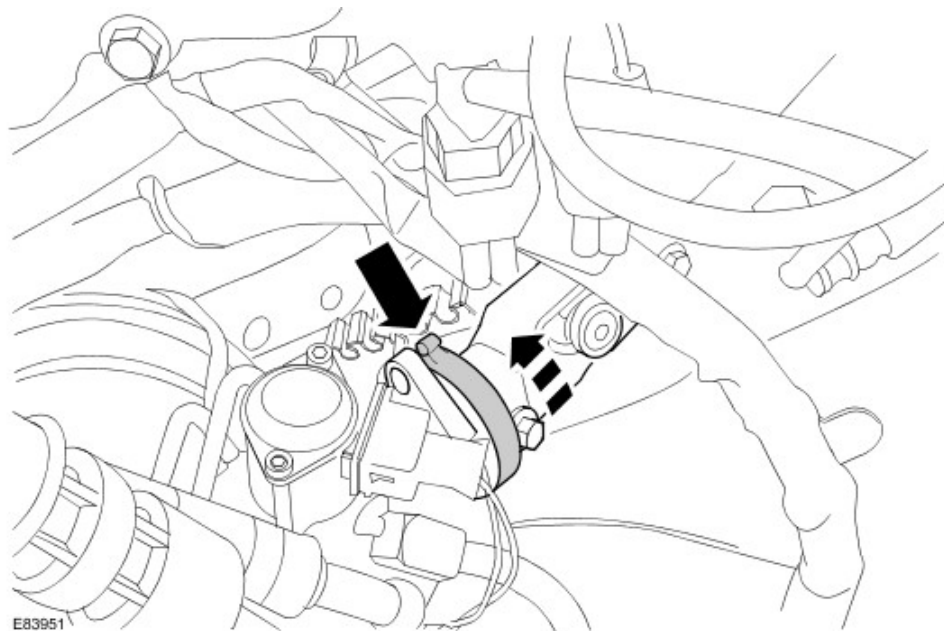
Summary:
This bulletin is to provide diagnostic clarification for steering wheel alignment during the pre-delivery inspection road test, or a customer complaint with the vehicle in low time service, with no impact damage.
This bulletin has been re-issued to update the causal part number.
The Service Instruction detailed below provides information to prevent unnecessary adjustments of the steering wheel alignment.

- 1 . Raise the vehicle on a suitable lift.
- 2 . Remove the vehicle undertray
- 3 . With assistance, rotate the steering wheel to align the steering column to the boss on the steering rack pinion housing.

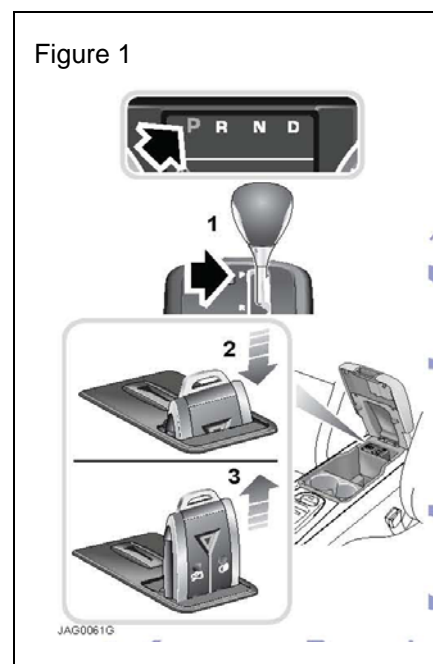
**NOTE:** After turning the ignition "off" a motor will drive the Smart Key to the ejected position, allowing removal. If the Smart Key does not automatically eject after turning the ignition "off", the following procedure must be followed to eject and safely remove the Smart Key.

1. Ensure the engine has stopped.
2. Ensure the transmission is in the Park position.
(1 in Figure 1)
3. Slide the Smart Key docking station cover to the open position and hold open.
4. Wait 60 seconds.
5. Press downward on the Smart Key and release.
(2 in Figure 1)
6. Observe the key self-eject half way.
(3 in Figure 1)
7. Manually remove the Smart Key from the docking station.

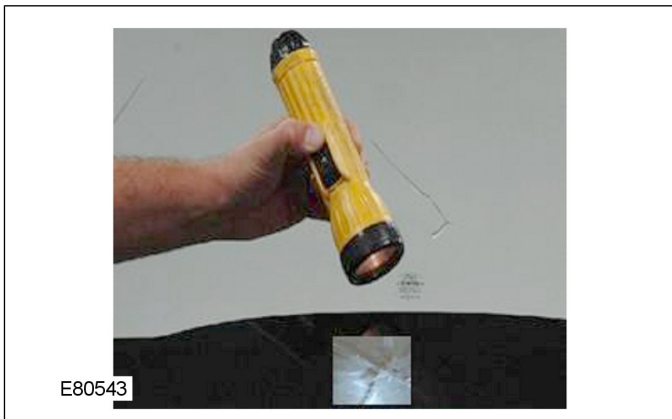
7. Flashlight test.

Examples of Damaged Windshields Caused by Stone Impact

8. View from outside using flashlight (radial cracks).
Several radial cracks emanate from origin point.
