© D. Jensen 2006	REPLACEMENT OF XK8 CONVERTIBLE REAR WINDOW REGULATOR	V. 1.0 September 2006
Distribution: www.jag-lovers.com

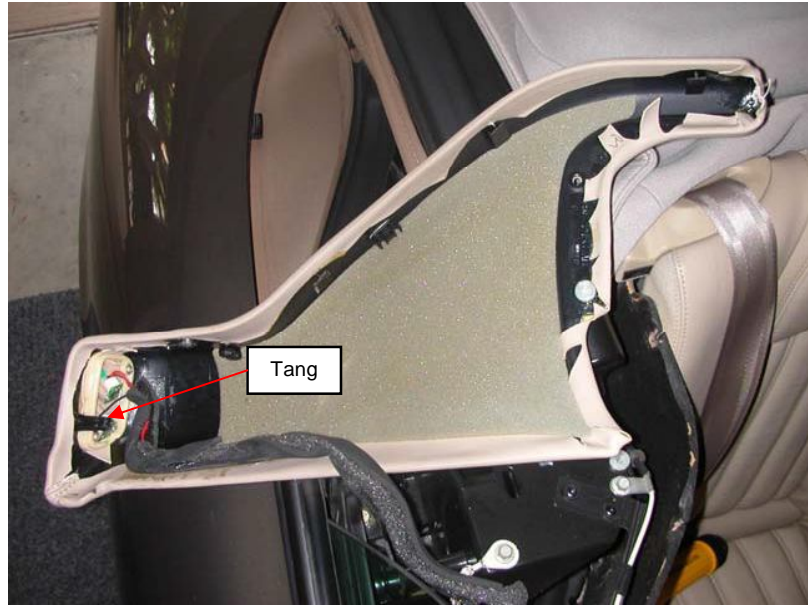
Fig. 4 Underside of rear quarter capping showing tang

2. Remove (a) the screw covered by the seat belt bracket, (b) the screw on the rear of capping, and (c) the 9-mm tonneau-cover fastener. Lift the capping off and disconnect the lead to the airbag passenger sensor, if your car has one. Note that there was a tang on my capping that keeps its front edge in place (see Fig. 4). I didn't realize this when I removed the capping, but fortunately I didn't break it off during removal. It was a bit tricky to reinstall the capping later due to the need to ensure the tang was positioned in its hole in the B post. Earlier XK8s have a screw where the passenger position sensor is located and thus may not have the tang.

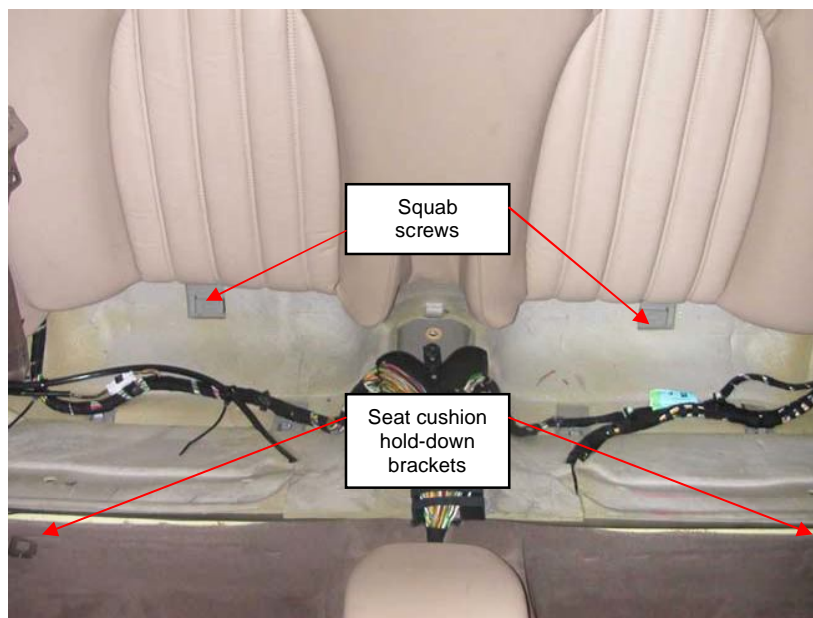
Fig. 5 Squab following removal of cushion

3. Remove the rear seat cushion (Sec. 76.70.37) and squab (seat back) (76.70.38). These steps are straight forward, as described in the manual. The seat is held in place by two 10-mm nuts with integral washers covered by plastic caps. The squab is held in place by two screws (see Fig. 5).

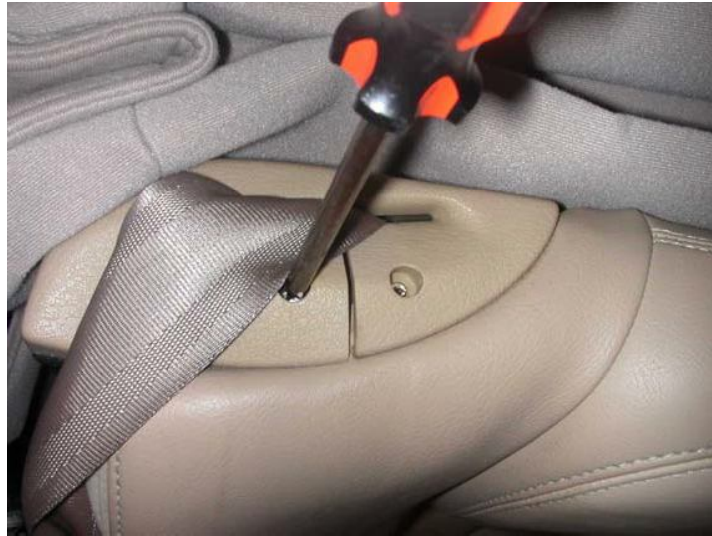
Fig. 6 Seat belt guide on seat back

4. Remove the seat belt guide at the top of the squab (Fig. 6) and lift the squab up and out (Fig. 7).

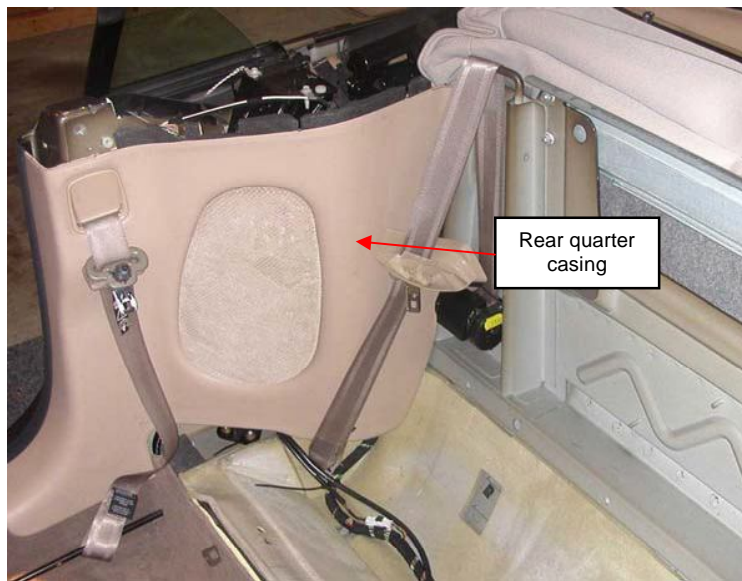
Fig. 7 Rear seat area with squab removed

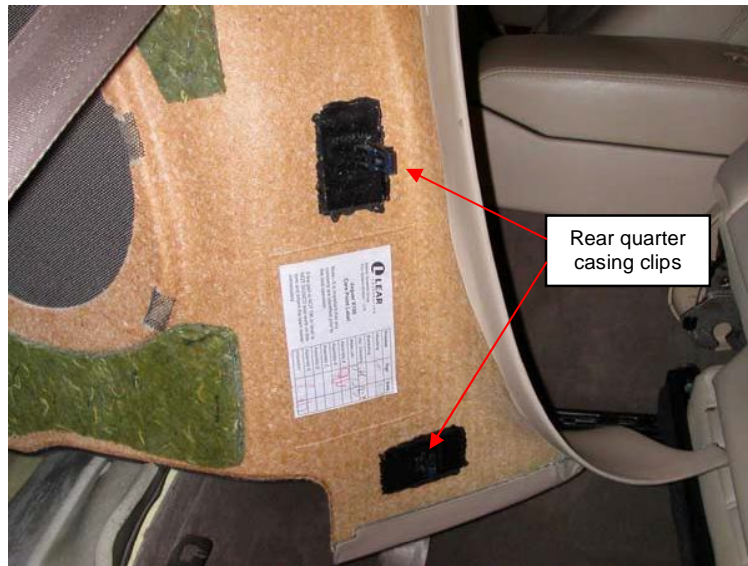
Fig. 8 Clips on front edge of rear quarter casing

5. Remove the rear quarter casing by freeing the two clips at the front edge (see Fig. 8) and pulling the casing forward along with the rear tang located in a positioning hole in the body. Position the casing toward the center of the car and out of the way (see Fig. 9). As noted earlier, it is not necessary to remove the seat belt that passes through it.

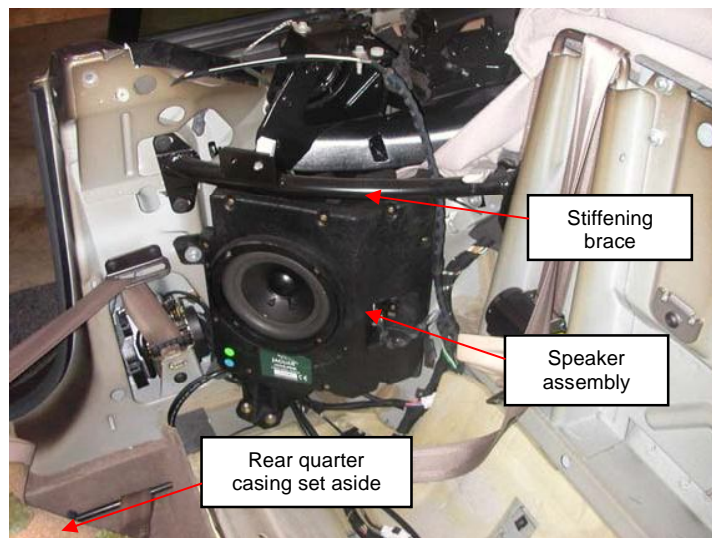
Fig. 9 Rear quarter with casing removed

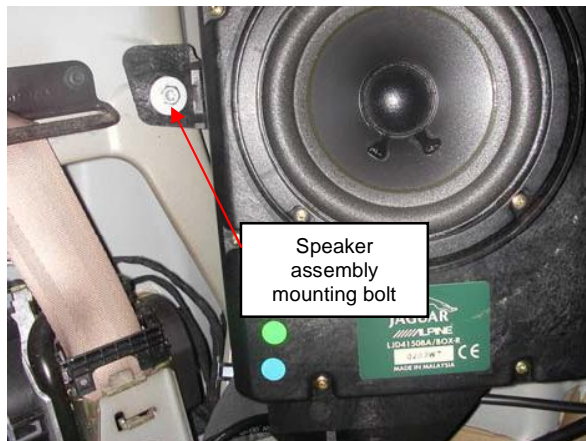
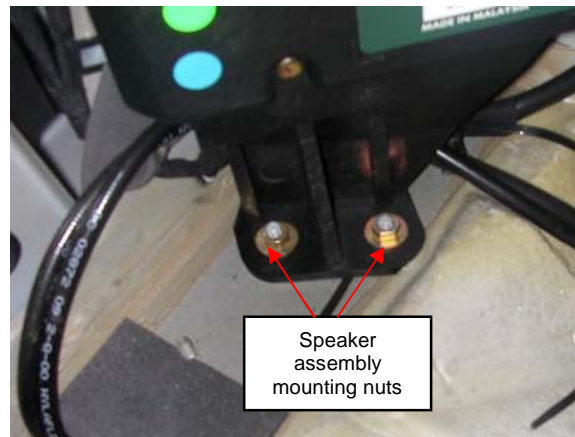
Figs. 11a and 11b Rear speaker mounting points

7. Disconnect the rear speaker harness multiplug (one vs. two described in the instructions) (Sec. 86.50.12). Remove the two 10-mm bolts and two 10-mm nuts holding the rear speaker assembly in place (see Figs. 11a and 11b) and remove the assembly.

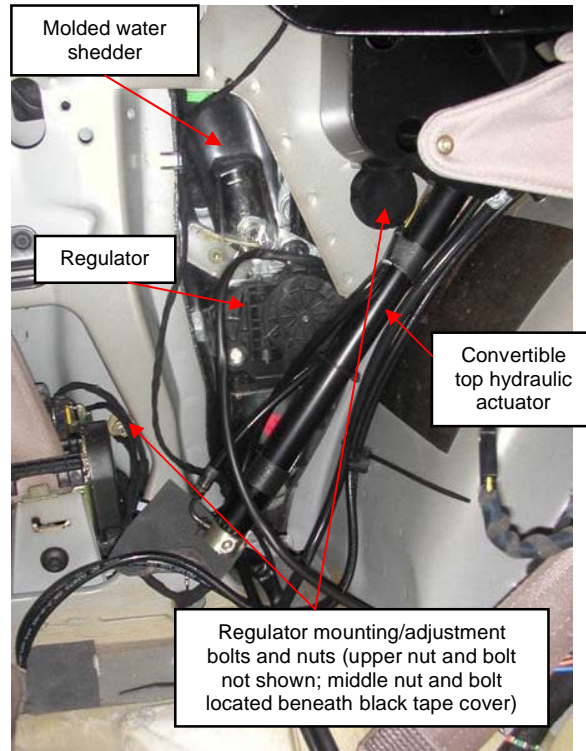
8. Note the location of (a) the window regulator, visible through the opening in the body and the clear, molded-plastic water shedder (see Fig. 12), and (b) the three adjusters/nuts. The lower nut/washer is held in place by silicone seal to ease installation (a big help). Remove the black, circular tape cover to gain access to the middle adjuster/nut. The top adjuster/nut is accessible as is. Note that the convertible top hydraulic actuator sits on a boss (not visible in photo) at about the midpoint of the actuator. It is not held in place by a fastener. Be sure to reposition it on the boss during reassembly.

Fig. 12 Regulator as mounted

14. Remove the upper and middle nuts holding the regulator in place and undo the lower nut (it will remain in place because the attached washer is held to the body by silicone sealer) (Sec. 86.25.11, Steps 12 and 13) (see Fig. 12 above). Route the feed link and multiplug connector through the water shedder. Once loose, push the regulator outward to free the adjustment bolts from their holes. As I inferred from the Jag instructions re removal of the top, I could not remove the window/regulator due to interference between the regulator motor and the convertible top bracket (see Fig. 19).

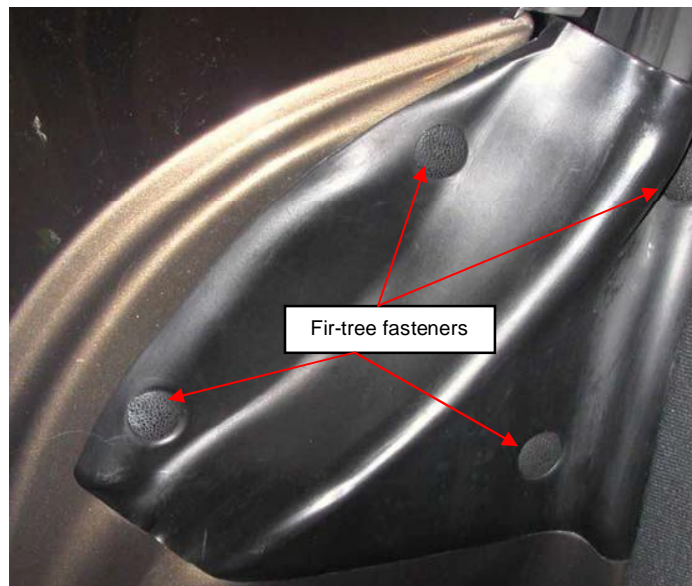
Fig. 13 Fir tree fasteners at front of window inner seal

9. Remove (a) the window inner seal by extracting the four “fir tree” fasteners on the front of the seal (Sec. 76.40.33) (see Fig. 13) using a flat-bladed screwdriver and (b) the screw securing the rear of the seal (see Fig. 14, which also shows the convertible top mounting bracket). Then remove the two 8-mm bolts holding the inner seal carrier in place (Sec. 86.25.11) (not shown).

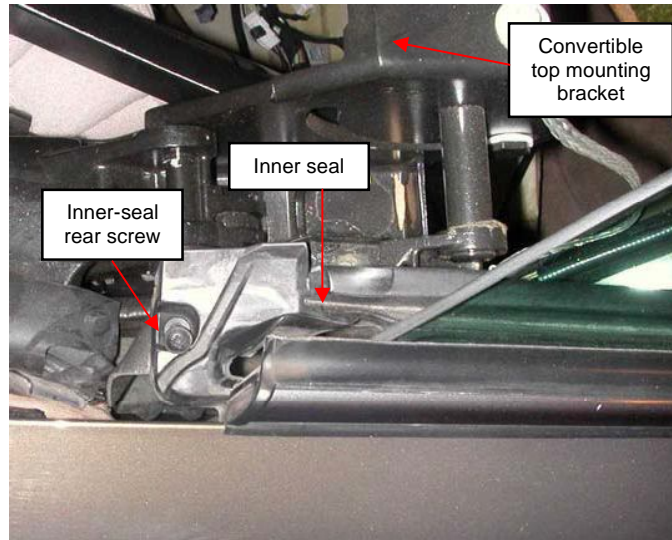
Fig. 14 Window inner seal and convertible top mounting bracket

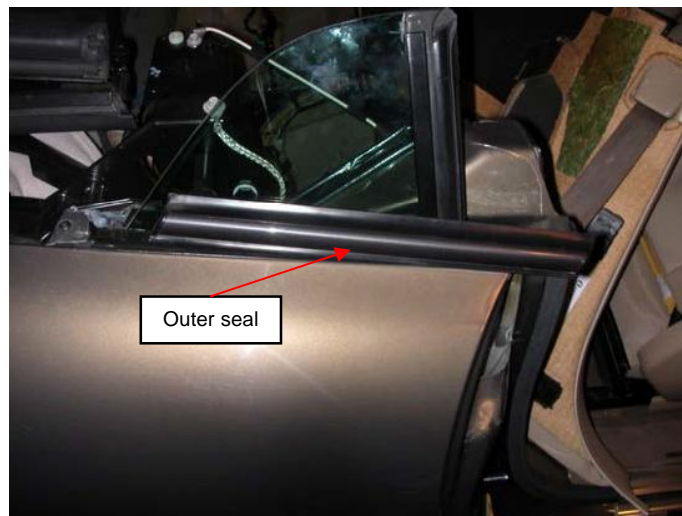
Fig. 15 Window outer seal

10. Remove the outer seal by pulling up (see Fig. 15). I did not need to use a knife as called for in the manual.

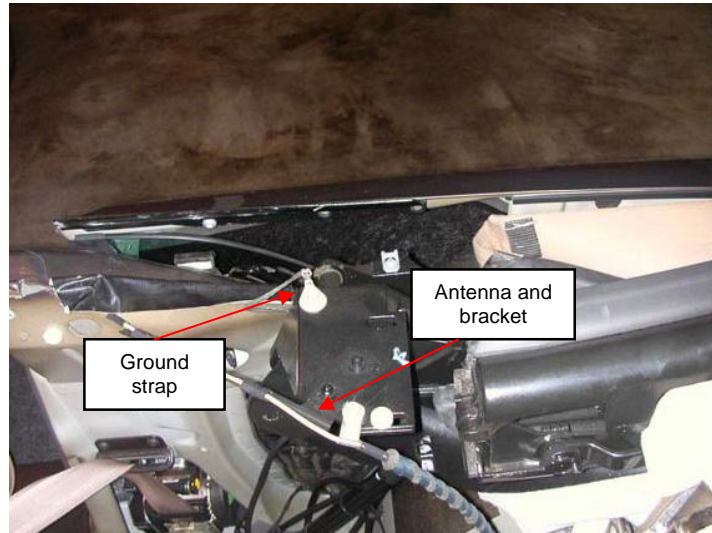
Fig. 16 Alarm antenna, support bracket and ground strap

12. Remove the alarm antenna and bracket (Sec. 76.86.15, Steps 12 and 13) (see Fig. 16). While not strictly necessary, these both appear to be fragile items that are best moved out of the way. I also removed the ground strap as well.

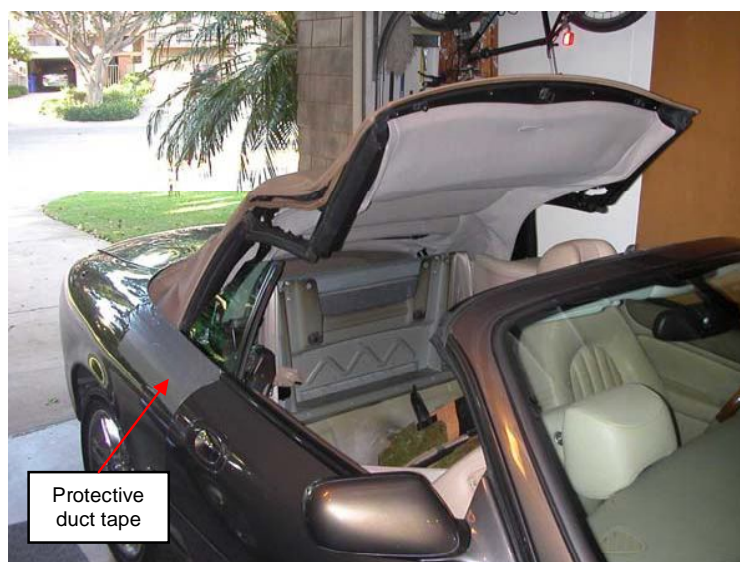
Fig. 17 Roof partially closed to allow access to top bracket cover and mounting bolts

13. Apply several layers of duct tape or similar protective material to the fender surface to prevent possible scratches (see Fig. 17). Disconnect the battery negative ground strap, loosen the top of the trunk right-hand liner, and turn the convertible top hydraulic pump valve fully counter clockwise (Sec. 76.86.15, Steps 15 and 16). Manually raise the top to a partially closed position. This provides improved access to the convertible top mounting-bracket cover-plate screws, bracket (see Fig. 14 above), and bracket mounting bolts (see Fig. 18).

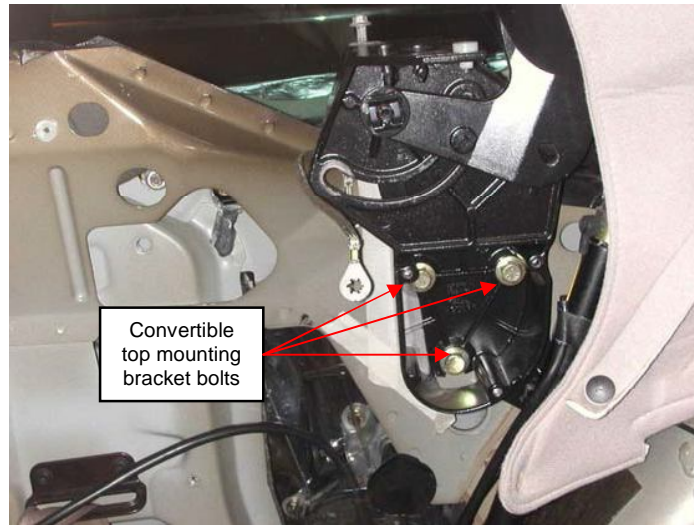
Fig. 18 Convertible top mounting-bracket bolts

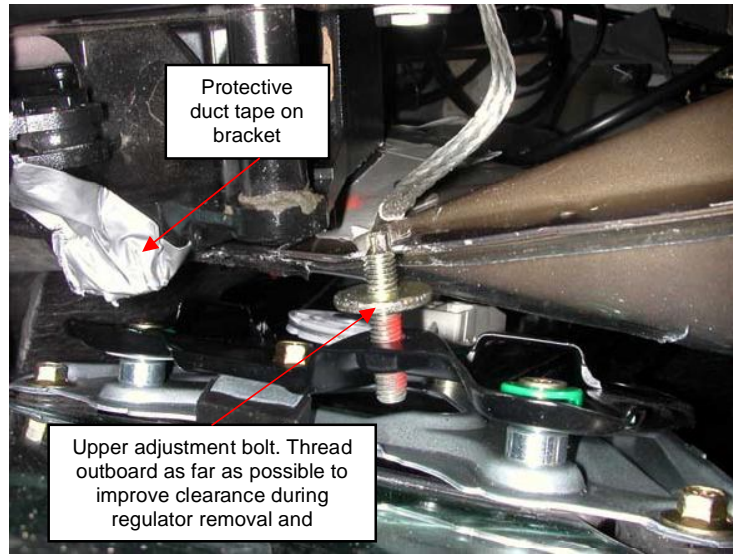
15. Thread the upper adjuster bolt fully outboard (see Fig. 19). This eases removal in the regulator in the limited space available. The small piece of protective duct tape in Fig. 20 sits on the protruding portion of the convertible top bracket that causes the interference if the bracket is not first loosened and pushed inward.

Fig. 20 Close up of upper adjuster bolt

16. The next step is the real time saver. Remove the three bolts holding the convertible top bracket in place. Then push the bracket inward enough to provide clearance for the window/regulator assembly. As you might imagine, I breathed a large sigh of relief when the assembly came up and out.
17. Upon examination, the cause of the failure was evident (see Fig. 21). The plastic slide that secures both ends of the drive cable had split, allowing one end of the cable to come free (accounting for the loud “pop” since the cable is very tightly wound) and preventing further movement. Note that the slide is of two-piece construction plus pivot (not evident in the photo) and has fairly complex internal features that could be replicated, but not easily.
