<u>Centre Console Button Sticking - Jaguar XJ 2011</u>

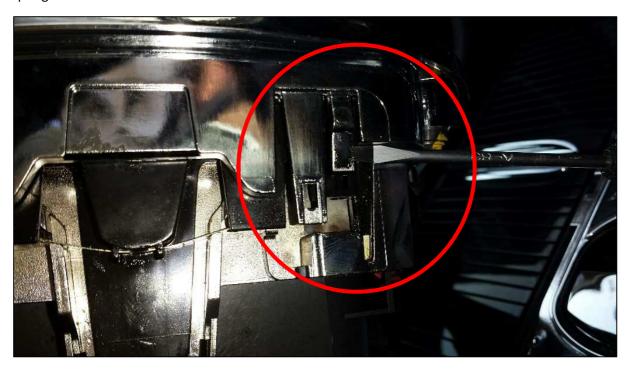
Open the console lid then using a trim tool start from the back where the button is and work your way forward, carefully working the trim loose.

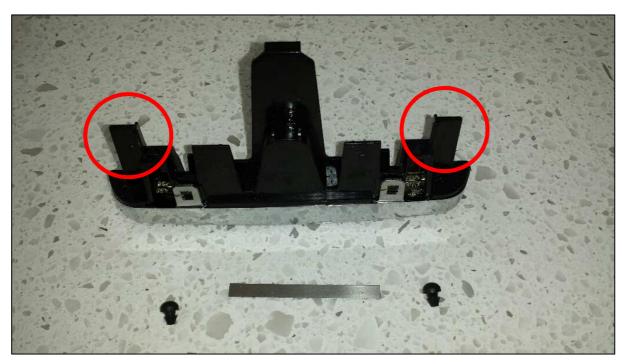
You will now see why the button sticks. Look at the grease/oil. This needs to be cleaned up. I used earbuds, rags, paint brush and white spirit.

Once the button is out you will see clearly the build up of oil/grease in the trim.

To get the button out of the trim you need to use a flat screw driver to lift the tabs gently either side and then push the button out. There are 2 rubber stoppers that fall out easily as well as the flat spring.

Using the white spirit and a paintbrush I cleaned out the grease. I also wrapped a cloth around a flat screwdriver to get into the groove.
