TECHNICAL BULLETIN

415-00

Buzzing Sound From Tweeter Speaker

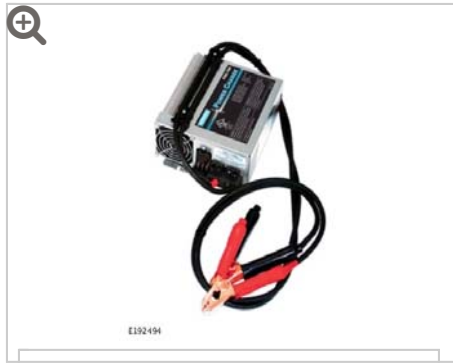
Jaguar Land Rover-approved Midtronics battery power supply

- A Jaguar Land Rover-approved Midtronics battery power supply must be connected to the vehicle battery during diagnosis / module programming.
- Make sure all ignition ON/OFF requests are carried out; failure to perform these steps may cause damage to control modules in the vehicle.

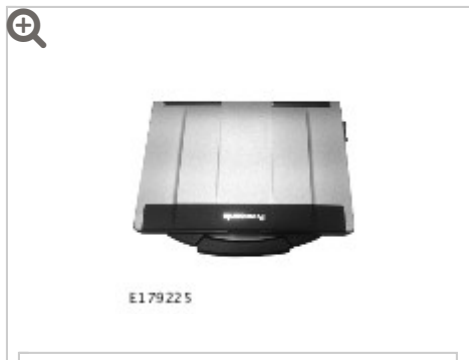
Jaguar Land Rover-approved diagnostic tool with latest SDD software, Calibration File, and InControl© Touch Pro™ Software
