## 6 Speed Transmission mechatronic sleeve replacement

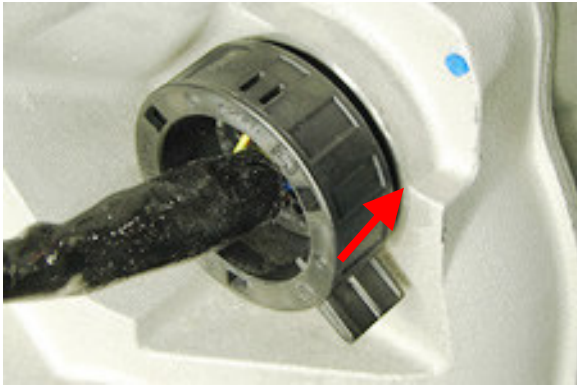
1. **Drain the transmission fluid and remove the transmission oil pan.**  
On applications with steel oil pan also remove the oil filter.
2. **Unlock and disconnect the vehicle electrical connector from the transmission.**

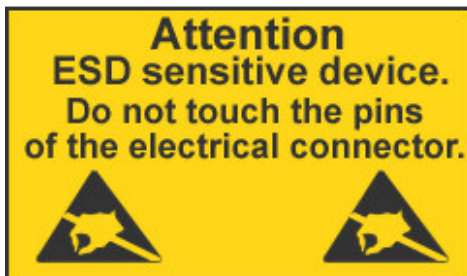
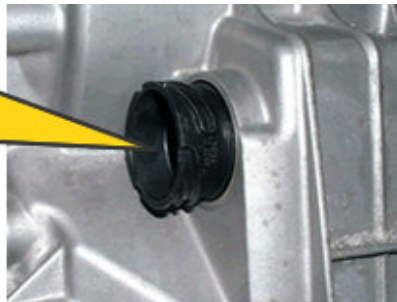
The Mechatronic (electronic valve body) located within the transmission is an electrostatic sensitive device, avoid touching any electrical pins to prevent ESD (electrostatic discharge) damage.

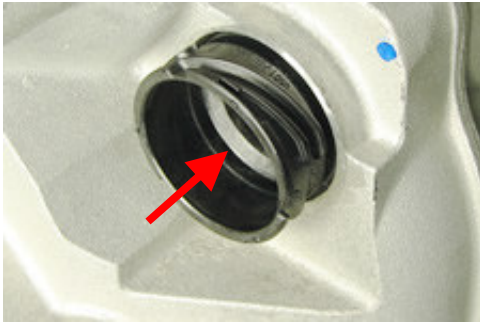
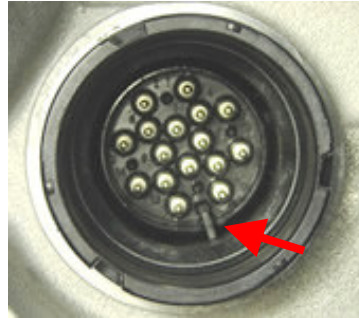
5. Lubricate the sealing sleeve o.-rings with Vaseline and push the sealing sleeve back into place. Avoid twisting or rotating of the sleeve as this may cause damage to the connector pins. Do not force the sleeve in place and pay close attention to the proper alignment of the locking tab.
