# **ZF Trouble Shooting Guide**

**JLR 13 38 10\_2E**

The ZF Trouble Shooting Guide (TSG) is a knowledge-based system. It is designed to aid diagnosis of transmission-related faults which have previously been encountered with ZF products in Land Rover applications.

The guide is intended to cover 6 speed transmission vehicles, which include the following;

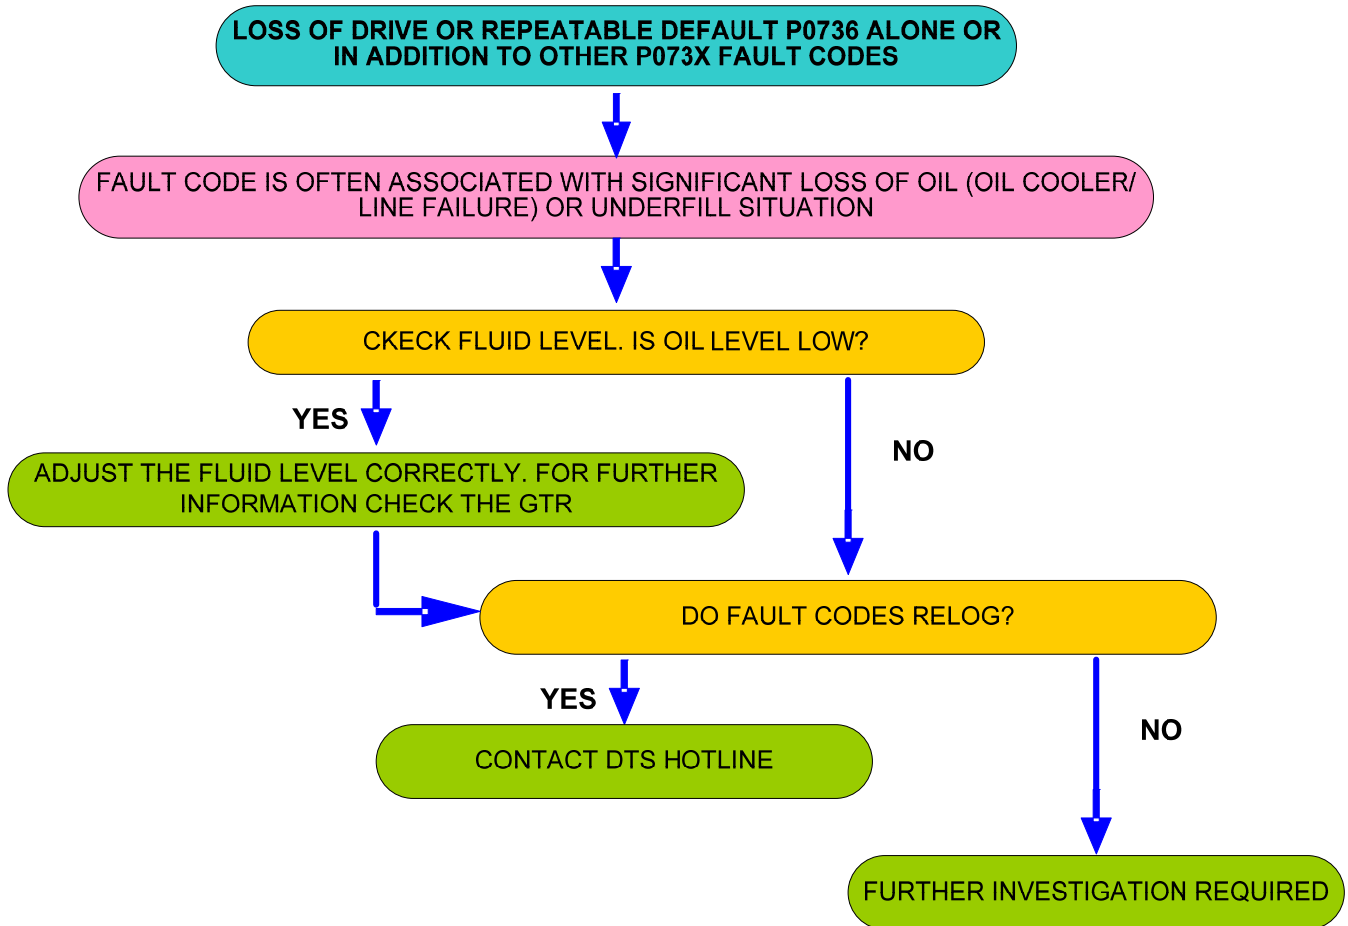
## Intermittent Loss Of Drive

# P0736, P073X
