TECHNICAL BULLETIN

JTB00399NAS1

Front End Panel Alignment

F-TYPE (X152)

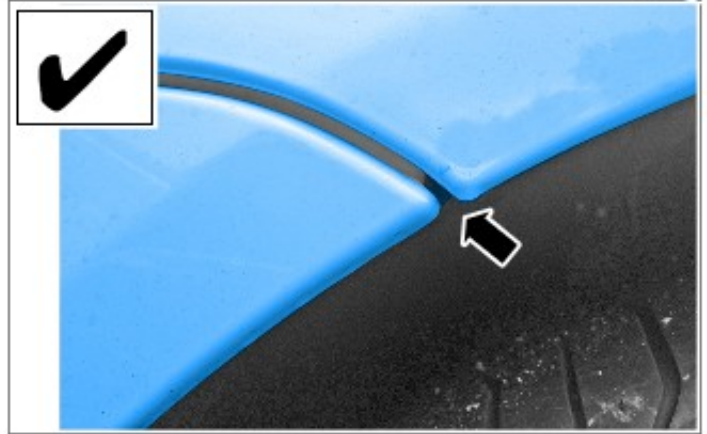
5. Check area shown for correct bumper cover-to-hood alignment - '✓'.

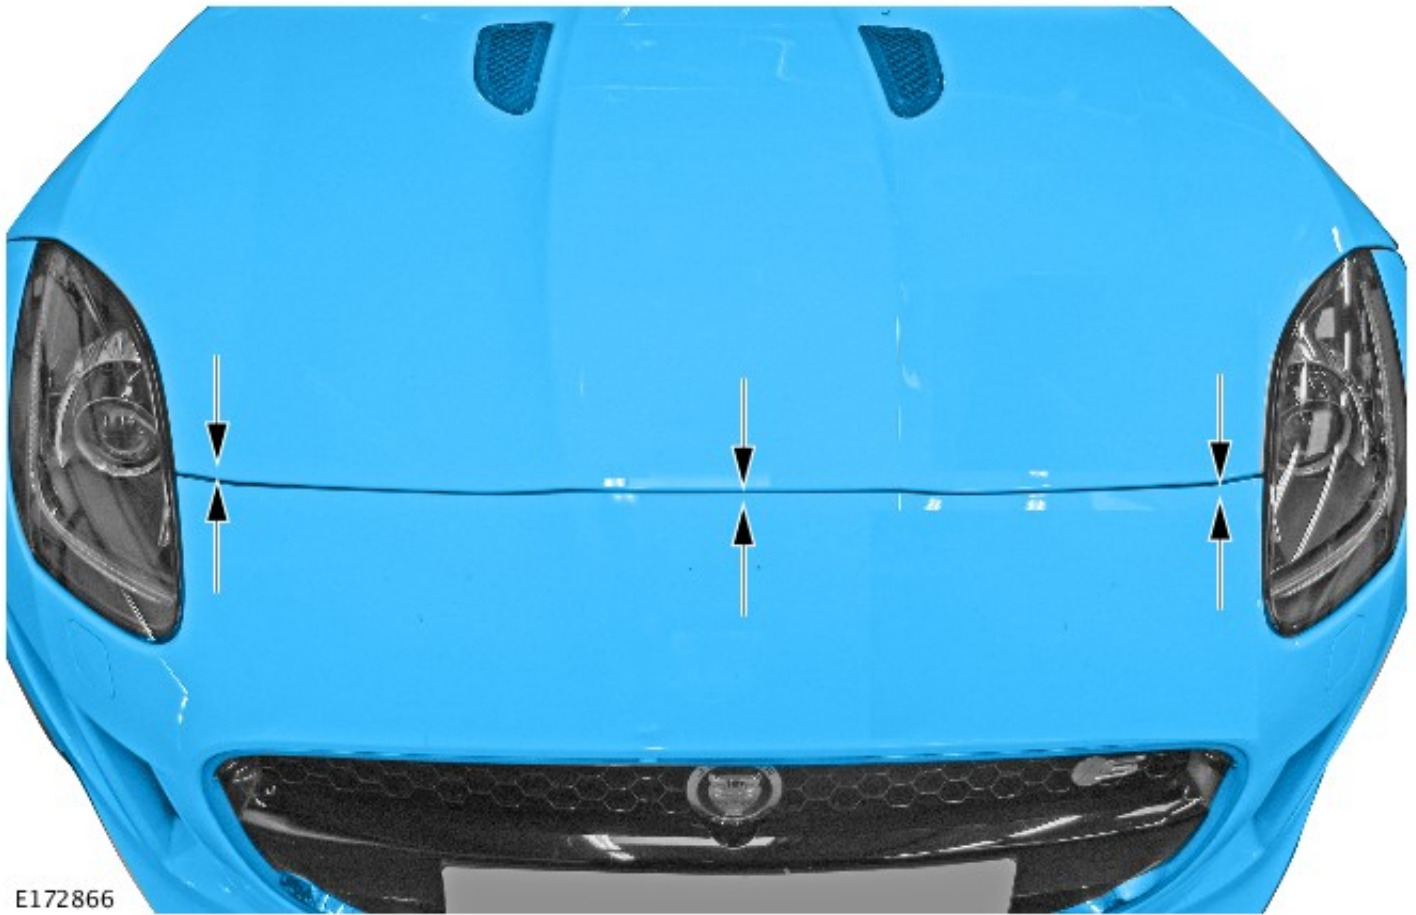
E172866

7. Check the area shown for correct bumper cover-to-hood alignment.
