## **Fitting grease nipples to lower balljoints of X200**

My S Type (X200 V6) at 126000kms, has had a strange creaking in the lower ball joints that is annoying, and adds stiffness to the steering, as well as a general harshness to the ride of the car.

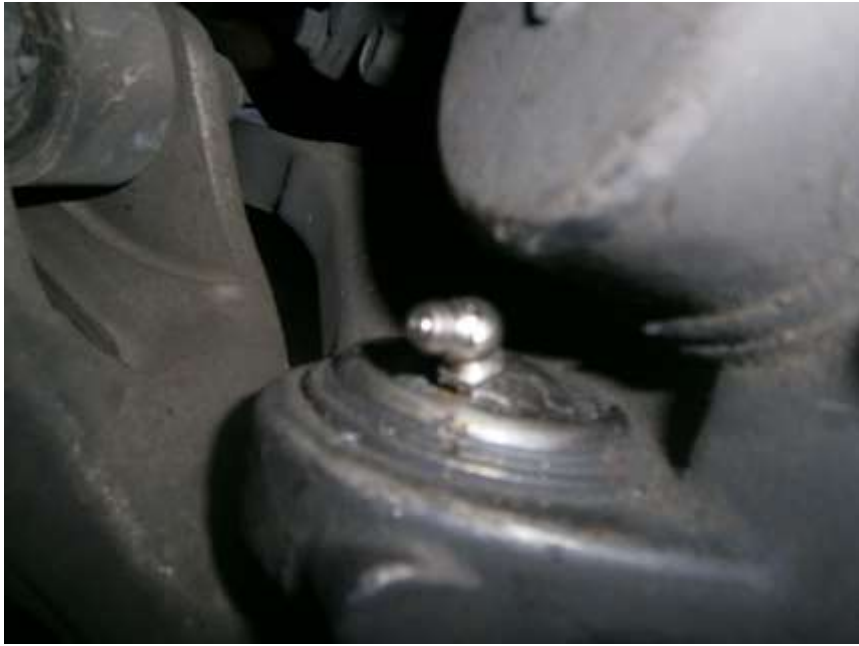
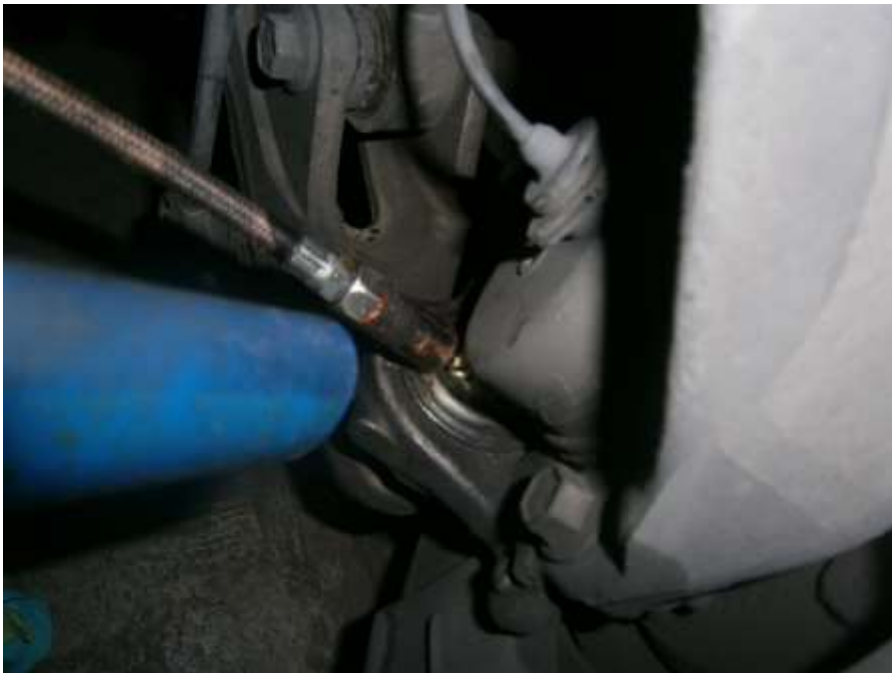
The 2 snaps show the installed nipple, and the grease attached to the finished job.

- 6) Make a centre piunch mark in that cap.
- 7) Attach a STRONG magnet to that cap adjacent to that mark.
- 8) Drill a 2mm hole in that cap. The STRONG magnet will attract the filings, so fear not.

- 9) Enlarge that hole to 5mm, and tap a thread to suit the grease nipple to be used. I used a 1/4NF tap, as the nipples I used are 1/4NF threaded.
- 10) Screw in the nipple, and tighten so that grease gun nozzle access is possible.

- 11) Attach the grease gun and pump that joint with grease. Swivel the stub assembly from lock to lock a few times, and then grease it some more.
- 12) Refit the road wheel, and lower the car.
