TECHNICAL BULLETIN

No: JTB00183
Issue: 1
Date: 07 JAN 2010

Air Conditioning System Not Cooling Sufficiently

MODIFY AIR CONDITIONING COMPRESSOR VALVE SPRING

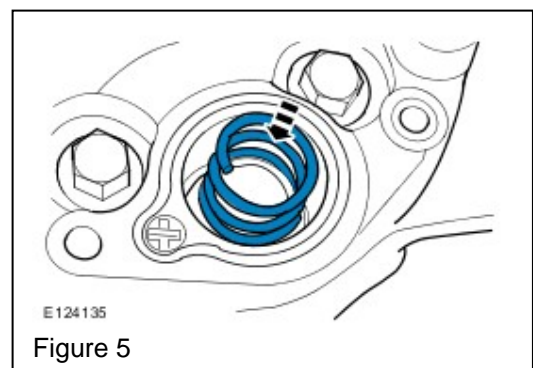
8. Install the A/C compressor valve spring. (Figure 5)
