Connector: **C44-L**

Description: **Rear bumper harness to telematics harness**

Location: **Adjacent to spare wheel - LH side**

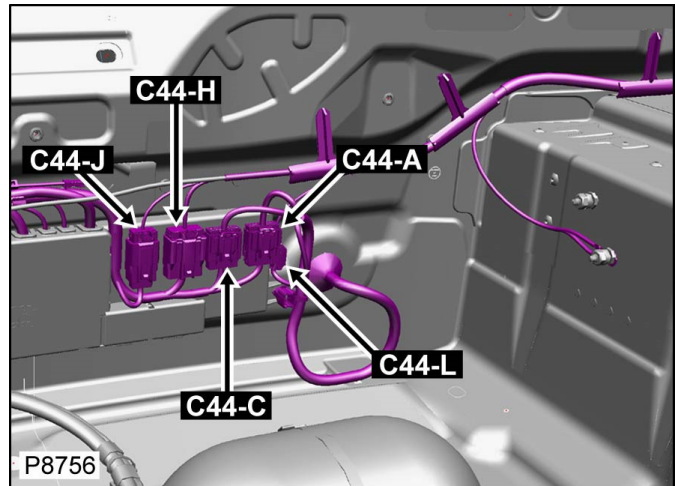
Part No.: **YPC902310**

Cavities: **4WY**

Harness: **REAR BUMPER HARNESS**

CAV	CSA	COL	CCT	DESTN	Pre-Terminated Lead	Extract Tool	Crimpers	Wire Stripper	Heat Shrink Sleeve	Ident Sleeve	Splice
1	0.5	GN	J3KAB	C4MP19	418-411-45	-	418-116A	418-117	-	418-112	418-107
2	0.5	GN	J3KAB	C4MP19	418-411-45	-	418-116A	418-117	-	418-112	418-107
3	0.5	YE	J3KAB	S/JOINT SPL266	418-411-45	-	418-116A	418-117	-	418-112	418-107
4	0.75	GN	J3KAB	C4MP19	418-411-45	-	418-116A	418-117	-	418-112	418-107
