2000 XJ RANGE - Automatic Transmission/Transaxle - Vehicles With: Supercharger - 307-01

Transmission Fluid Pan Gasket 44.24.05

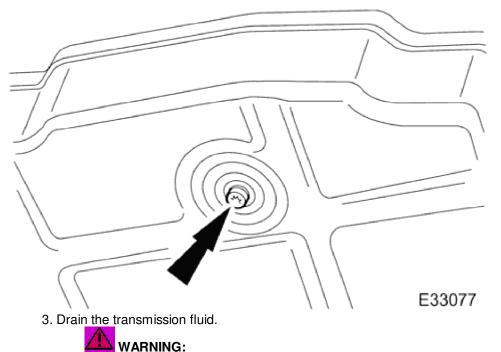
TRANSMISSION FLUID MAY CAUSE SEVERE BURNS, ENSURE THAT ALL SAFETY PROCEDURES ARE OBSERVED AND THAT THE RECEPTACLE FOR WASTE HAS SUFFICIENT CAPACITY.

• Carefully remove the drain plug and discard the sealing washer.

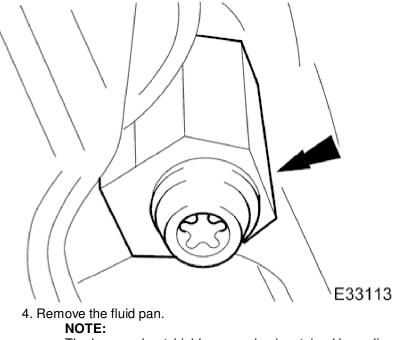
The harness heatshield upper edge is retained by a clip.

• Remove the six bolts and clamps which secure the fluid pan to the transmission.

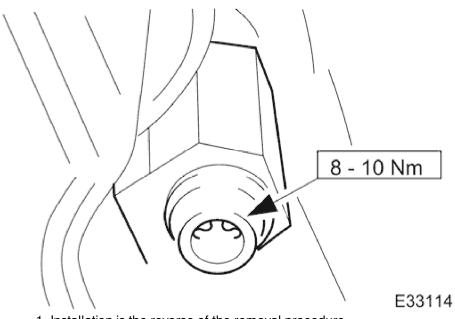
- 1. Installation is the reverse of the removal procedure.
 - Tighten the fluid pan retaining bolts to the specified torque figure.

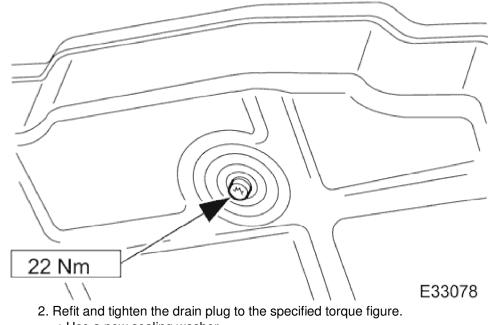
- Use a new sealing washer.
- 3. Refer to Operation **<<44.24.02>>** for fluid fill procedure.
- 4. Check for leaks and remove spilt fluid.
