1983 Jaguar XJS Rear Windscreen, Gasket, and Chrome Trim Installation

3rd Time – rear windscreen and gasket removal – reinstallation of same with sealant:

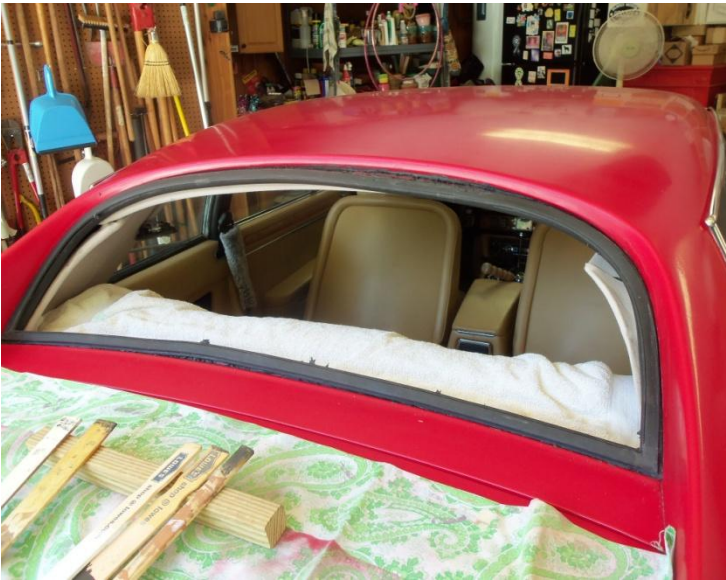
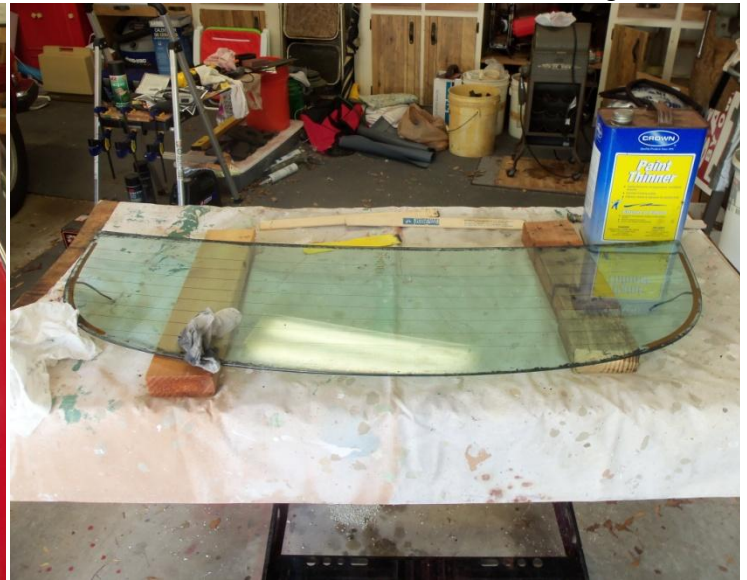
The first step is to remove the rear windscreen glass.

First, don't forget to unplug the defroster leads which are attached to each side of the rear windscreen.

The rear windscreen resting on wood to keep the still-sticky sealant from sticking to everything and getting all over everything.

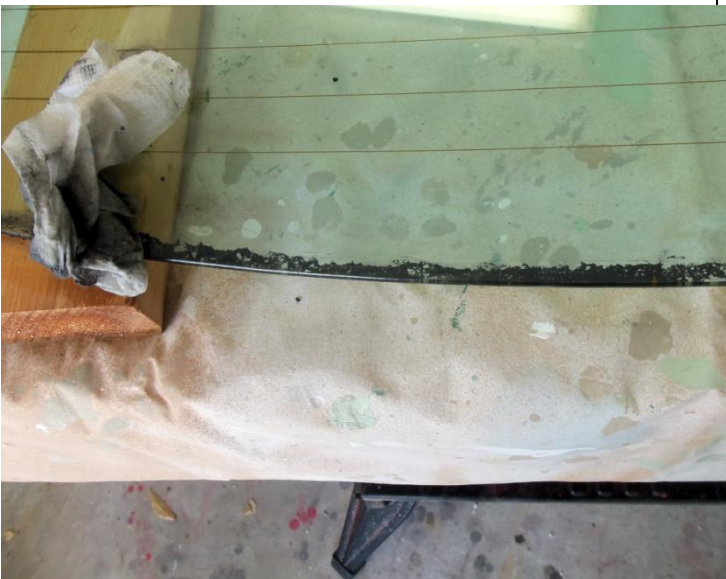
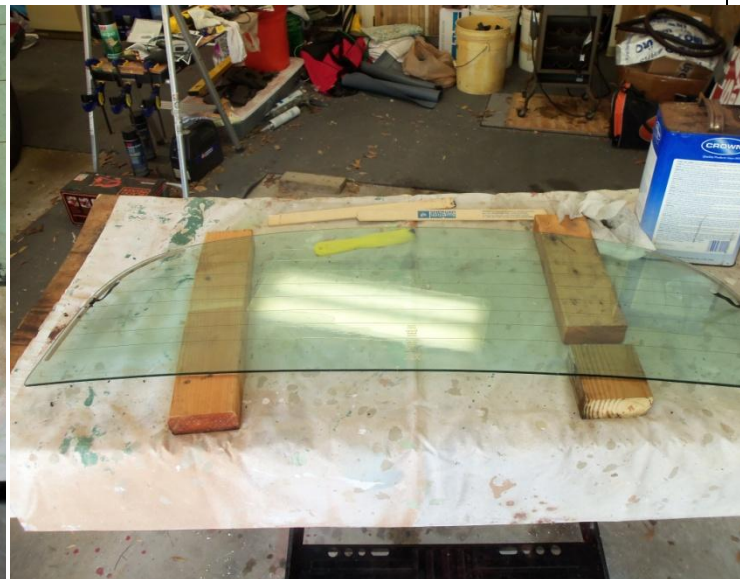
The first step is to use something which will not break or scratch the glass to scrape off as much sealant as possible – I found that a plastic putty knife worked quite well for that job, that yellow putty knife in the photo above became quite useful for all phases of this project.

After scraping off as much sealant as possible, the remaining sealant must be cleaned off.

Mineral spirits makes an excellent cleaner for cleaning the sealant off the glass and off the paint.

The sealant has been mostly cleaned off the glass at this point.

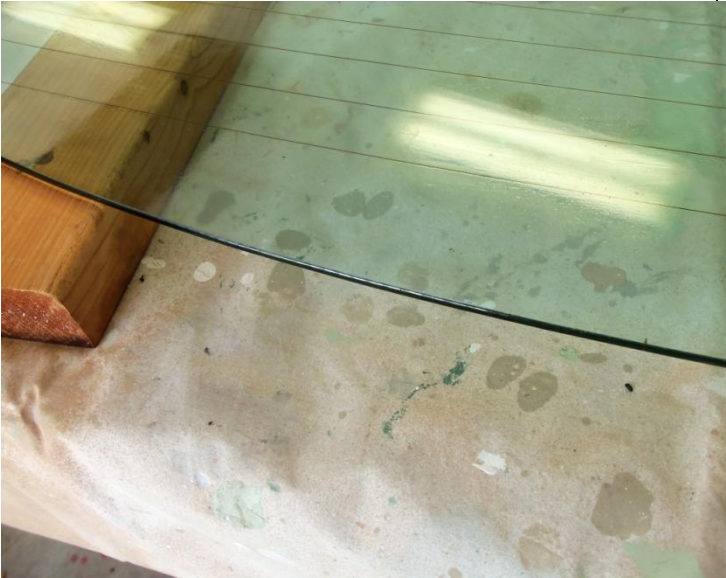
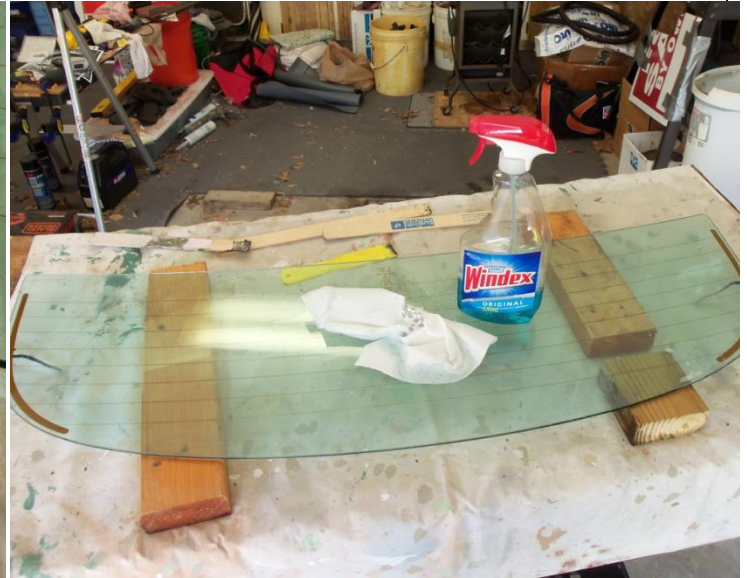
After cleaning the sealant off the glass.

Finished cleaned rear glass.

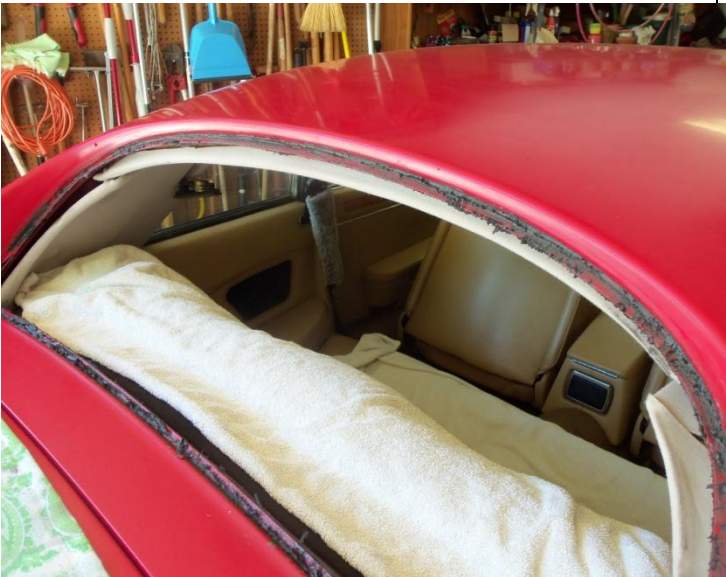
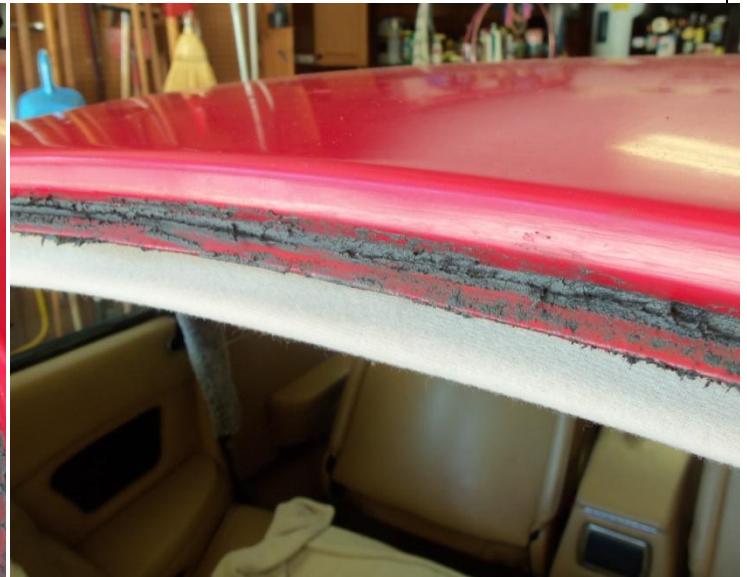
Remove the gasket and set it aside where it will not get anything messy from the sealant on it.

This (and the previous photo) shows the sealant which remained on the pinch-weld after removing the gasket.

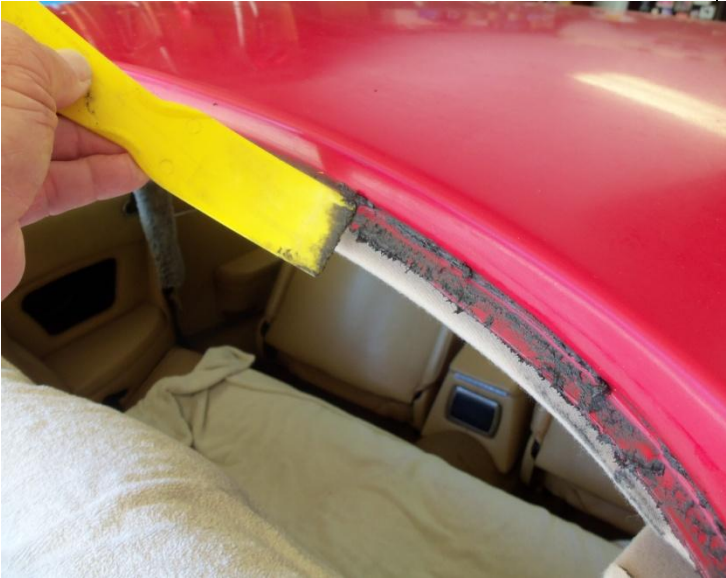
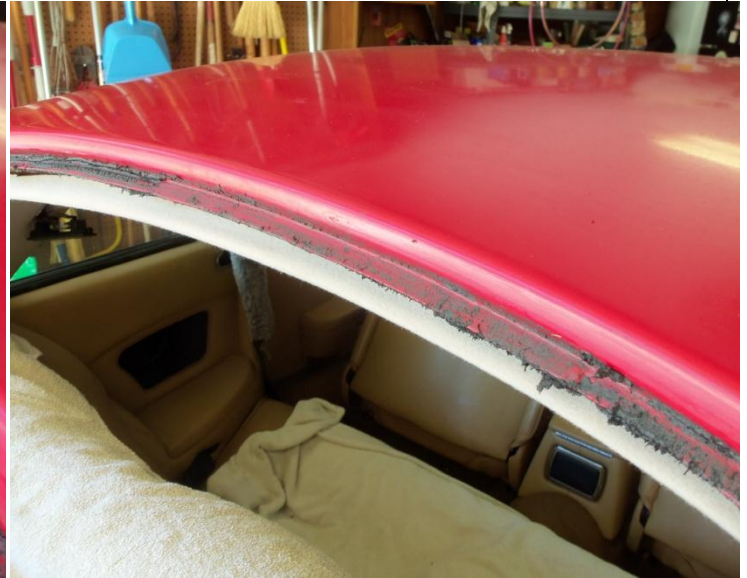
The yellow putty knife worked quite well in scraping off most of the sealant, as can be seen ...

... in this photo.

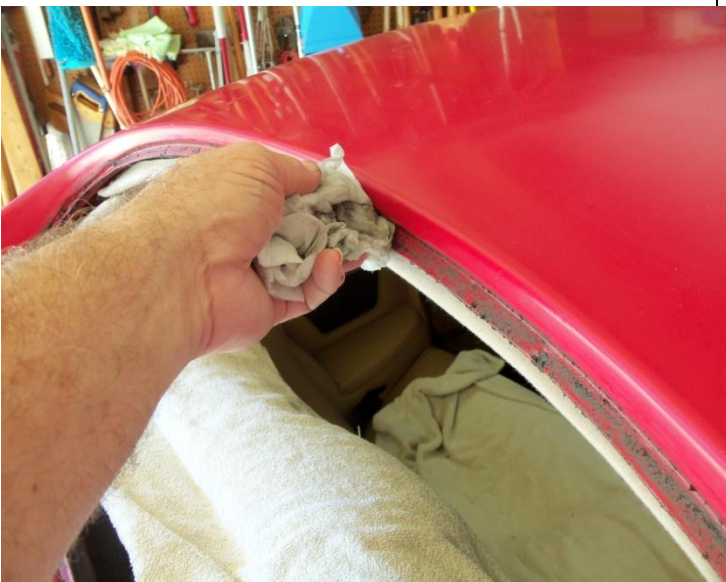
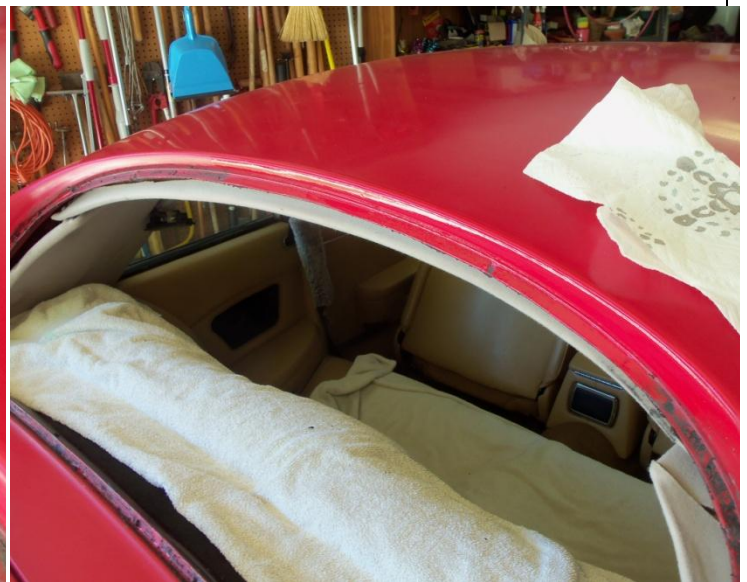
A paper towel wetted with mineral spirits (wetted but not soaked – you don't want mineral spirits dripping and squeezing out) ...

... works quite well is wiping off the remaining sealant.

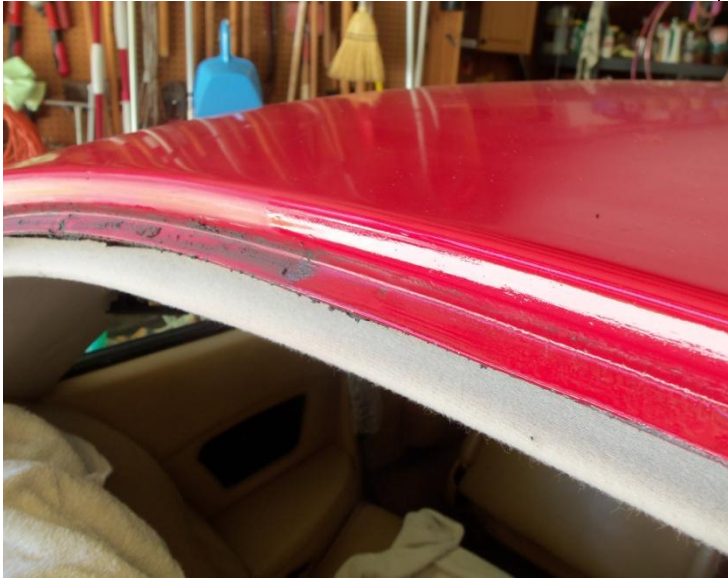
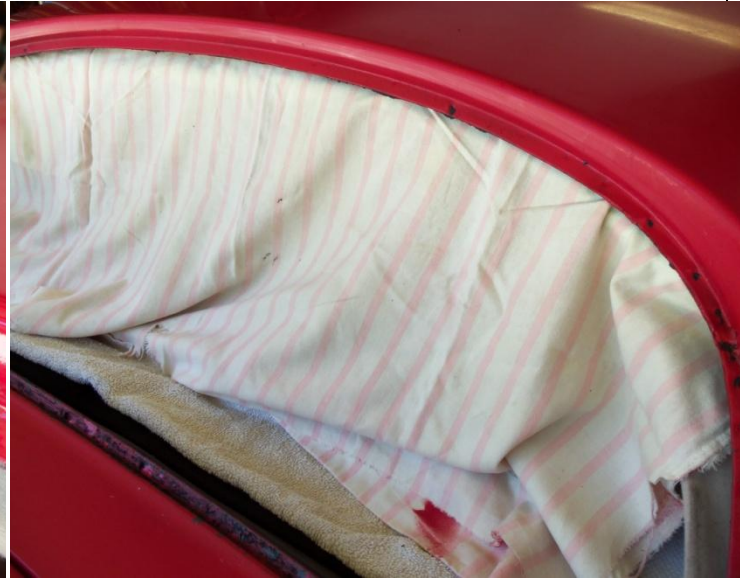
Closer view showing the results of wiping the sealant off with mineral spirits.

I used paper towels as that allowed me to keep using a fresh towel as they became coated with residue and left a lot of streaking behind.

Showing the top exterior side of the pinch-weld has been scraped clean and wiped clean.

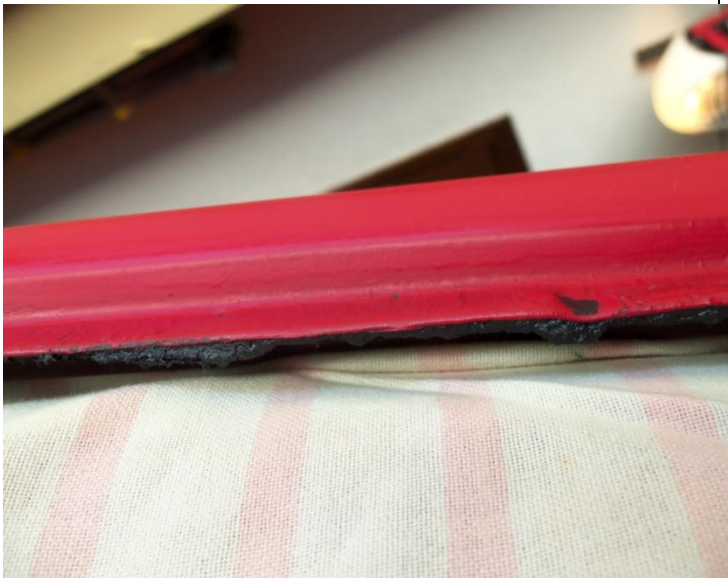
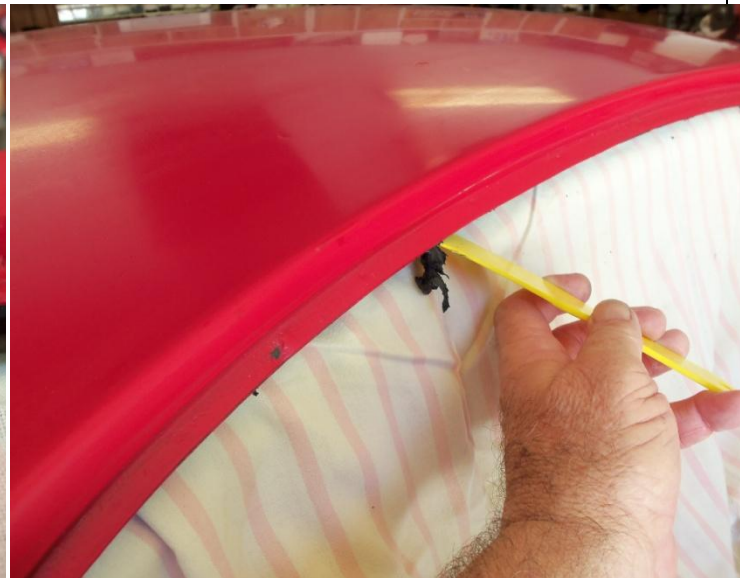
Shows sealant on the inside (underside) of the pinch-weld which is ready to be cleaned off.

Yellow putty knife in action again!

See what I mean about the sealant and the headliner? If the headliner was not protected – it would be smeared with sealant when the sealant touches it.

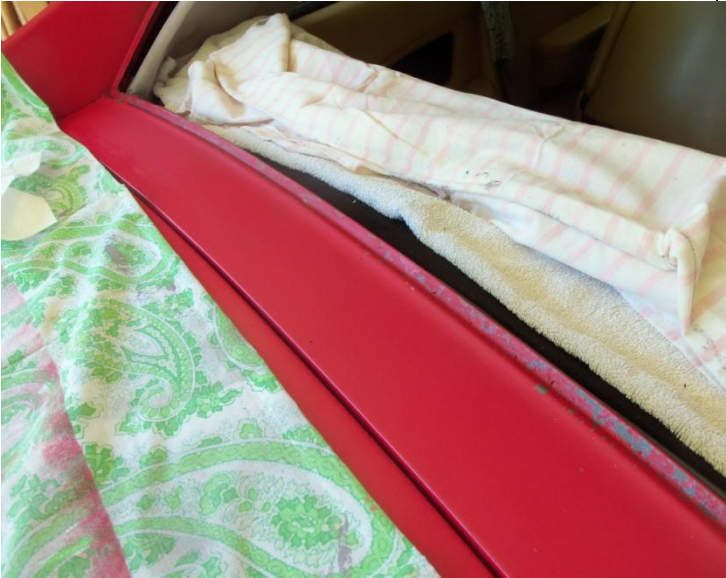
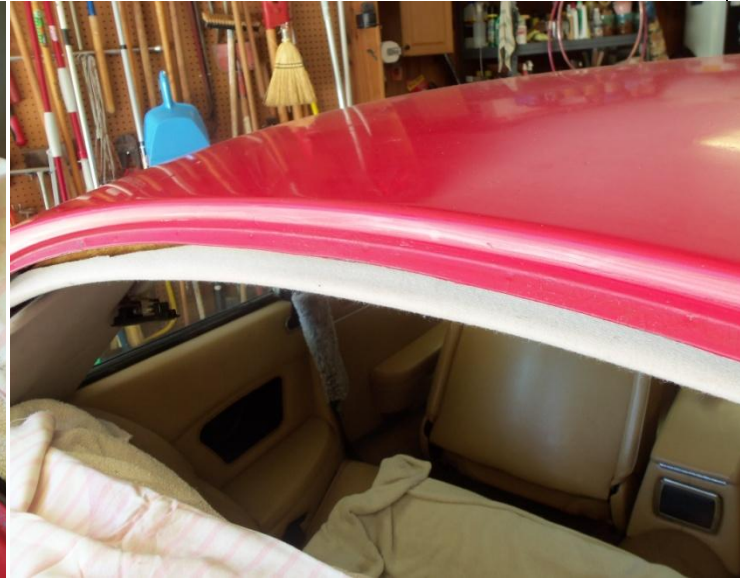
Showing the pinch-weld flange has been cleaned – along the bottom, the sides, and ...

... across the top.

The opening is now ready to receive the glass / gasket / chrome trim assembly.

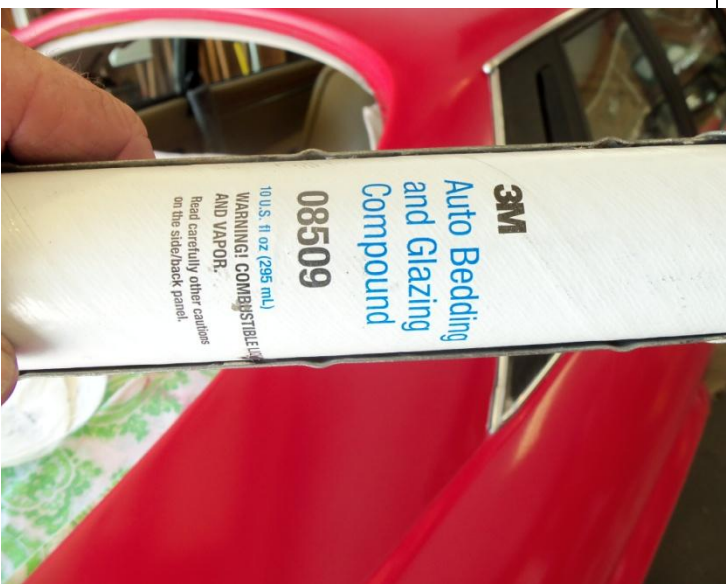
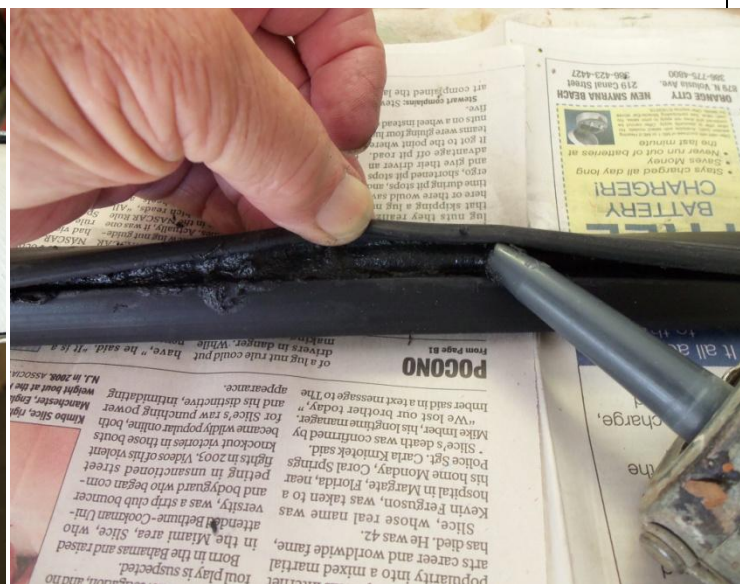
This is the 3M Auto Bedding and Glazing Compound 08509 which I found and used.

Applying sealant to the inside of the gasket.

One tube is all that is needed for the rear windscreen.

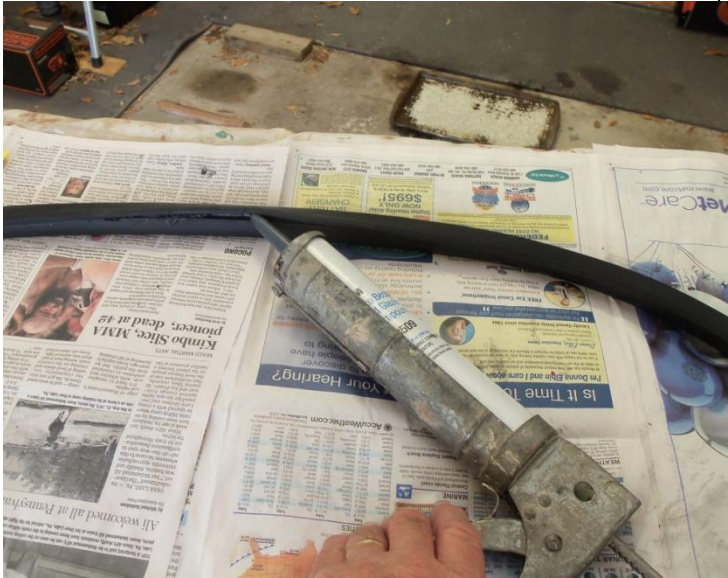
Applying sealant all the way around the inside of the gasket.

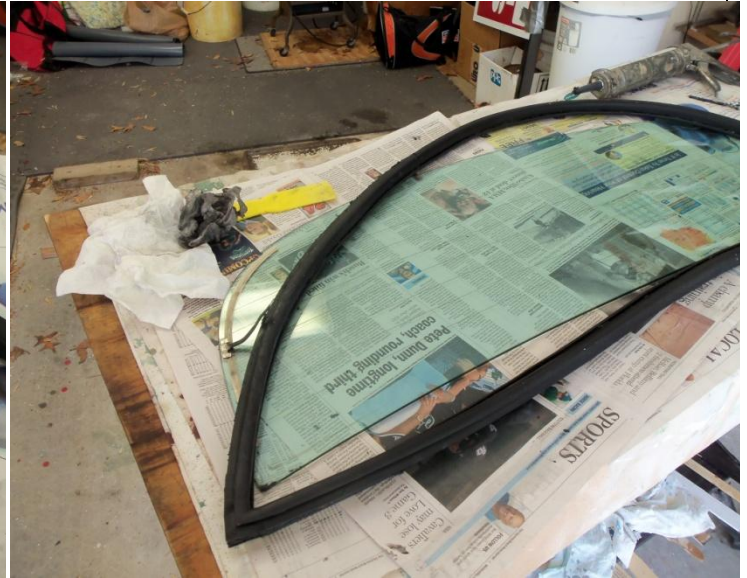
The gasket now has sealant around the entire inside groove which will receive the glass.

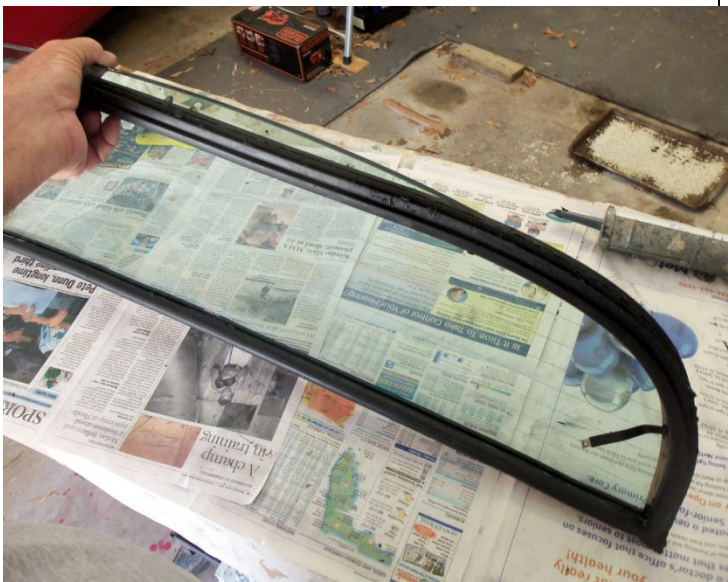
Start by setting the glass in the bottom of the gasket, then with the glass vertical (or mostly vertical, however you have to tilt it to work with it), then push the gasket onto the glass so the glass is snugly in the gasket.

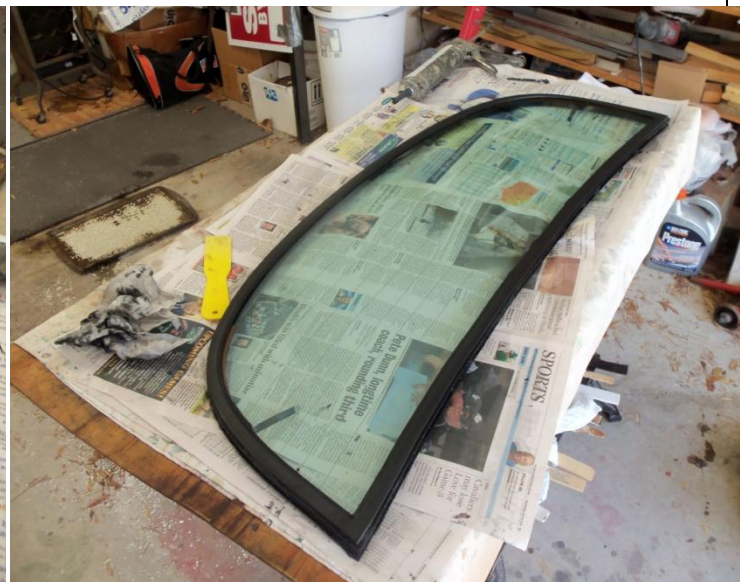
The rear glass is fully in the gasket and ready for the next step – installing the chrome trim.

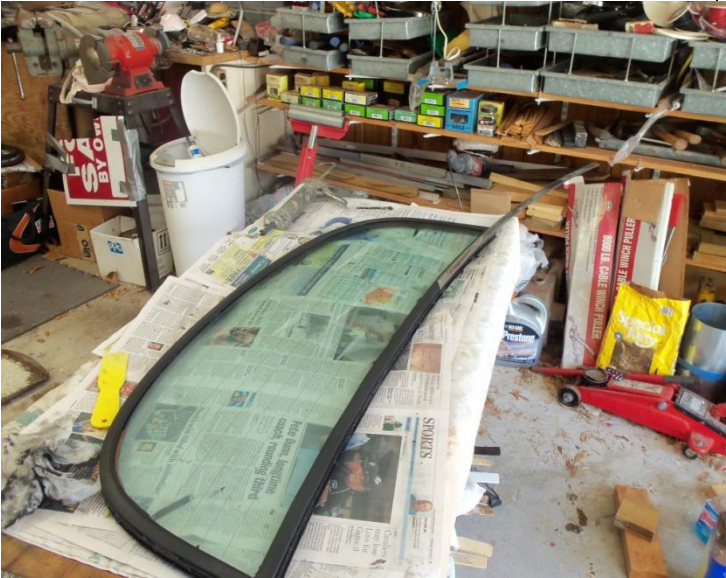
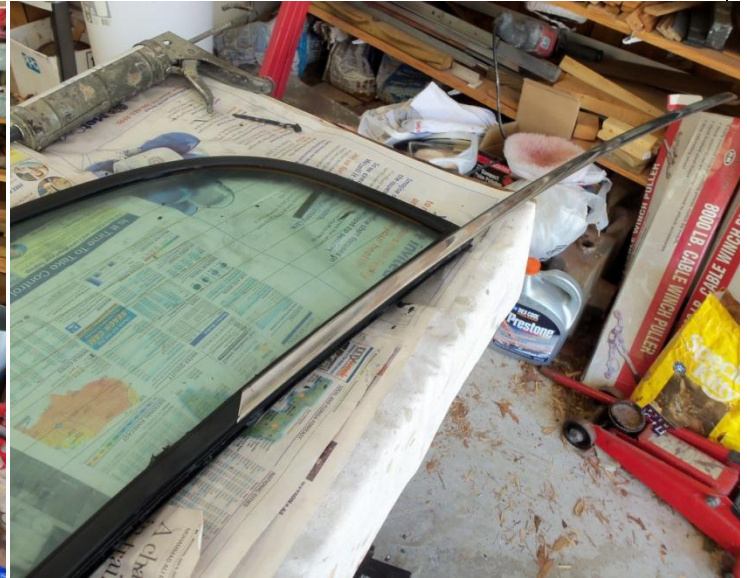
Installing the chrome trim ... easier said than done.

I could not get the lip of the bottom chrome trim to stay in its groove in the gasket until I tried sliding the bottom chrome trim in from one end ...

... sliding the chrome trim in from one end is not an easy thing to do because the more of the chrome trim you get on, the more friction and interference there is to resist sliding it further.

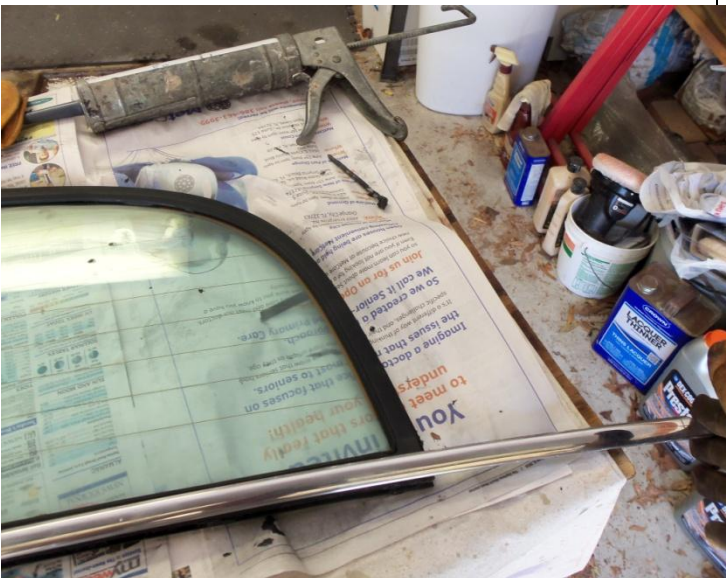
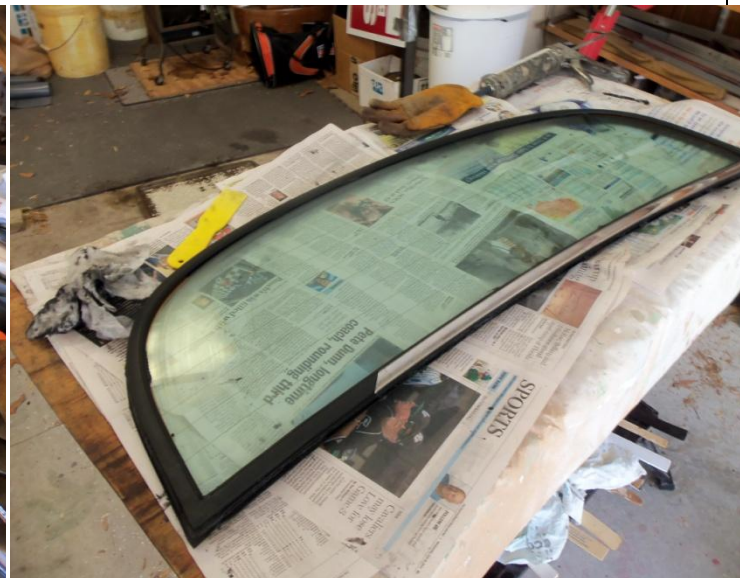
When pushing the bottom chrome into the slot, be very careful not to bend the chrome trim (I didn't bend it, but I felt like it would be an easy slip-up to make, and then the chrome trim may not be useable).

See the leather gloves on the working table?

You will need to use leather gloves to keep the chrome trim's pointed ends from poking through your skin. My leather gloves have a seam (doubled leather thickness) across the palm area; I had to use the doubled seam to keep from poking the end of the bottom chrome trim through the leather glove.

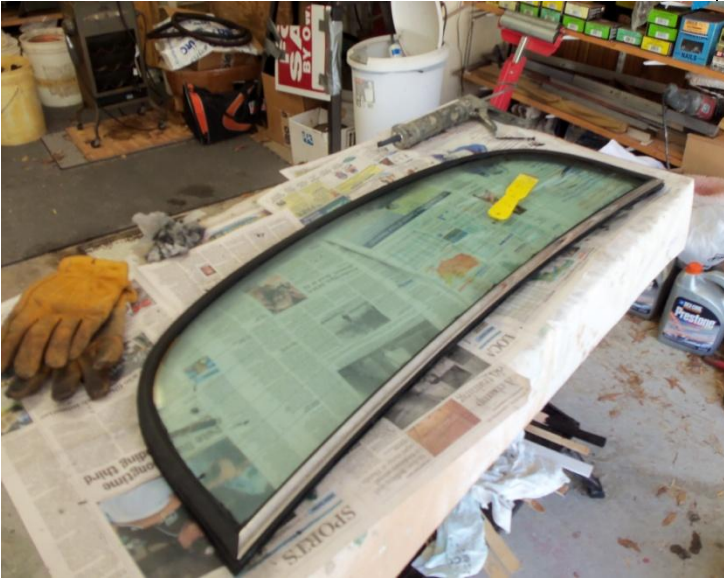
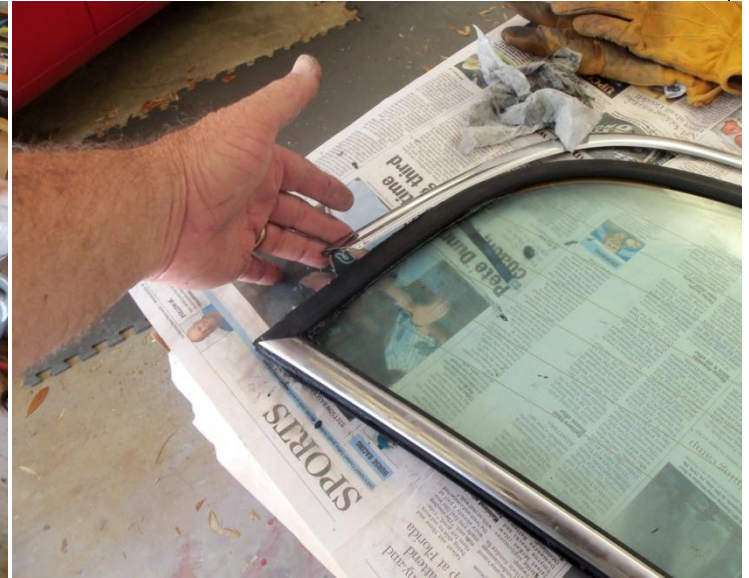
But, with patience, the bottom chrome trim can be slid into its groove in the gasket and the bottom chrome trim is now in place.

Start the top chrome trim at one end, I found it easier (for me) to start at the left end.

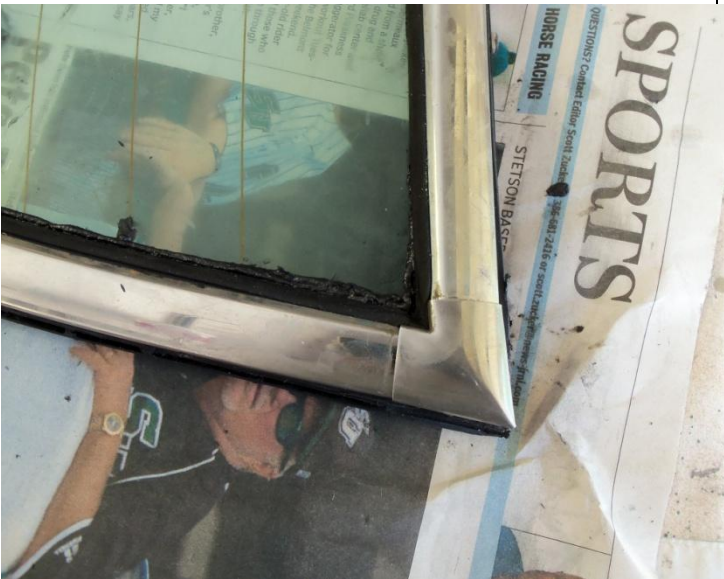
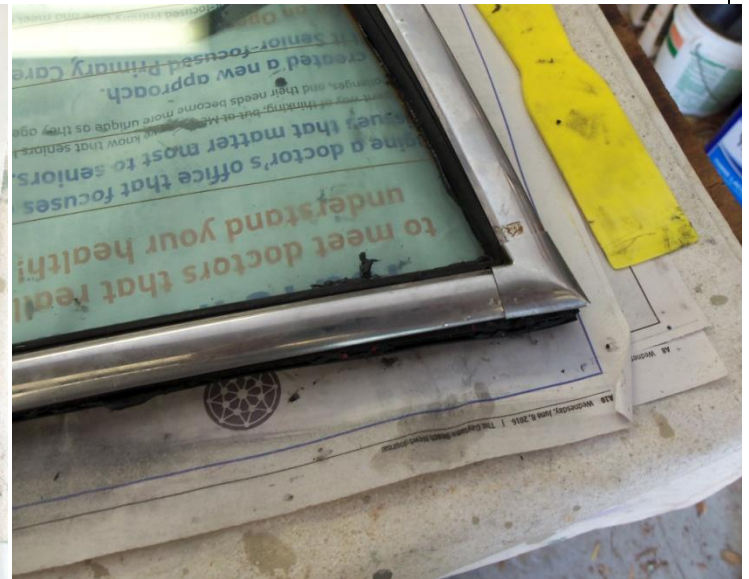
Make sure the top chrome trim fits into its groove fully and properly; then install the corner piece (the corner pieces appear to be identical and interchangeable).

When you get all the way around the gasket and the other end of the top chrome trim meets the end of the bottom chrome trim, install the other corner piece to hold it in place.

Then work up and around the top of the gasket with the top chrome trim.

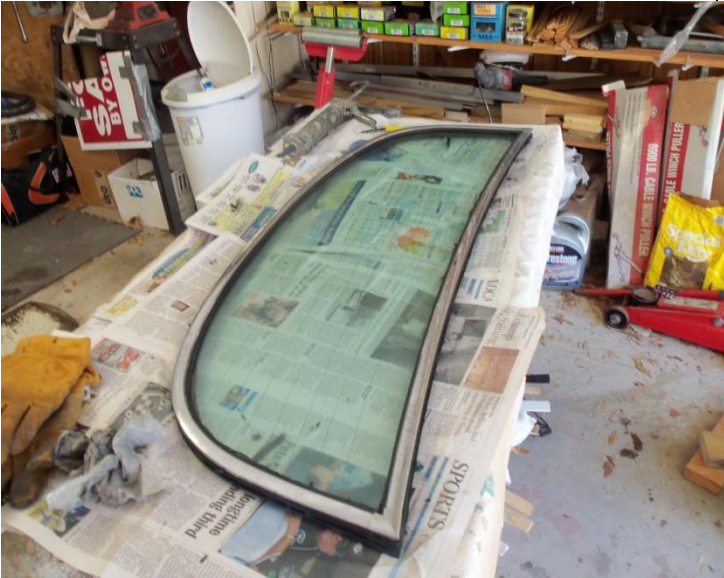
Chrome trim installed.

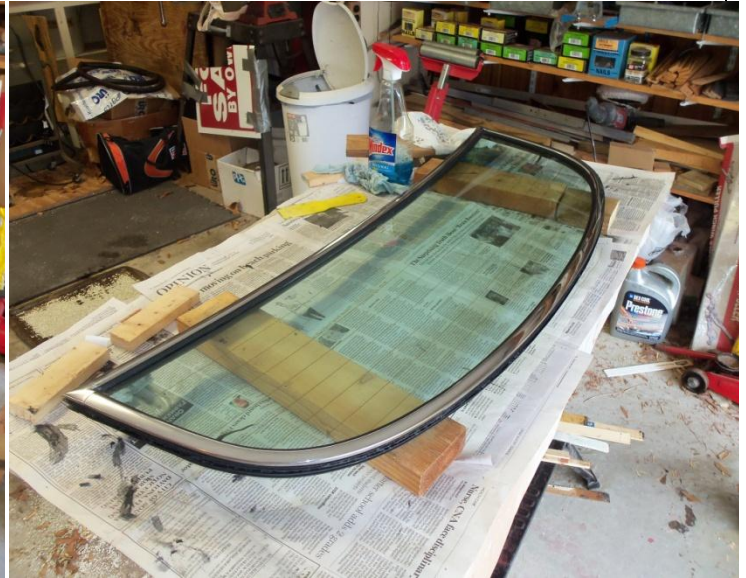
Another view of chrome trim installed.

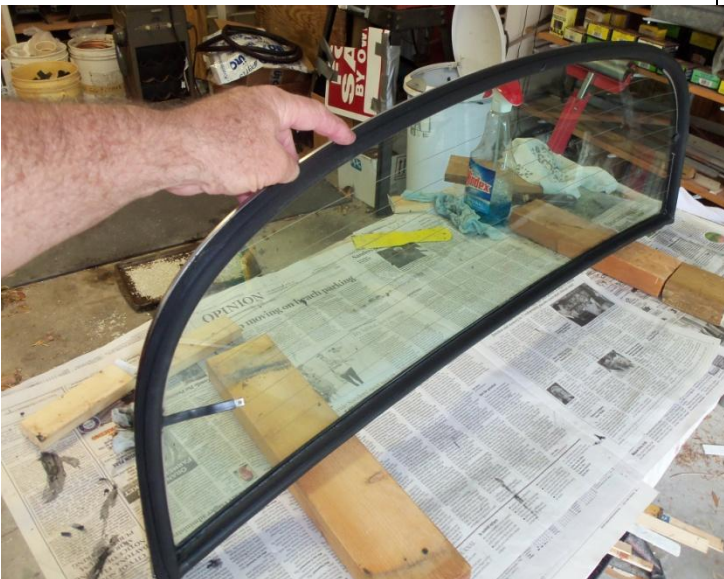
Carefully check all the way up and around the top chrome trim to make sure that it went into its groove properly – mine did not.

I used a 5-in-1 tool (I keep a well used and worn 5-in-1 tool which has no sharp point or sharp edges to use for project like this) to work the gasket up and under the top chrome trim as it should be. If you don't check this and if the chrome trim is not fully on the gasket ... you may end up in the unfortunate position of having the completed assembly installed ... and a loose top chrome trim.

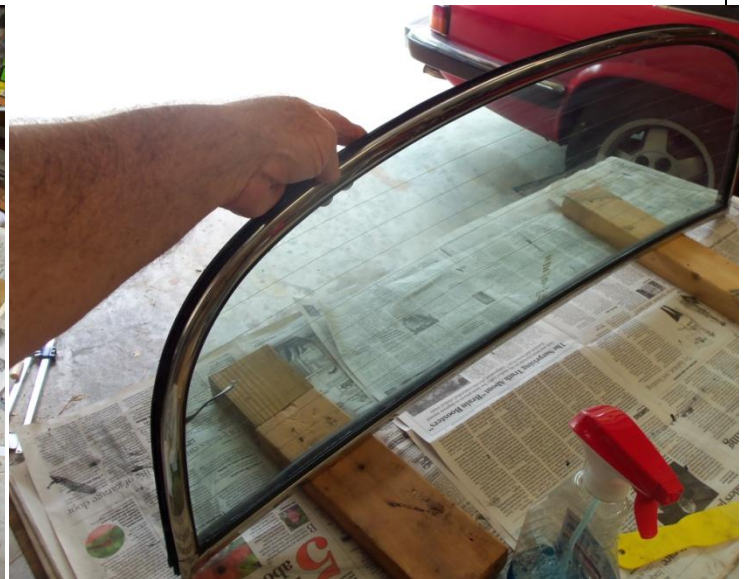
I would take all precautions necessary to not end up with a loose top chrome trim after the completed assembly is installed – that would mean going back and repeating the entire removal, cleaning, and installation process again.

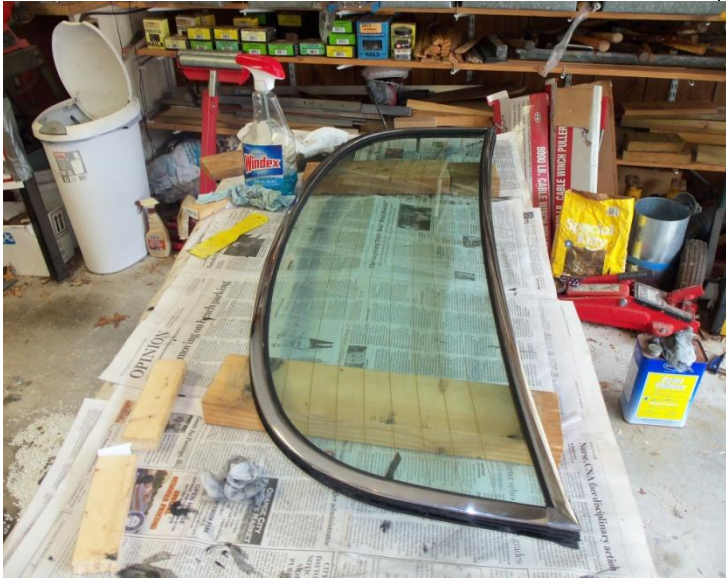
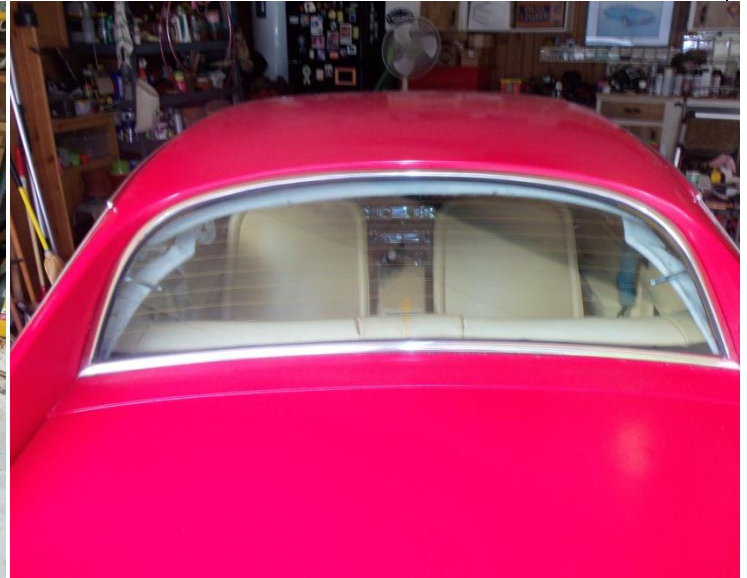
I cleaned the glass, inside and outside, one more time before I installed the assembly into the opening in the body.

This is the installed glass / gasket / chrome trim assembly installed from outside.

The inside has not been finished yet.

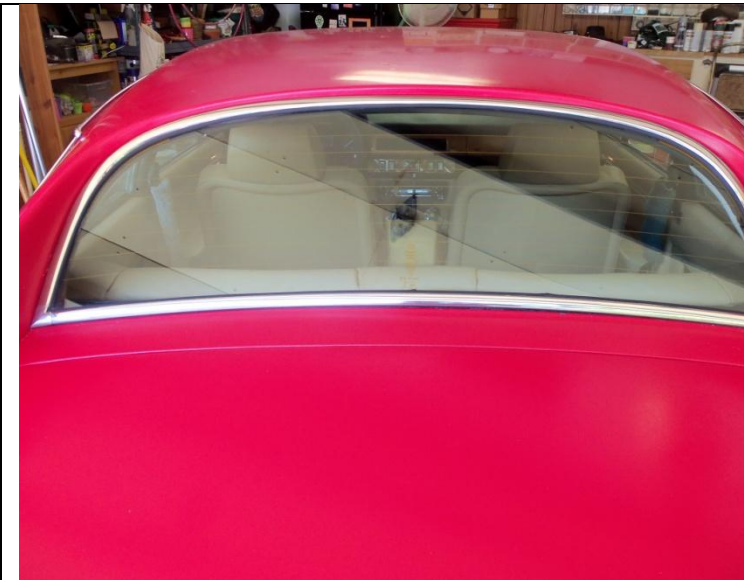
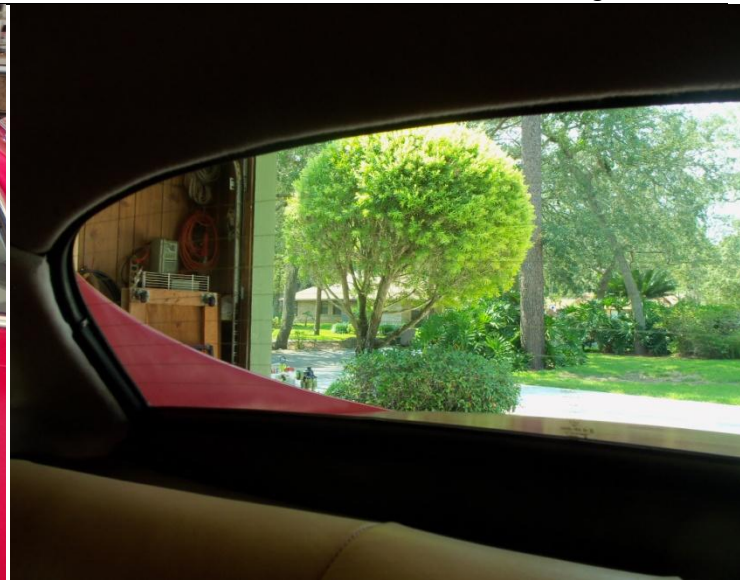
The completed installation after cleaning the glass, inside and outside, one more time.

As viewed from inside.

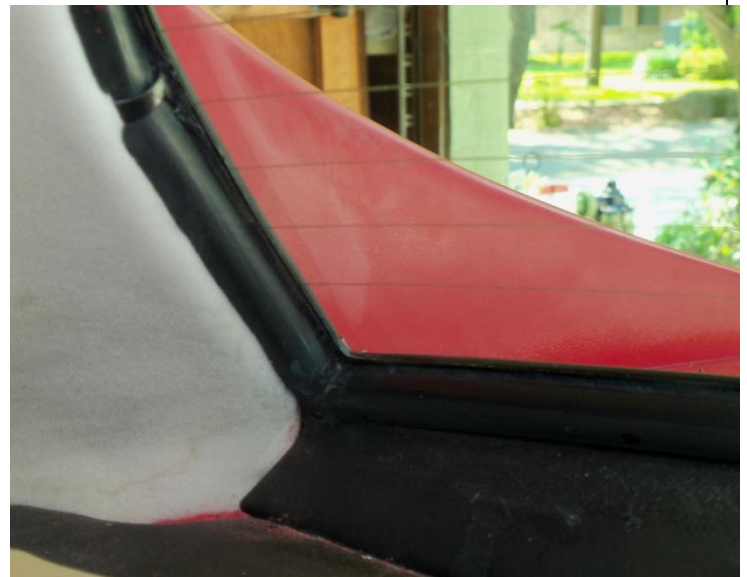
Closer view from inside, shows the headliner pieces tucked into the gasket lip as intended to be.

The headliner also tucks into the gasket lip, which holds the headliner up at the rear windscreen and keeps it in place.
