Adjusting the ECU fuel pot.

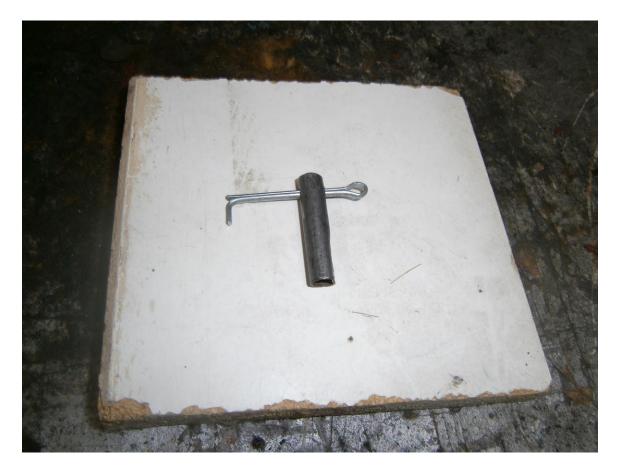
Locate the ECU, on the RH side of the boot area, behind the trim panel alongside the battery. Feel along the lower edge, just a little along from the edge that the plug goes into, near the vac hose spigot. It will feel like a rubber plug with a hole in the middle. Originally it had a plug in that hole to stop tampering, but they are long gone, mostly. Inside that hole is the shaft of the potentiometer that adjusts the idle fuel map. The shaft of the pot is <sup>1</sup>/<sub>4</sub>" diameter (I think), and of standard "D" shape. I had a piece of transmission cooler steel tubing (which is 5/16"od, with a <sup>1</sup>/<sub>4</sub>" bore, or close).

I simply filed a <sup>1</sup>/<sub>4</sub>" bolt flat on one side to give me the "D" I wanted, slid the tube over the end and tapped it into shape. This tube is about 2" long, so I drilled a hole in the opposite end to take a nail that gave the handle so it can be turned to adjust the pot.
