LED Warning Light

Fig. 2
XJG (1993 Model Year) SECURITY SYSTEM

Additional fitting instructions
LED and Valet Switch installation
With this kit a new LED bezel is provided to fit into the LED bezel location. The LED bezel is provided to fit into the LED bezel location.

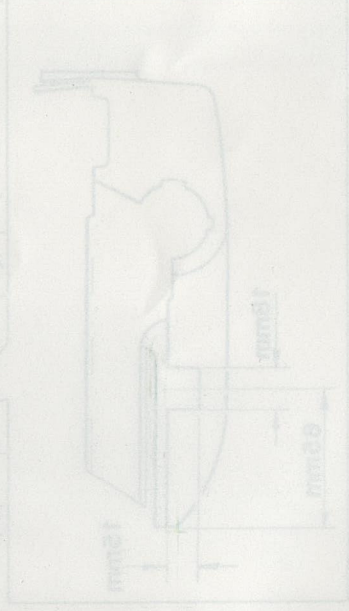
Mark the position for the LED hole as detailed in Fig. 2.

Position a piece of masking tape as detailed and mark the position 40mm. from the top of the stalk aperture.

Using a suitable drill (size C), drill the LED hole and deburr.
