Connector: **FL005**

Description: **Speed control sensor**

Location: **Behind center of bumper**

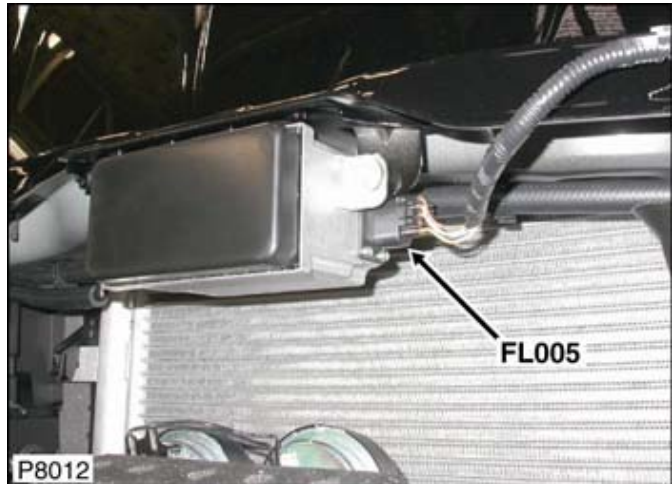
Cavities: **5WY**

CAV	CSA	COL	CCT	DESTN
1	0.5	Y	(GTDAC)	FL048
2	0.5	B	(GTDAC)	G01BR
3	0.5	U	(GTDAC)	FL070
4	0.5	Y	(GTDAC)	FL070
5	0.5	NW	(GTDAC)	S/JOINT FLS04
