Connector: **PI051**

Description: **Ground point**

Harness: **PETROL ENGINE V8 N/A HARNESS**

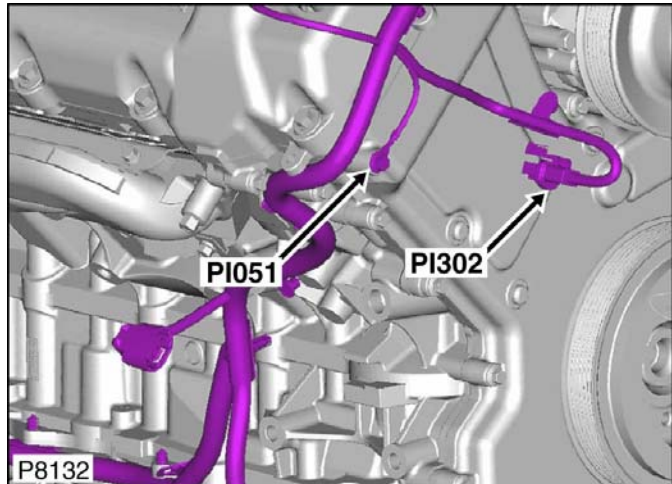
Location: **Front of engine - center**

Part No.: **YPG900360**

Cavities: **1WY**

CAV	CSA	COL	CCT	DESTN
1	2.0	B	(V_6)/(V_8)	S/JOINT PIS31
